[Docket No. 99-SW-81-AD]

#### Airworthiness Directives; Sikorsky Aircraft-manufactured Model CH-54A Helicopters

**ACTION:** Notice of proposed rulemaking (NPRM).

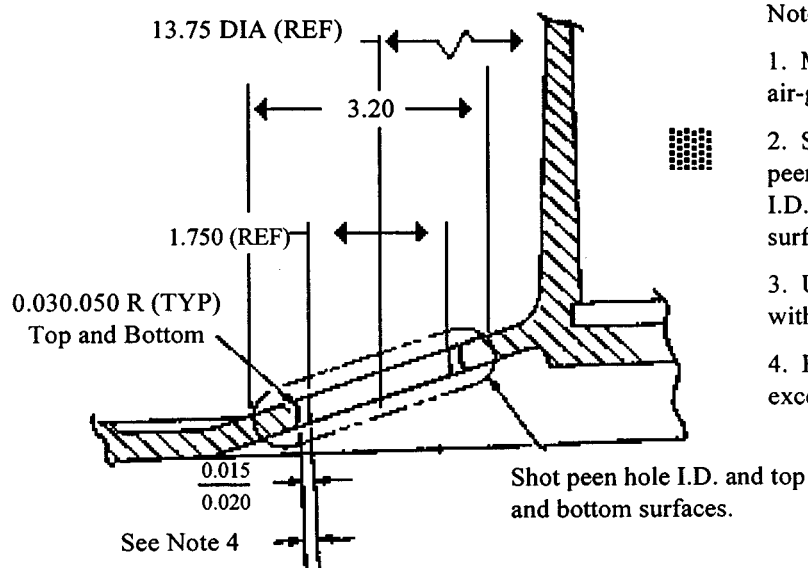
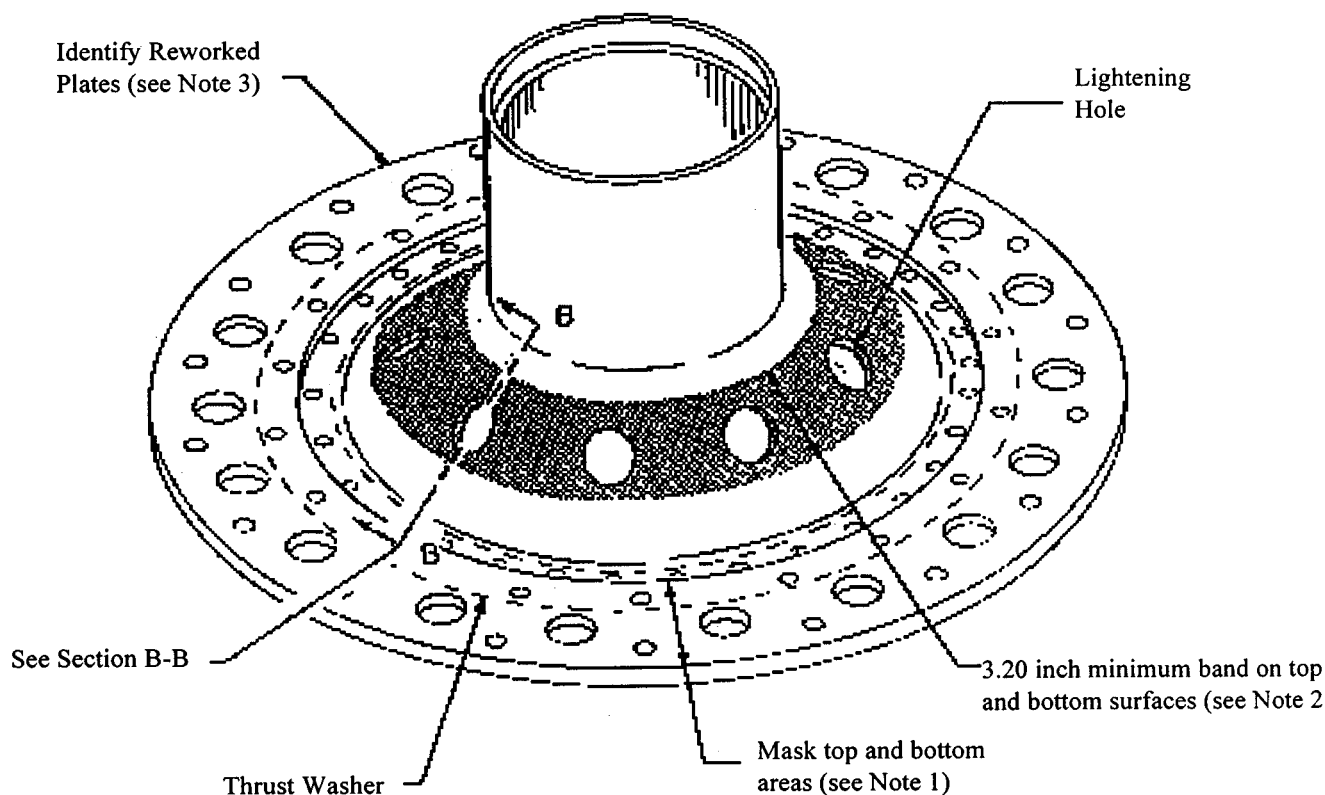
Rework of Second Stage  
Lower Planetary Plate (6435-20229-102)  
Figure 1

To prevent failure of the second stage lower planetary plate (plate), P/N 6435-20229-102, due to fatigue cracking, which could lead to failure of the main gearbox, failure of the drive system, and subsequent

(a) On or before accumulating 1,300 hours time-in-service (TIS), conduct a fluorescent magnetic particle inspection of the plate, P/N 6435-20229-102, in the circumferential and longitudinal directions using the wet continuous method. Pay particular attention to the area around the 9 lightening holes.

Section B-B  
(Typical Nine Places)

1. Mask top and bottom areas to protect from liquid air-grit and shot peen.
2. Shaded area to be liquid air-grit blasted and shot peened includes plate top and bottom surfaces and I.D. of all lightening holes. Feather shot peened surface edges.
3. Use low-stress depth controlled impression-stamp with full fillet depth of no more than 0.003 inch.
4. Reworked machined surface roughness shall not exceed 63 microinches AA rating.

(2) If no crack is discovered, rework the plate as follows:

(i) Locate the center of each 1.750 inch-diameter lightening hole and machine holes 0.015 to 0.020 oversize on a side (0.030 to 0.040 diameter oversize). Machined surface roughness must not exceed 63 microinches AA rating (see Figure 1).

(ii) Radius each hole 0.030 to 0.050 inches on each edge as shown in Figure 1.

(iii) Mask the top and bottom surfaces of the plate to expose 3.20 inch minimum width circumferential band as shown in Figure 1.

(viii) Identify the reworked plate by adding “TS-107” after the part number using a low-stress depth-controlled impression-stamp with a full fillet depth of not more than 0.003 inch (see Figure 1).

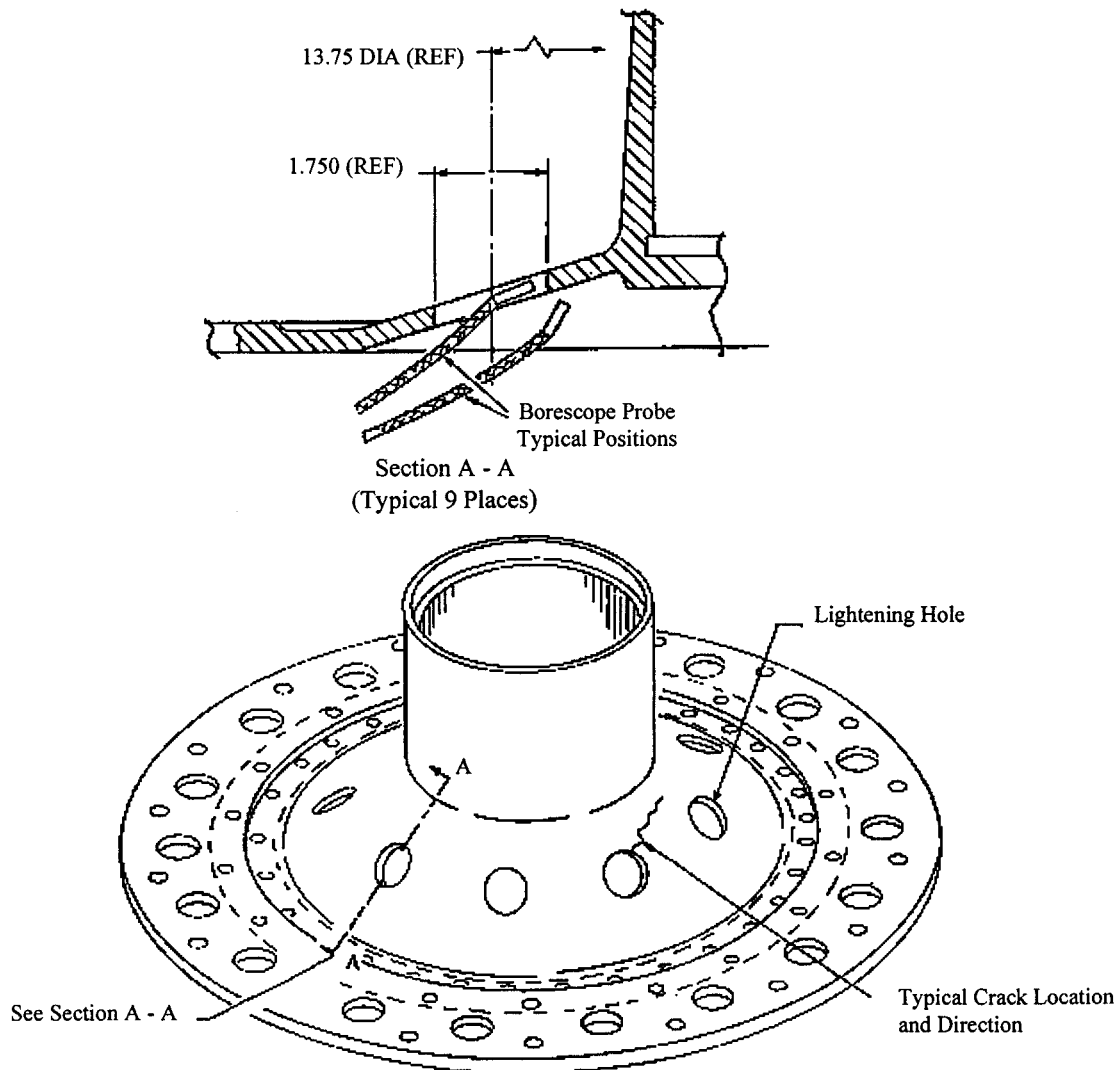
Borescope Inspection of  
Second Stage Lower Planetary Plate  
Figure 2

(b) For any plate, P/N 6435-20229-102, that has been reworked and identified with "TS-107," on or before the accumulation of 1,500 hours TIS and thereafter at intervals not to exceed 70 hours TIS, accomplish the following:

(1) Inspect the plate for a crack in the area around all nine lightening holes using a Borescope or equivalent inspection method (see Figure 2).

(2) If a crack is found, replace the plate with an airworthy plate prior to further flight.
