[Docket No. 2002-SW-22-AD; Amendment 39-12835; AD 2002-08-54]

**Airworthiness Directives; Bell Helicopter Textron Canada Model 222, 222B, 222U, and 230 Helicopters**

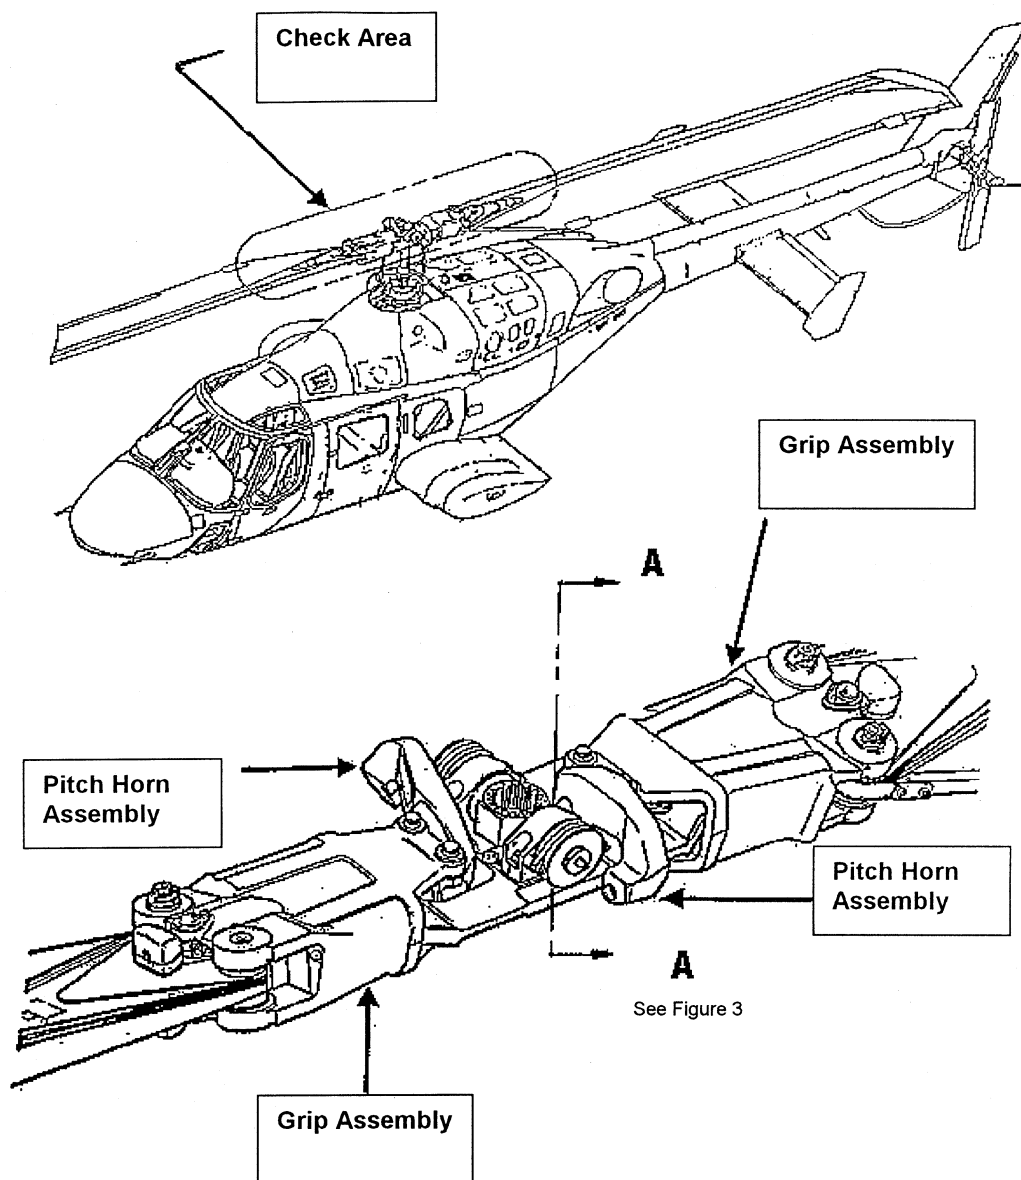
**Figure 1**

(1) Wipe clean the main rotor grip and pitch horn surfaces to remove grease and dirt in the check area as shown in Figure 1 of this AD:

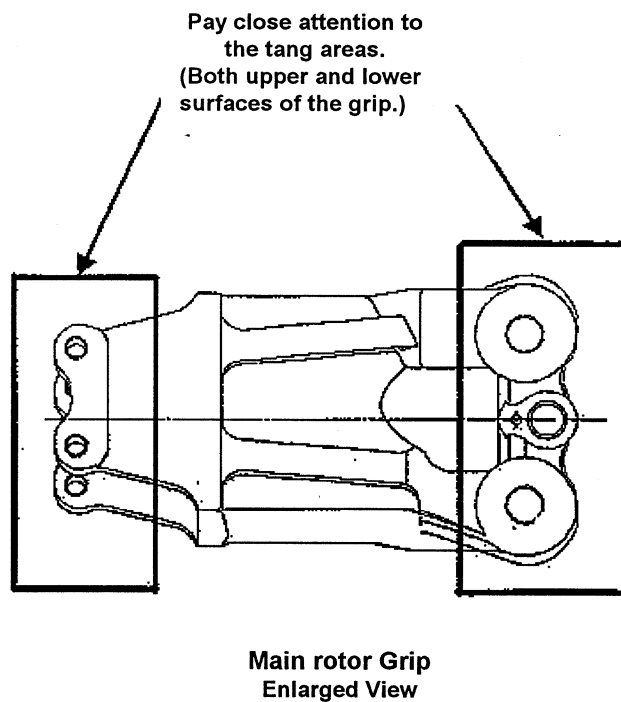
**Figure 2**

(2) Visually check both main rotor grips for a crack, paying particular attention to the inboard and outboard tangs/portions of the grip, which are in direct contact with the pitch horns and the main rotor blades. Check the area to at least 3 inches beyond the grip/pitch and grip/blade contact areas as shown in Figure 2 of this AD:

**Check entire surface of the grip.**
