**[Docket No. 2002-NM-128-AD]**

#### **Airworthiness Directives; Boeing Model 747-400 Series Airplanes Equipped With General Electric Model CF6-80C2 Series Engines**

**ACTION:** Notice of proposed rulemaking (NPRM).

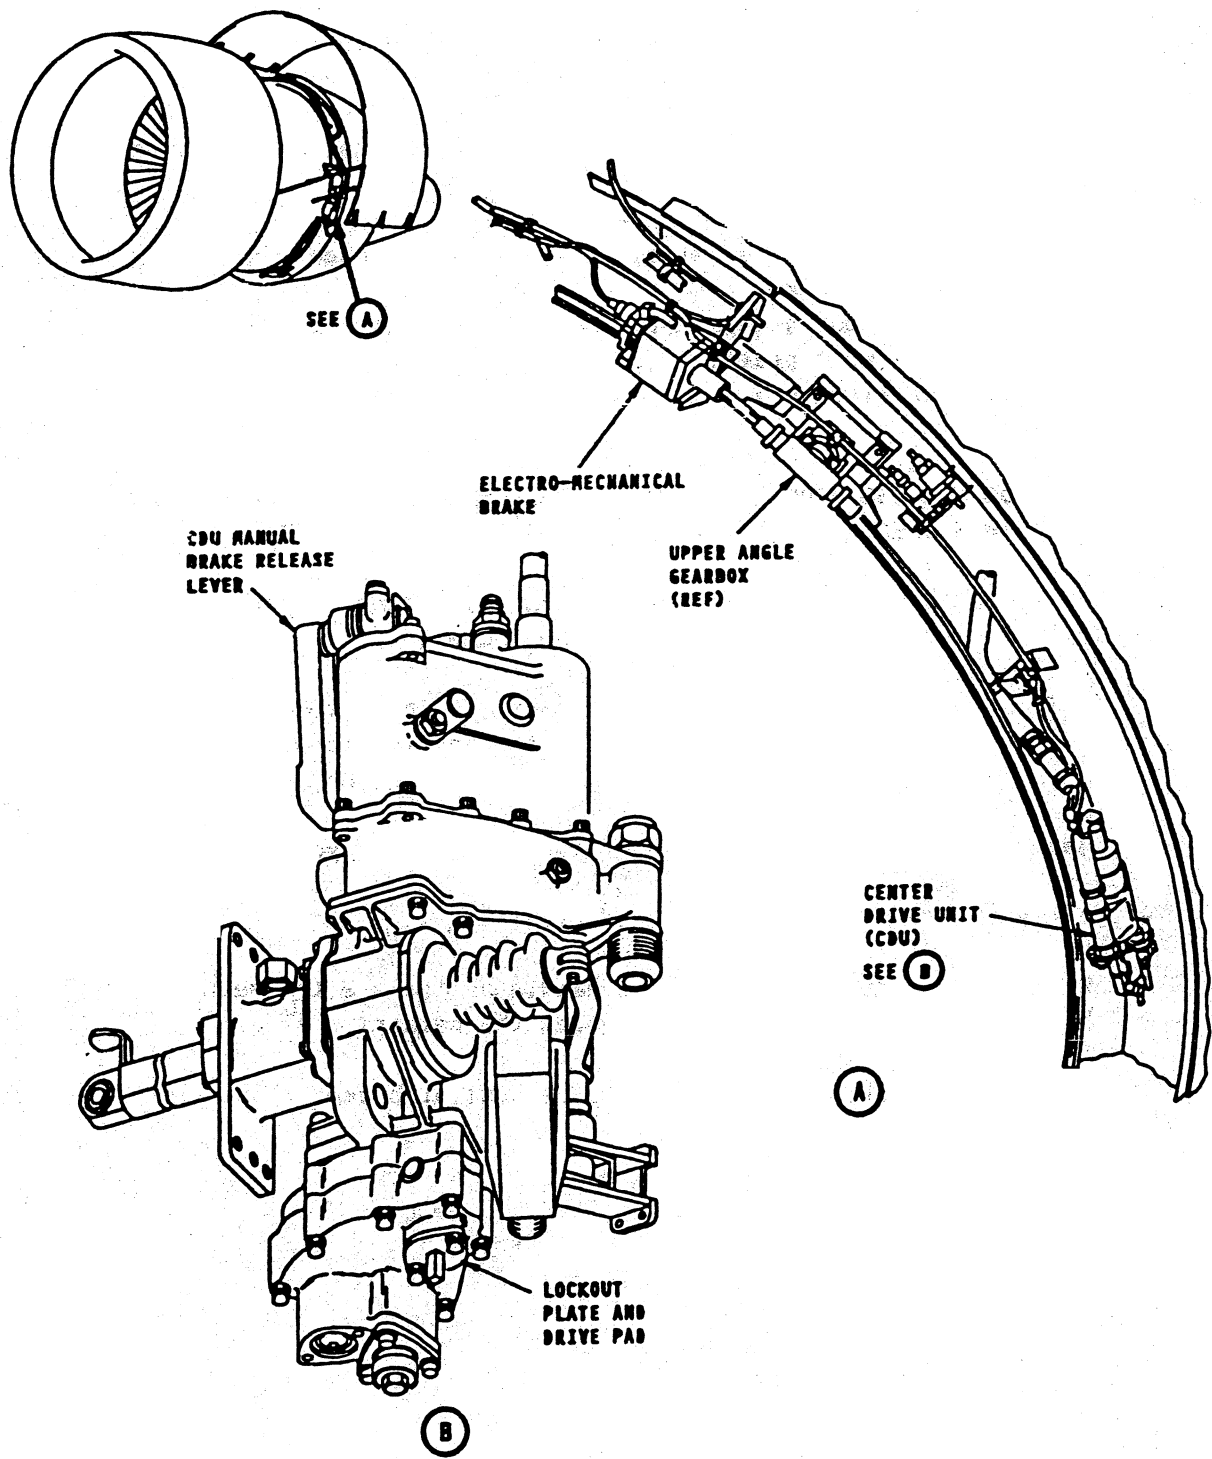
Electro-Mechanical Brake and CDU Cone Brake Torque Check  
Figure 1

**Caution:** Do not use more than 100 pound-inches of torque when you do this check. Excessive torque will damage the CDU.

(8) If the torque is less than 15 pound-inches, you must replace the CDU.
