[Docket No. FAA-2006-23871; Directorate Identifier 2006-NE-01-AD]

Airworthiness Directives; General Electric Company (GE) CF6-80C2 Turbofan Engines

ACTION: Notice of proposed rulemaking (NPRM).

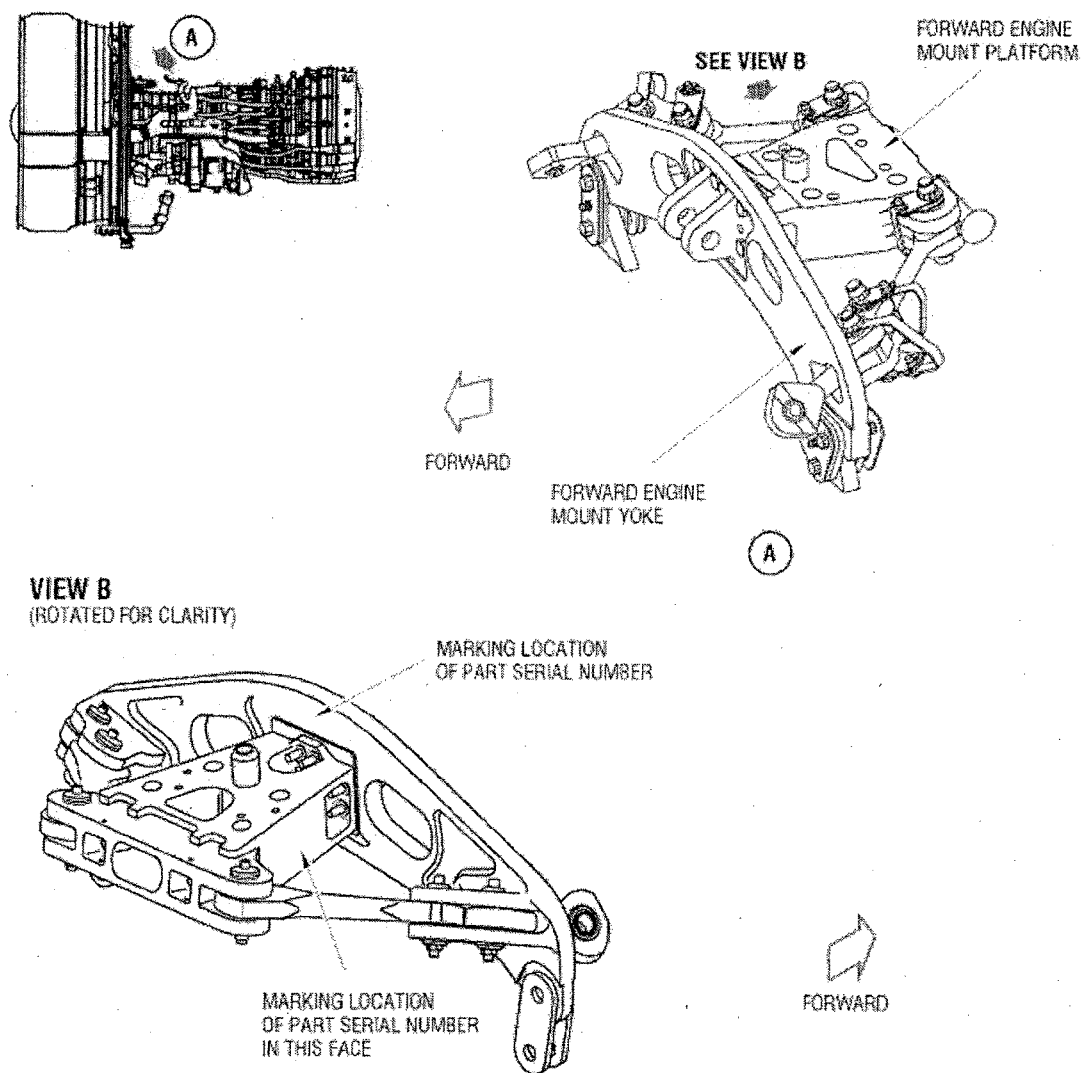
Location of Forward Engine Mount Platform and Forward Engine Mount Yoke
Figure 1

(d) This AD results from the discovery of cracks in a forward engine mount platform and a forward engine mount yoke found during fluorescent penetrant inspection (FPI). We are issuing this AD to prevent cracks in the forward engine mount platform and forward engine mount yoke that could result in possible separation of the engine from the airplane.

(p) Location of the forward engine mount platform and forward engine mount yoke and SN are illustrated in the following Figure 1.

(n) Replace the affected forward engine mount platform and or the affected forward engine mount yoke with a non-weld-repaired cast titanium forward engine mount platform and or the forward engine mount yoke or a forged titanium forward engine mount platform or a forged titanium forward engine mount yoke.
