[Docket No. 2003-SW-17-AD; Amendment 39-13215; AD 2003-08-51]

#### **Airworthiness Directives; MD Helicopters, Inc. Model 369A, D, E, H, HE, HM, HS, F, and FF Helicopters**

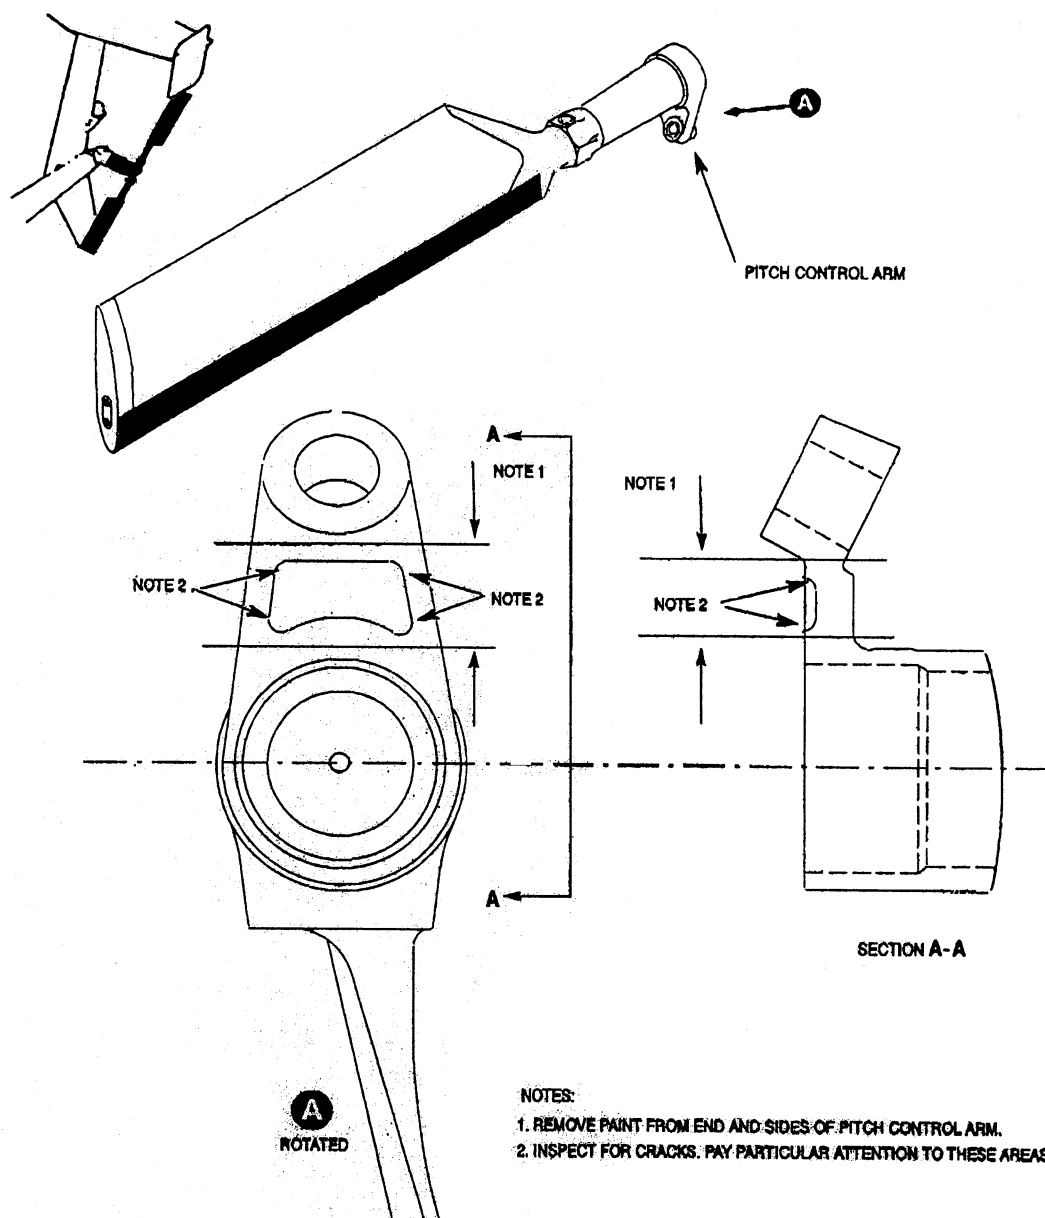
**Figure 1. Tail Rotor Blade Assembly Inspection**

To prevent a tail rotor blade pitch horn (pitch horn) from separating from the tail

(b) Before further flight, perform a one-time visual inspection of each pitch horn for a crack or corrosion in the area indicated by Note 2 in Figure 1 of this AD. Paint removal in accordance with Note 1 of Figure 1 of this AD is not required for the visual inspection.

repair facility may be issued only upon completion of an eddy current surface scan of each affected pitch horn (see Figure 1 of this AD). Paint removal in accordance with Note 1 of the Figure 1 of this AD is required for the surface scan. If a crack is found,

remove the tail rotor blade and replace it with an airworthy tail rotor blade before further flight.
