#### 14 CFR Part 39

[Docket No. FAA-2011-0450; Directorate Identifier 2011-CE-010-AD]

**Airworthiness Directives; Cessna Aircraft Company (Cessna) Models 337, 337A (USAF 02B), 337B, 337C, 337D, 337E, T337E, 337F, T337F, 337G, T337G, M337B, F 337E, FT337E, F 337F, FT337F, F 337G, and FT337GP Airplanes**

**ACTION:** Notice of proposed rulemaking (NPRM).

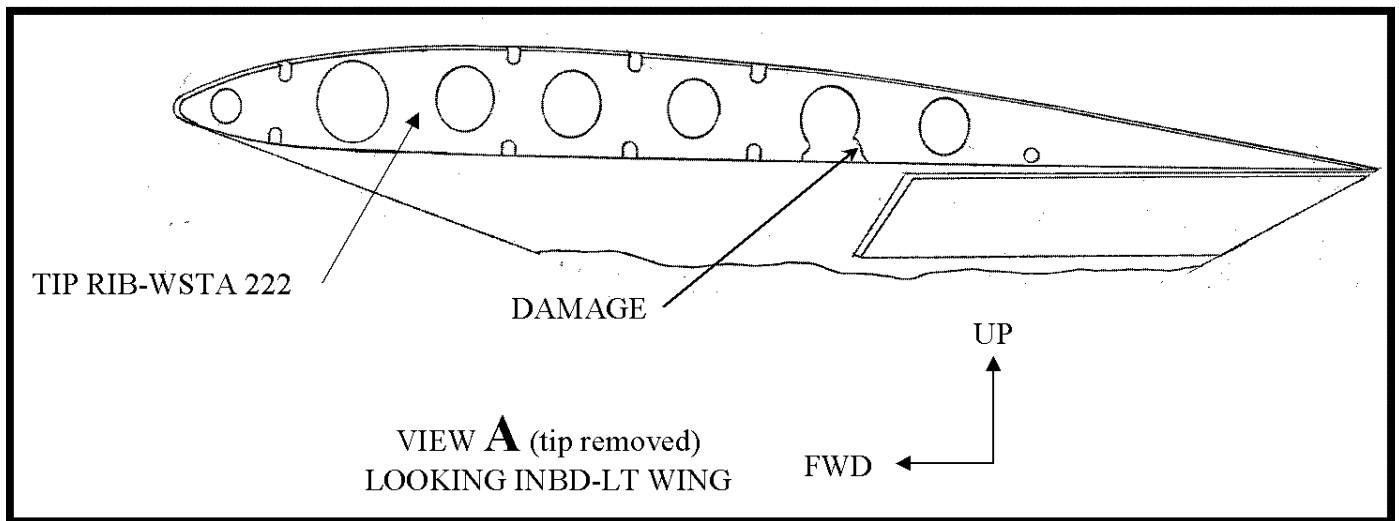
Figure 2

(11) Inspect rib at WSTA 222 for damage. Trimming of the rib may have been done to allow installation of fuel lines (See View A, Figure 2). Repair in accordance with AC 43.13–1B, Chapter 4, paragraph 4–58(g) and Figure 4–14, or by using another FAA-approved method that restores equivalent strength of the wing rib.

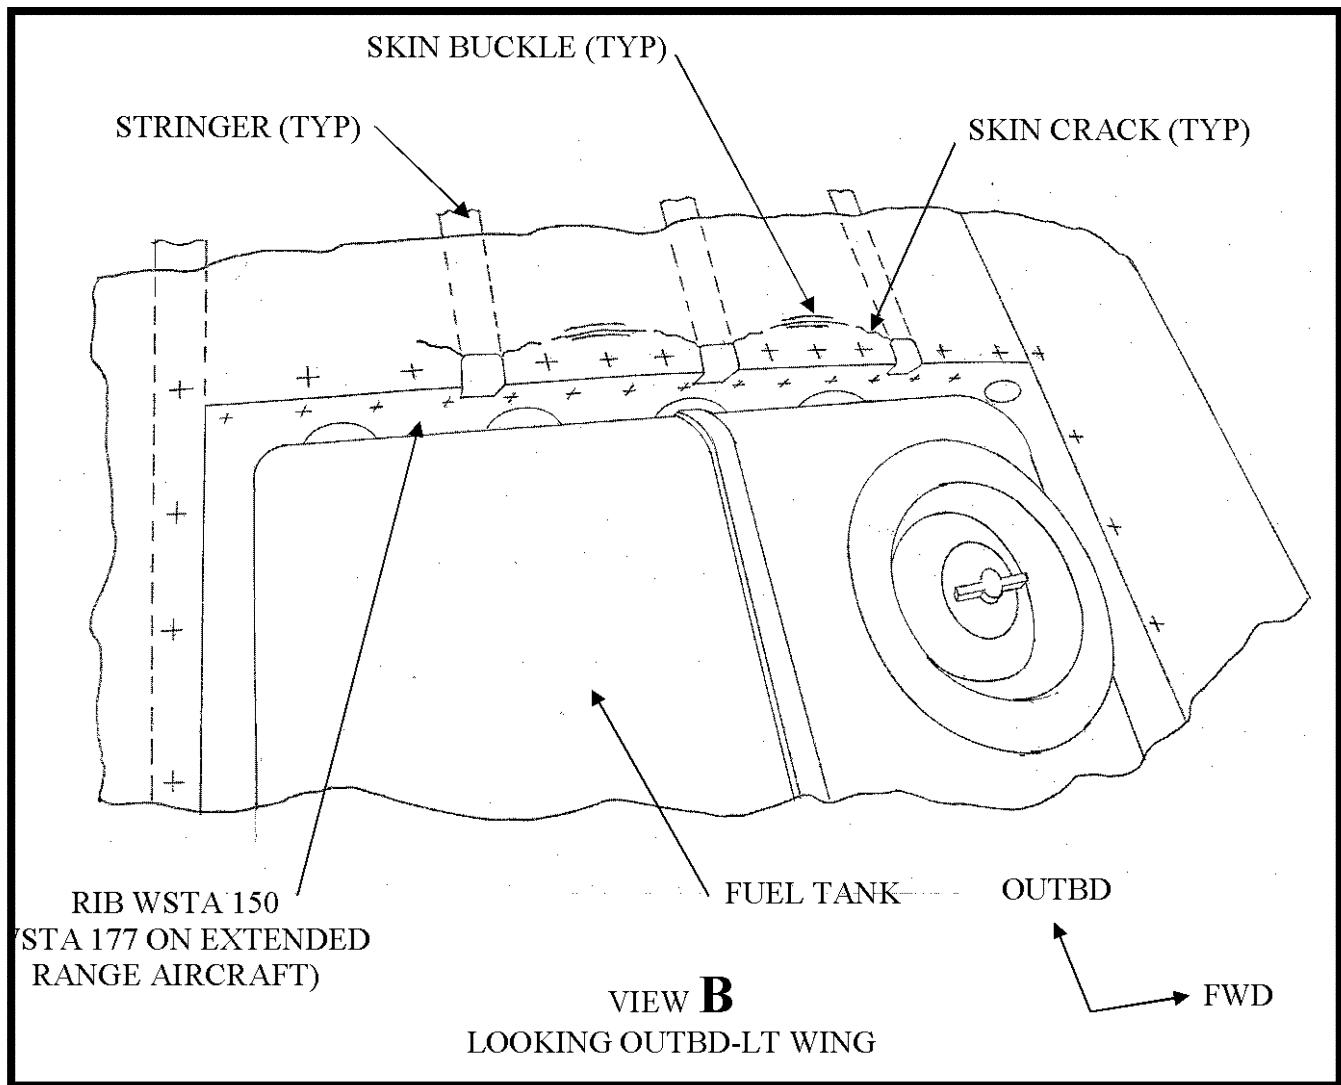
Figure 3

(1) Wrinkles in upper wing skins, from the outboard edge on the fuel tank access covers (WSTA 150 or 177) to the WSTA 222 (See View B, Figure 3).

(3) Cracking of the upper wing skins. Pay particular attention to any wrinkles, the radius between stiffeners at WSTA 150

(under fuel tank covers), and unreinforced access holes (See View B, Figure 3).

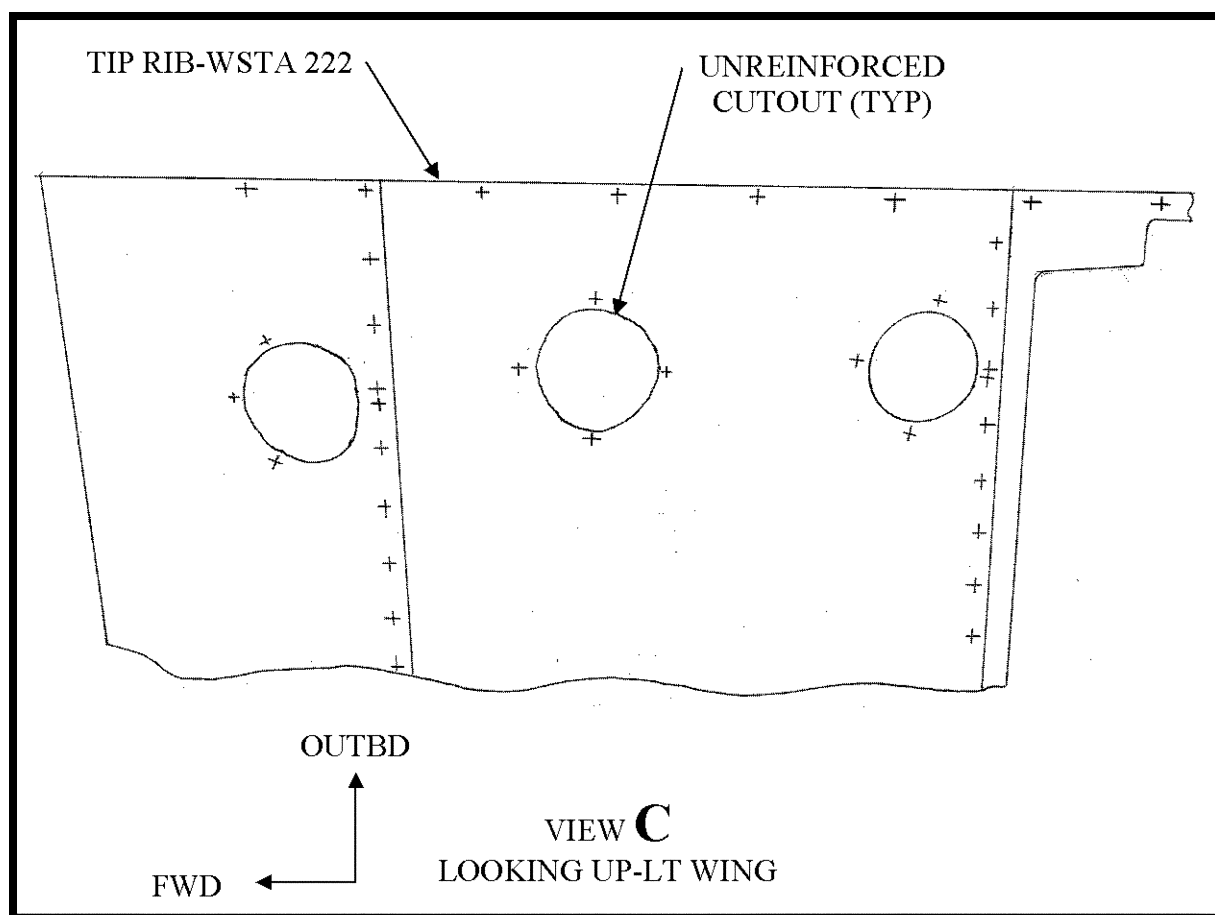
Figure 4

(13) Inspect wing skins for unreinforced cutouts. (See View C, Figure 4).

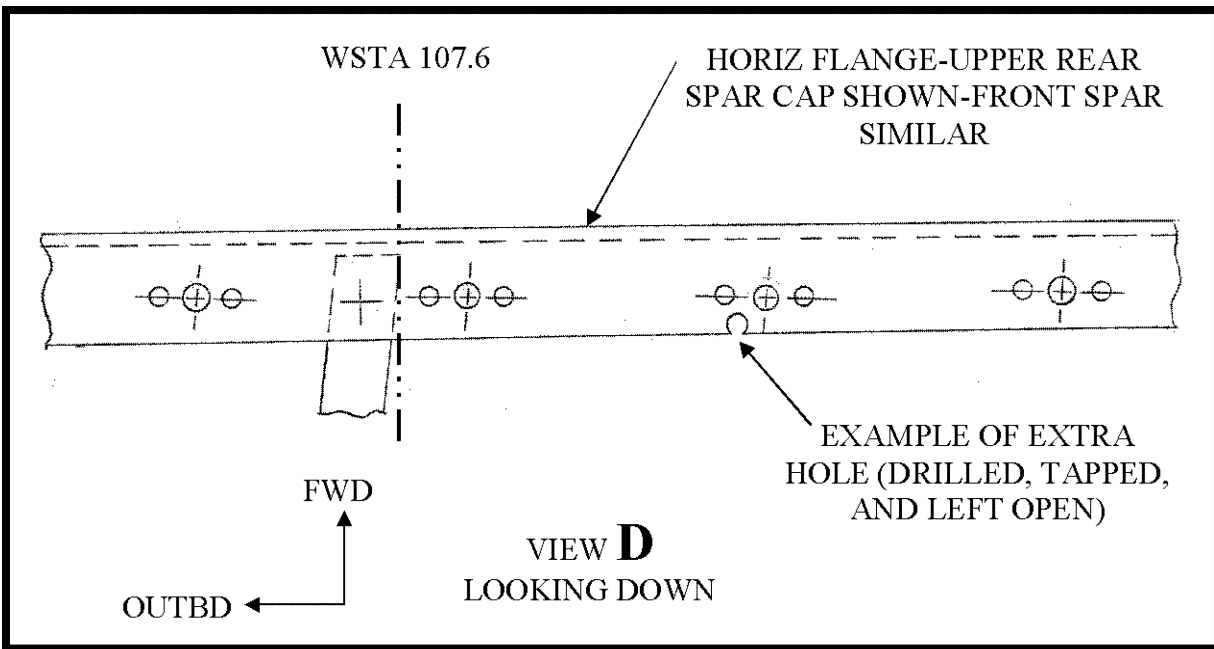
Figure 5

(14) Inspect the upper spar cap horizontal flanges for open holes (See View D, Figure 5).

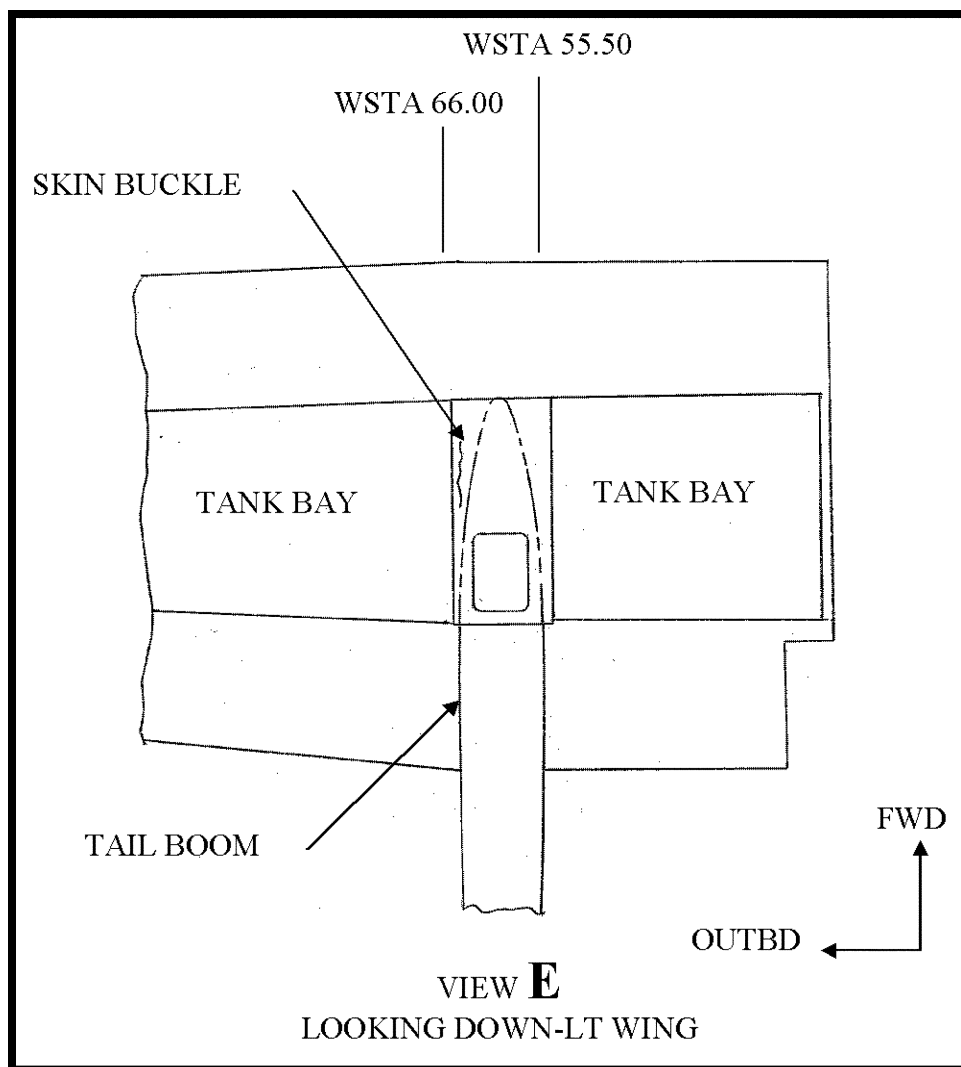
Figure 6

(2) Wrinkles in the upper wing skins from WSTA 55 to 66, adjacent to the booms (See View E, Figure 6).

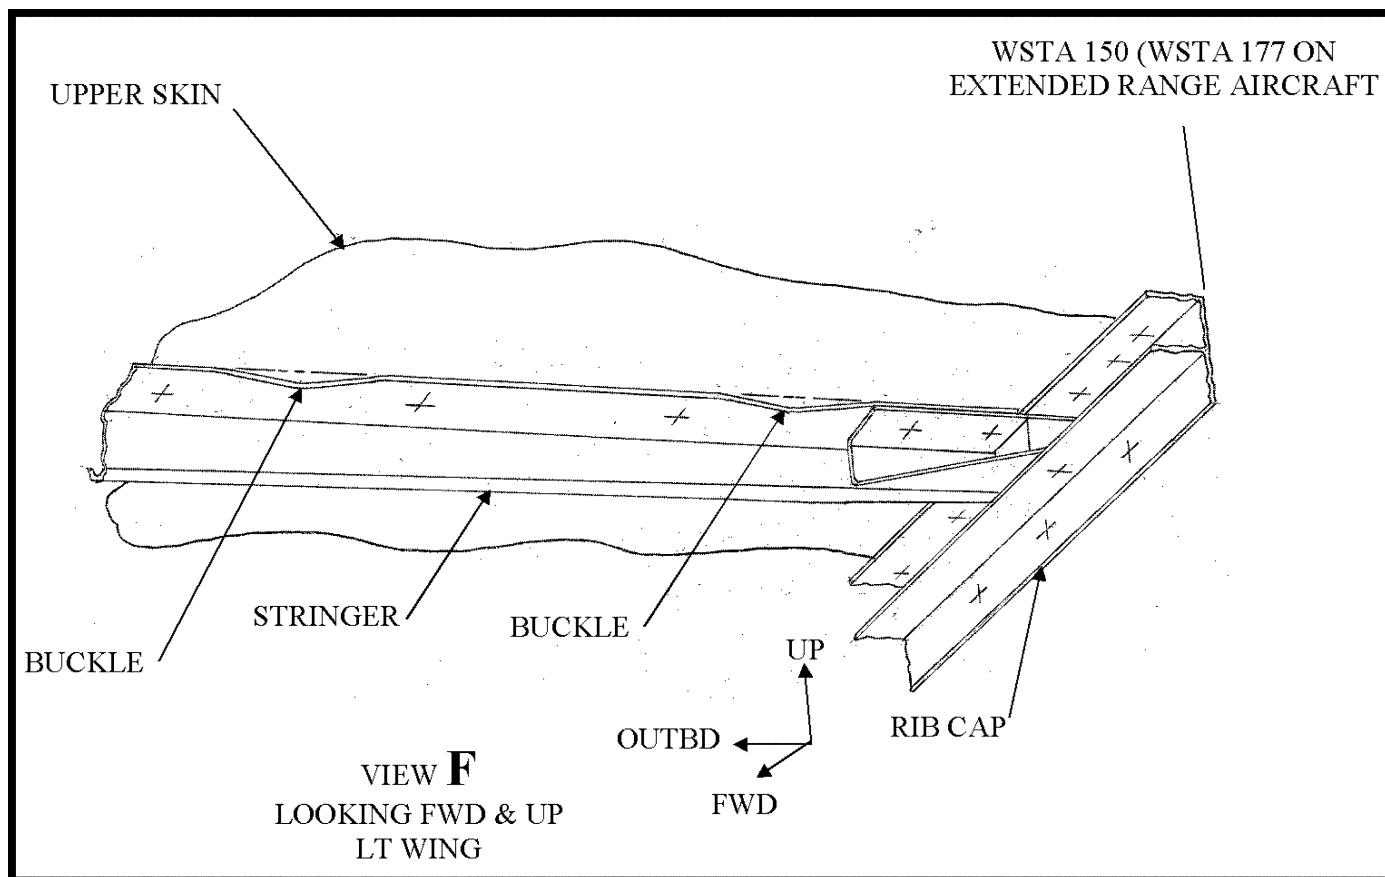
Figure 7

(10) Inter-rivet buckling of the stringers attached to the upper surface skin, outboard of the fuel tank access covers (See View F, Figure 7).
