**Federal Aviation Administration**

**[Docket No. FAA–2021–0189; Project Identifier AD–2020–00645–R; Amendment 39–21875; AD 2021–26–16]**

**Airworthiness Directives; Various Restricted Category Helicopters**

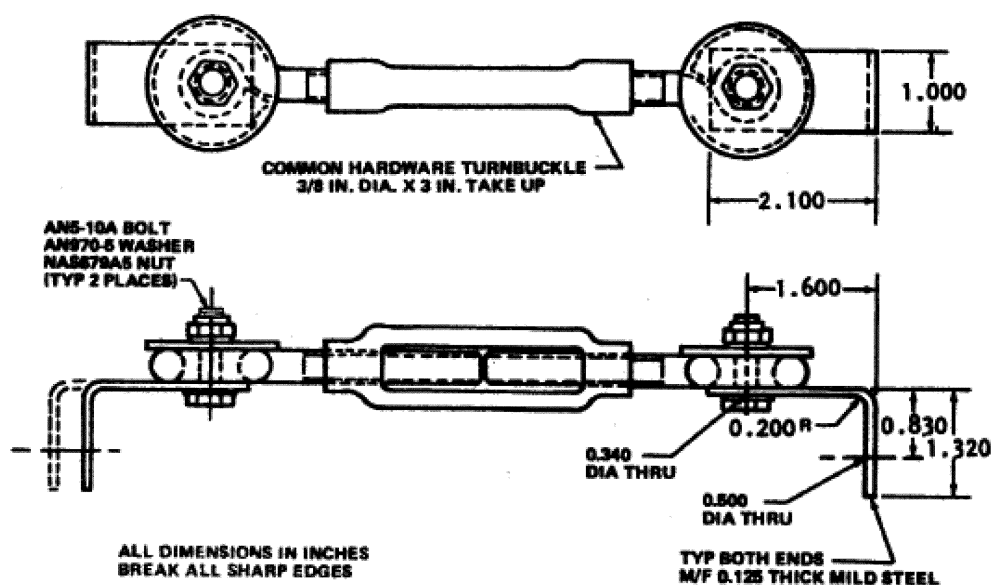
Figure 1 to the Introductory Text of Paragraph (g)(3) – Main Driveshaft Installation and Removal Tool

(3) Within 25 hours TIS after the effective date of this AD, remove main driveshaft P/N SKCP2180–1, SKCP2281–1, SKCP2281–1R, or SKCP2281–103 by following “6–24.3. Removal—Main Driveshaft P/N SKCP2281–103” on page 6–24, including “4–24. Removal—Air Inlet Filters” on page 4–17 and “Figure 4–9. Engine Air Inlet Filter Installation” on page 4–16, of Headquarters, Department of the Army, Aviation Unit and Intermediate Maintenance Instructions Army Model UH–1H/V/EH–1H/X Helicopters, Technical Manual TM 55–1520–210–23–1, Change No. 42, dated April 14, 2003 (TM 55–1520–210–23–1 C 42), except where instructed to “refer to figure 6–12.2” in TM 55–1520–210–23–1 C 42, refer to Figure 1 to the introductory text of paragraph (g)(3) of this AD, and where instructed to “see figure 6–12.3” in TM 55–1520–210–23–1 C 42, see Figure 2 to the introductory text of paragraph (g)(3) of this AD, and:

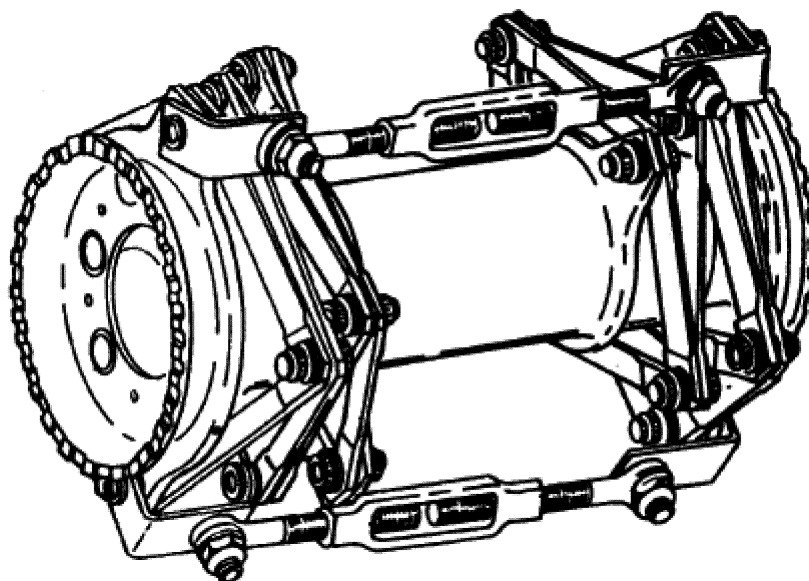
Figure 2 to the Introductory Text of Paragraph (g)(3) – Work Aid Tool Installed on Main Driveshaft

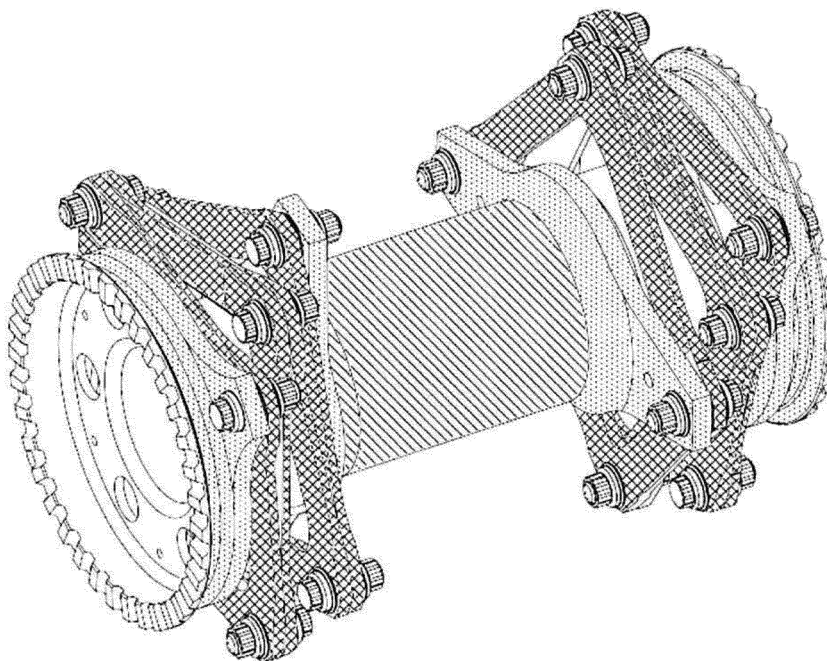
(iv) Inspect the main driveshaft for mechanical damage, corrosion, an edge dent, and nick as shown in Figure 3 to paragraph (g)(3)(iv) of this AD. For the purposes of this inspection, mechanical damage may be indicated by a crack, scratch, or wear; and corrosion may be indicated by corrosion or pitting. If there is a scratch, wear, corrosion, pitting, an edge dent, or a nick within allowable limits, before further flight, repair the main driveshaft in accordance with FAA-approved procedures. If there is a crack, or a scratch, wear, corrosion, pitting, an edge dent, or a nick that exceeds allowable limits,

1. No cracks are permitted
2. Repairs must be no less than 1.000 inch apart.
3. Repairs not to be within 0.500 inches of bolt hole.
4. Faying surfaces must be free of any raised metal areas.
5. All repairs to be smooth at maximum depth and smoothly blended with surrounding surface.
6. Exposed bare metal may be touched up with Sermetel Product 1122 or 196. Zinc Chromate, primer color T, even though it does not blend cosmetically with Sermetel coating, can be used if Sermetel touch-up products are unavailable.

Figure 3 to Paragraph (g)(3)(iv) – Damage Limits

before further flight, replace the main driveshaft. The main drive shaft may be overhauled in accordance with FAA-

approved procedures to accomplish the replacement required by this paragraph.
