[Docket No. 2001-SW-39-AD]

#### Airworthiness Directives; MD Helicopters Inc. Model MD-900 Helicopters

**ACTION:** Notice of proposed rulemaking (NPRM).

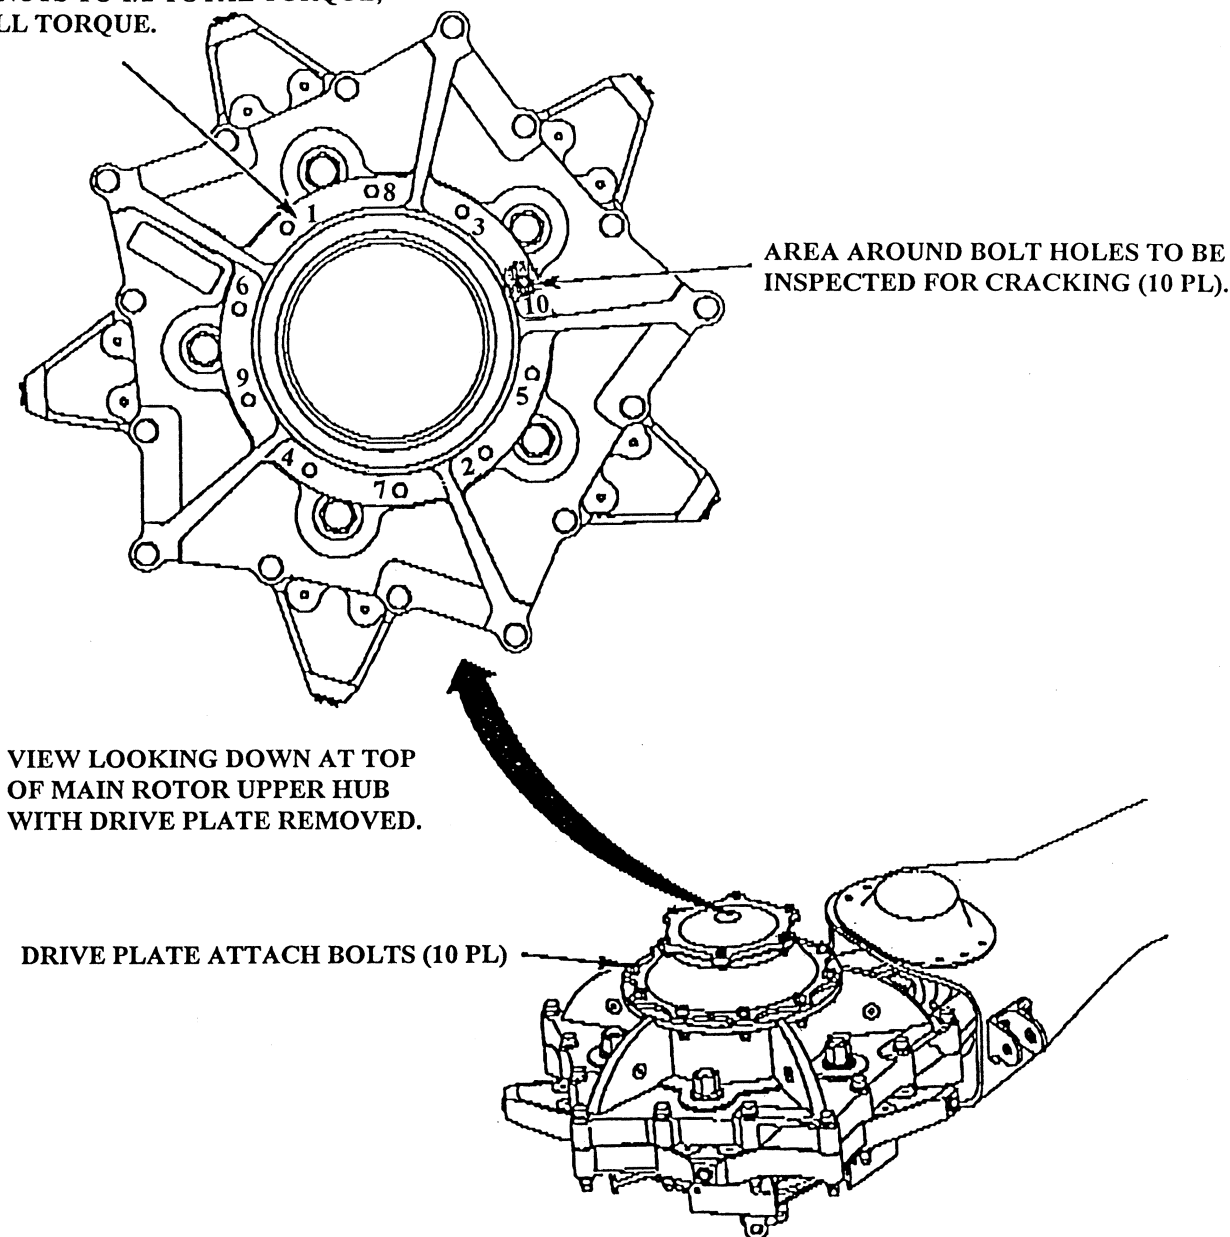
**Figure 1. Main Rotor Upper Hub Assembly Inspection.**

(v) Using paint stripper (Consumable Item List C313 or equivalent) and cleaning solvent (C420 or equivalent), remove the paint from the upper mating surface of the hub assembly to enable an accurate visual inspection of each drive plate attachment bolt hole (bolt hole) area for cracking (Figure 1). Ensure the paint stripper and solvent DO NOT contaminate the upper bearing and upper grease seal areas.

(vi) Using a 10× or higher magnifying glass and light, inspect the mating surface area and the area around and inside the 10 boltholes of the hub assembly for a crack. If a crack is found, prior to further flight, replace the hub assembly with an airworthy hub assembly.

(viii) Reinstall the main rotor drive plate using 10 new sets of replacement attachment hardware. Torque the nuts to 160 inch pounds above locknut locking/run-on torque in the sequence shown (Figure 1). Record in the rotorcraft logbook, or equivalent record, the locknut locking/run-on torque for each nut.
