[Docket No. FAA-2013-0146; Directorate Identifier 2012-SW-060-AD; Amendment 39-17559; AD 2013-16-21]

#### **Airworthiness Directives; Agusta S.p.A. (Type Certificate Currently Held by Agusta Westland S.p.A) (Agusta) Helicopters**

**SUMMARY:** We are superseding an airworthiness directive (AD) for Agusta Model A109E helicopters that required reducing the tail rotor (T/R) blade life limit, modifying a T/R hub and grip assembly, re-identifying two T/R assemblies, clarifying the never-exceed speed (Vne) limitation, and reducing the inspection interval. Since we issued that AD, the manufacturer has redesigned a T/R grip bushing (bushing) that reduces the loads, which caused the T/R cracking, on the T/R blades. This action requires installing the new bushing and re-identifying the T/R hub-and-grip and hub-and-blade assemblies and requires a recurring inspection of each bushing. These actions are intended to prevent fatigue failure of a T/R blade and subsequent loss of control of the helicopter.

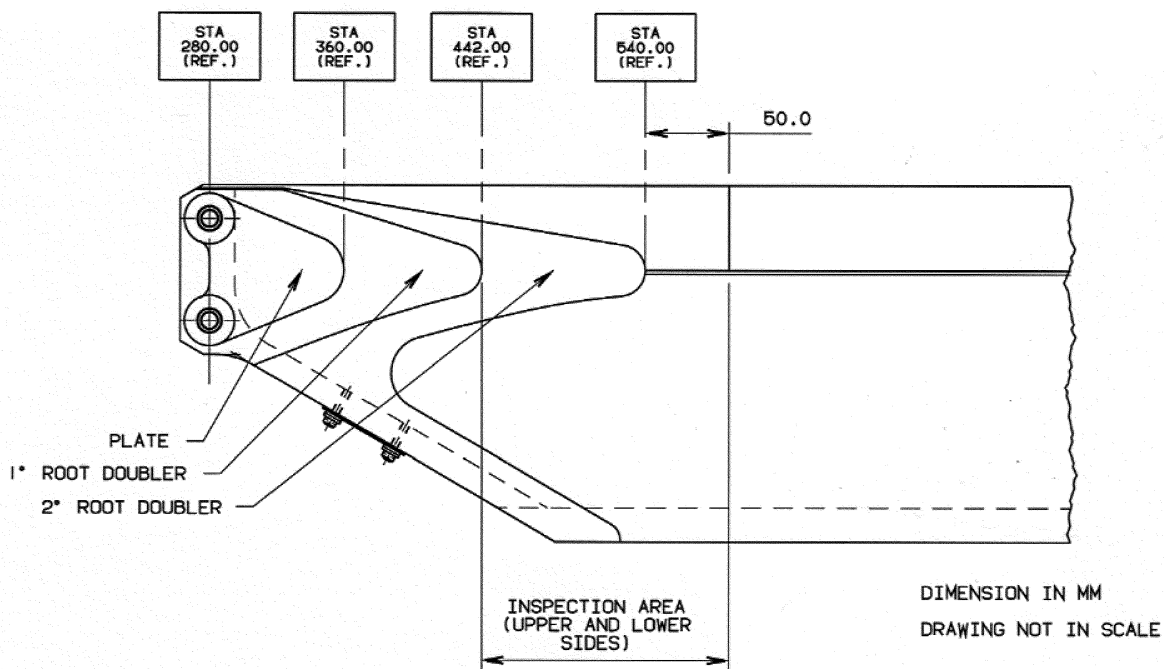
Figure 1 to Paragraph (f)(1), T/R Blade, P/N 109-8132-01-111

This AD defines the unsafe condition as a fatigue crack in a T/R blade. This condition could result in failure of the T/R blade and subsequent loss of control of the helicopter.

(1) Before each start of the helicopter engines, visually check both sides of each T/R blade for a crack in the inspection area depicted in Figure 1 to paragraph (f)(1) of this AD. This action may be performed by the owner/operator (pilot) holding at least a private pilot certificate, and must be entered into the aircraft records showing compliance with this AD in accordance with 14 CFR 43.9 (a)(1)–(4) and 14 CFR 91.417(a)(2)(v). The record must be maintained as required by 14 CFR 91.417, 121.380, or 135.439.

(5) If there is a crack in a T/R blade, before further flight, replace the cracked T/R blade.
