Federal Register

Wednesday, August 29, 2001

[Docket No. 2001-SW-24-AD; Amendment 39-12407; AD 2001-17-16]

#### Airworthiness Directives; Agusta S.p.A. Model A109E Helicopters

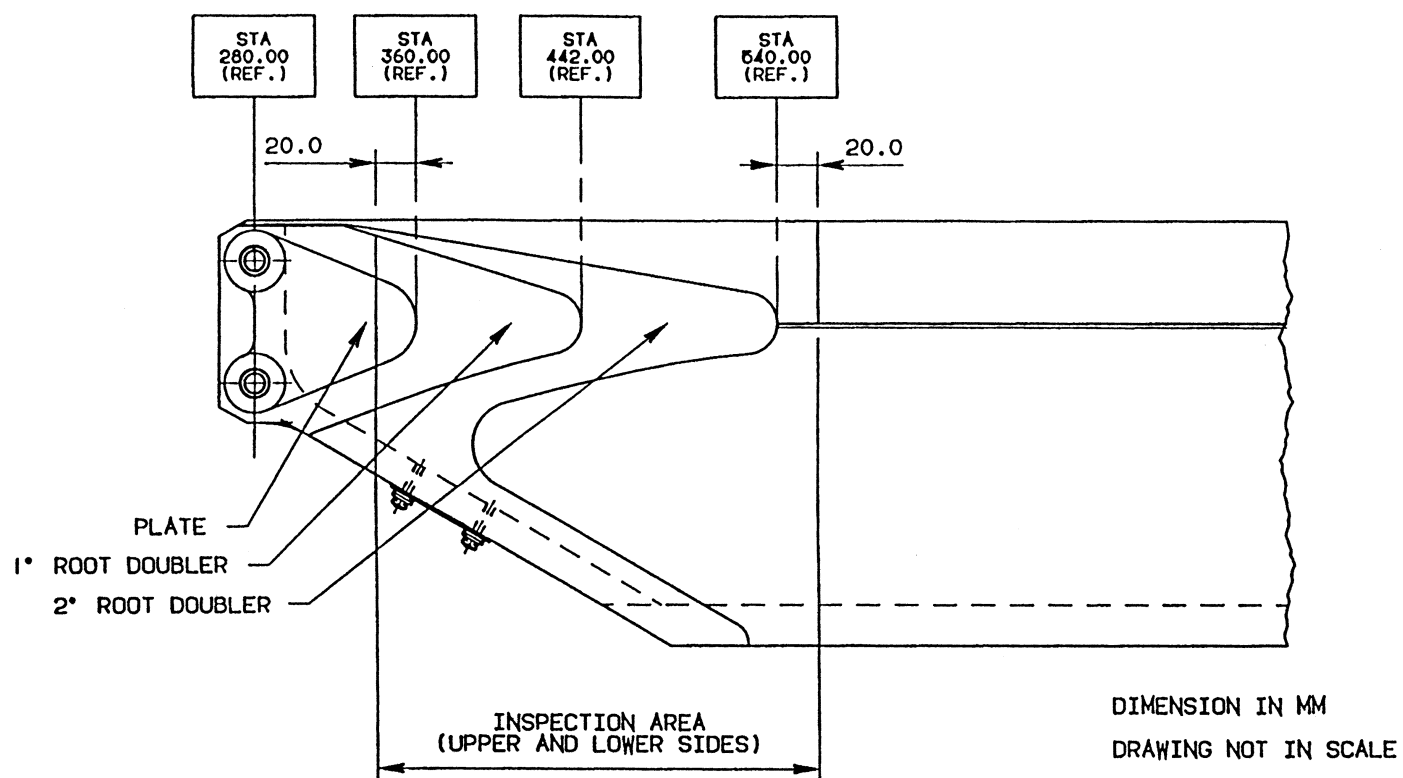
**FIGURE 1**

(a) Before each start of the engines, visually check both sides of each blade for a crack in accordance with Figure 1 of this AD for blade, P/N 109-8132-01-107, or Figure 2 of this AD for blade, P/N 109-8132-01-109. An owner/operator (pilot), holding at least a private pilot certificate, may perform the visual check required by this paragraph and must record compliance with paragraph (a) of this AD in the aircraft maintenance records in accordance with 14 CFR 43.11 and 91.417(a)(2)(v).

P/N 109-8132-01-107 T/R BLADE

(d) If a crack is found, replace the blade with an airworthy blade before further flight.

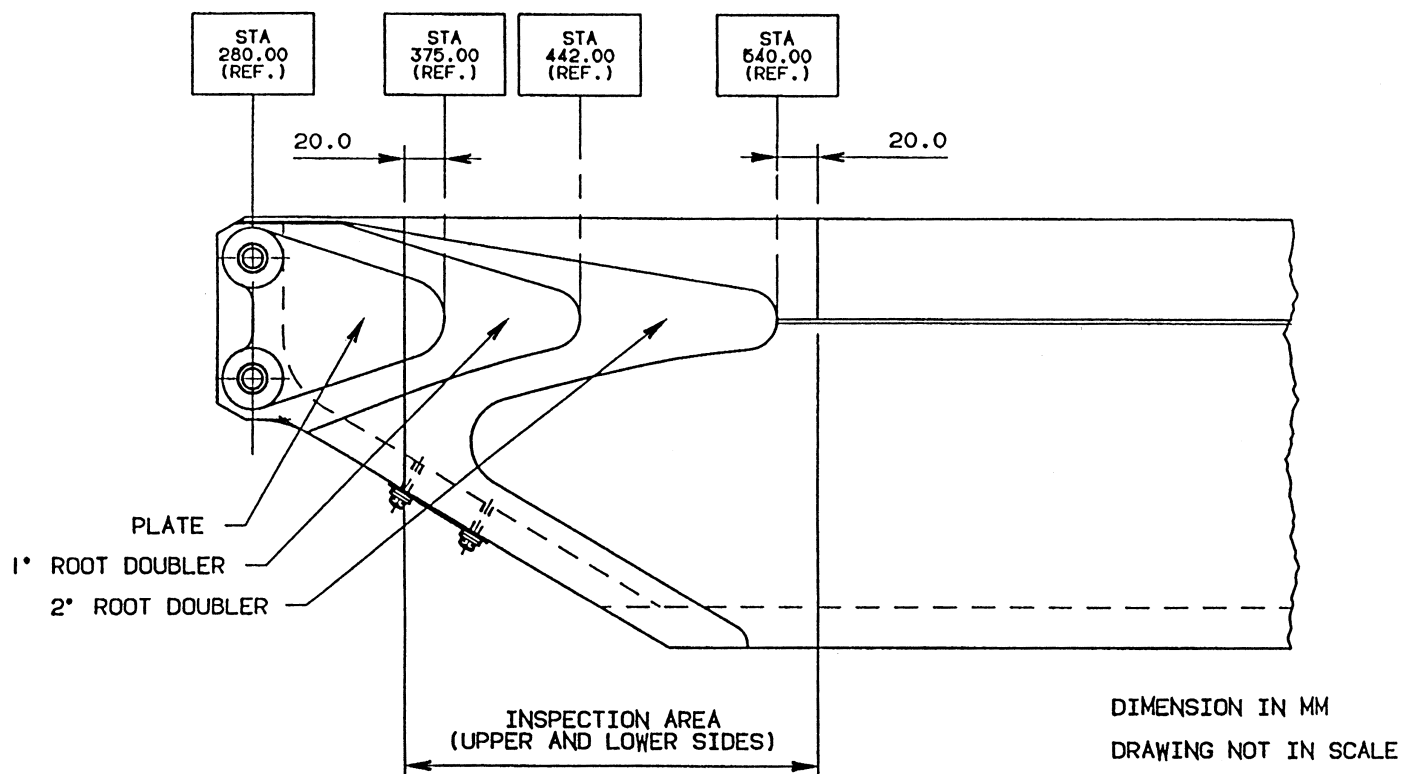
## FIGURE 2

P/N 109-8132-01-109 T/R BLADE
