[Docket No. 2004-SW-04-AD; Amendment 39-13812; AD 2004-20-07]

#### Airworthiness Directives; Bell Helicopter Textron Canada Model 222, 222B, 222U, and 230 Helicopters

**ACTION:** Final rule.

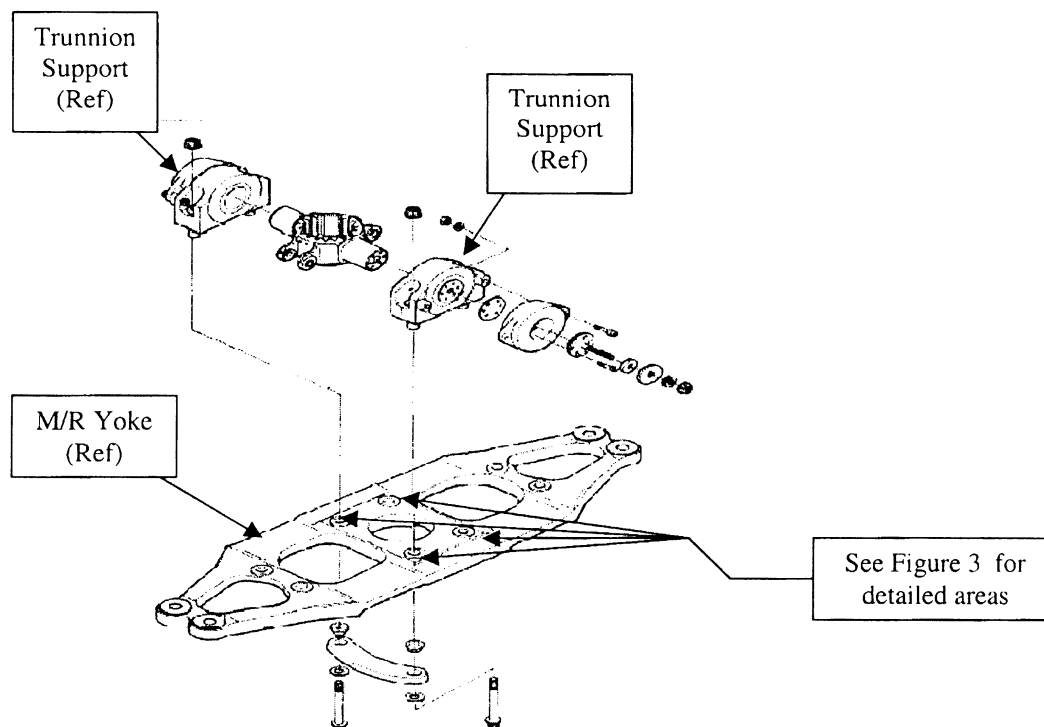
**Figure 2. Main Rotor Yoke**

inspect the yoke with a 10X or higher magnifying glass in the four areas shown in Figures 2 and 3 of this AD.

Shown with trunnion supports removed.

(i) If a crack is found on any part, before further flight, replace the part with an airworthy part.

(ii) If fretting or buffer deterioration is found on any part, before further flight, repair any unairworthy part or replace the part with an airworthy part.
