[Docket No. FAA-2005-22481; Directorate Identifier 2004-NM-176-AD; Amendment 39-14647; AD 2006-12-21]

#### Airworthiness Directives; Bombardier Model CL-600-2B19 (Regional Jet Series 100 & 440) Airplanes

**2006-12-21 Bombardier, Inc. (Formerly Canadair):** Amendment 39-14647. Docket No. FAA-2005-22481; Directorate Identifier 2004-NM-176-AD.

(d) This AD results from a number of cases of flap system failure that resulted in a twisted outboard flap panel. We are issuing this AD to prevent an unannounced failure of the flap system, which could result in a flap asymmetry and consequent reduced controllability of the airplane.

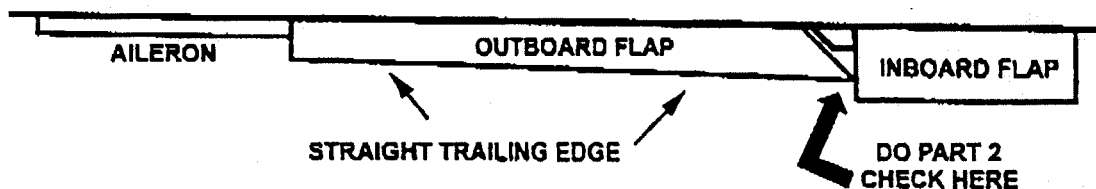
**1. NORMAL**

A normal outboard flap has a straight trailing edge, and the inboard corner is slightly above (i.e. higher) than the inboard flap.

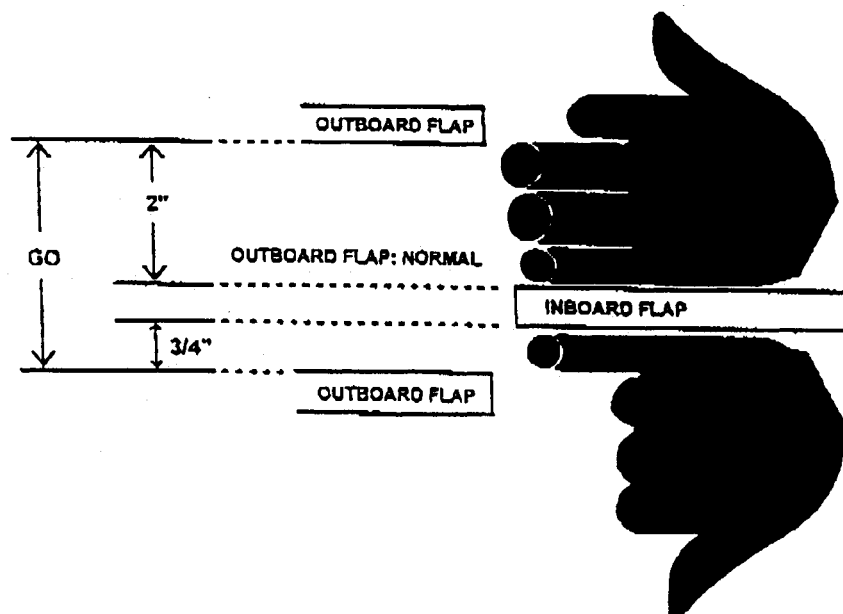
**1. FLAPS AT 8 DEGREES**

If the outboard flap position is outside the "GO" range as shown below further flight is prohibited.

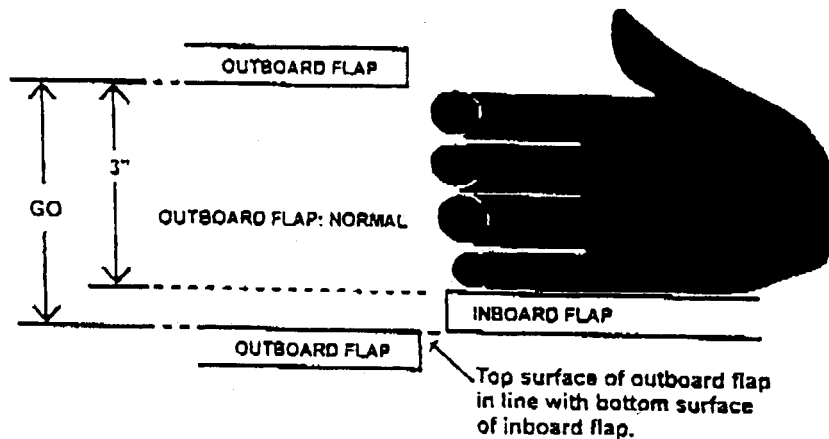
**2. FLAPS AT 20 DEGREES**

Figure 2. Outboard Flap Go/No-Go Criteria in Take-off Position"
