[Docket No. FAA-2011-1115; Directorate Identifier 2010-SW-011-AD]

#### Airworthiness Directives; Sikorsky Aircraft Corporation (Sikorsky) Model S-92A Helicopters

**ACTION:** Notice of proposed rulemaking (NPRM).

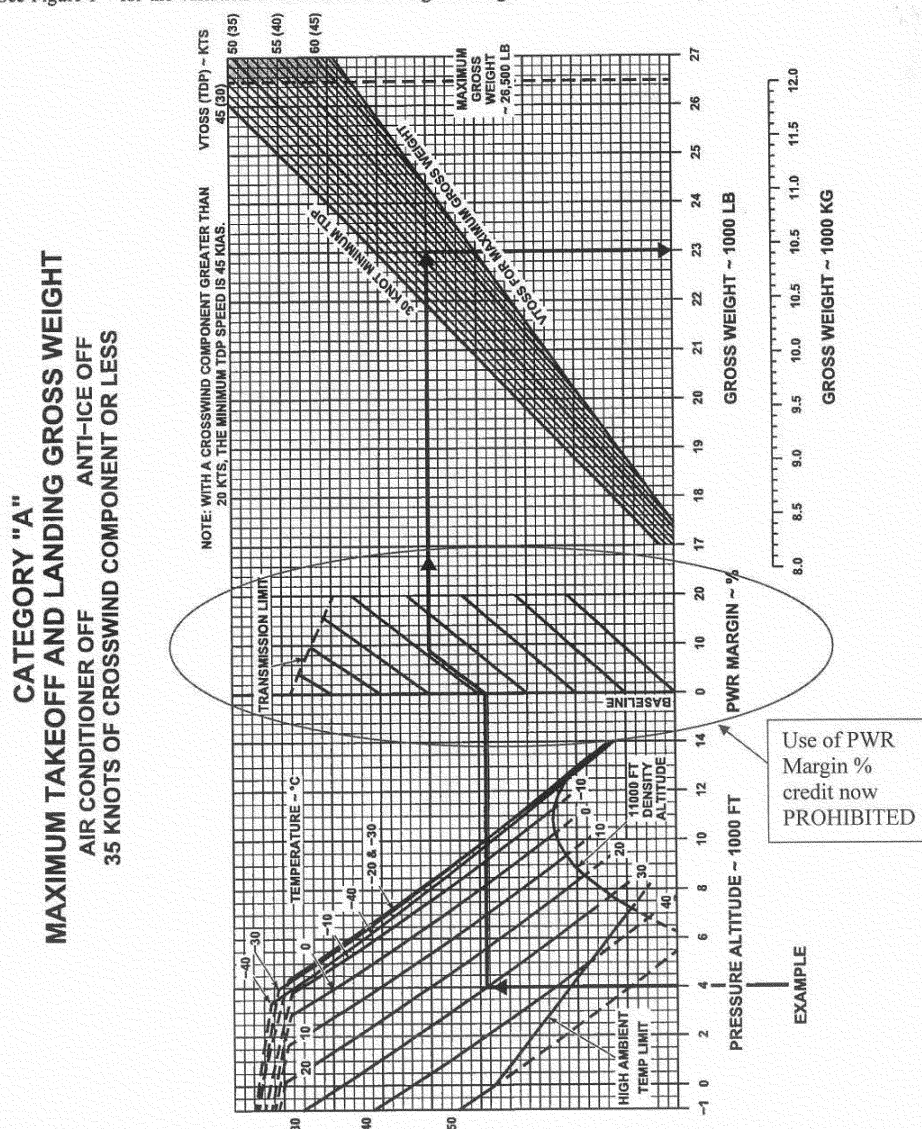
**Figure 1. Cat 'A' Takeoff and Landing Gross Weight**

(b) If the RFM already contains the revisions appropriate for your helicopter as listed in the following Table 1, all dated April 9, 2008, with the correct performance charts, without the performance credit as depicted in the circled area of Figure 1 of this AD, the operating limitation required by paragraph (a) of this AD does not need to be inserted into the RFM.

**Note 1:** Previous RFM revisions allowed for the use of above-specification engine power margin as depicted in the circled area of Figure 1 of this AD.

(a) By making pen and ink changes, insert into the Operating Limitations section, Part 1, Section 1, *Weight Limits*, of RFM SA S92A–RFM–002, –003, –004, –005, and –006 the following limitation “Performance credit for above specification engine power margin is prohibited.”
