[Docket No. FAA-2004-18850; Directorate Identifier 2004-SW-19-AD; Amendment 39-13771; AD 2004-16-15]

#### **Airworthiness Directives; Eurocopter France Model AS-365N2, AS 365 N3, EC 155B, EC155B1, SA-365N and N1, and SA-366G1 Helicopters**

#### 2004-16-15 Eurocopter France:

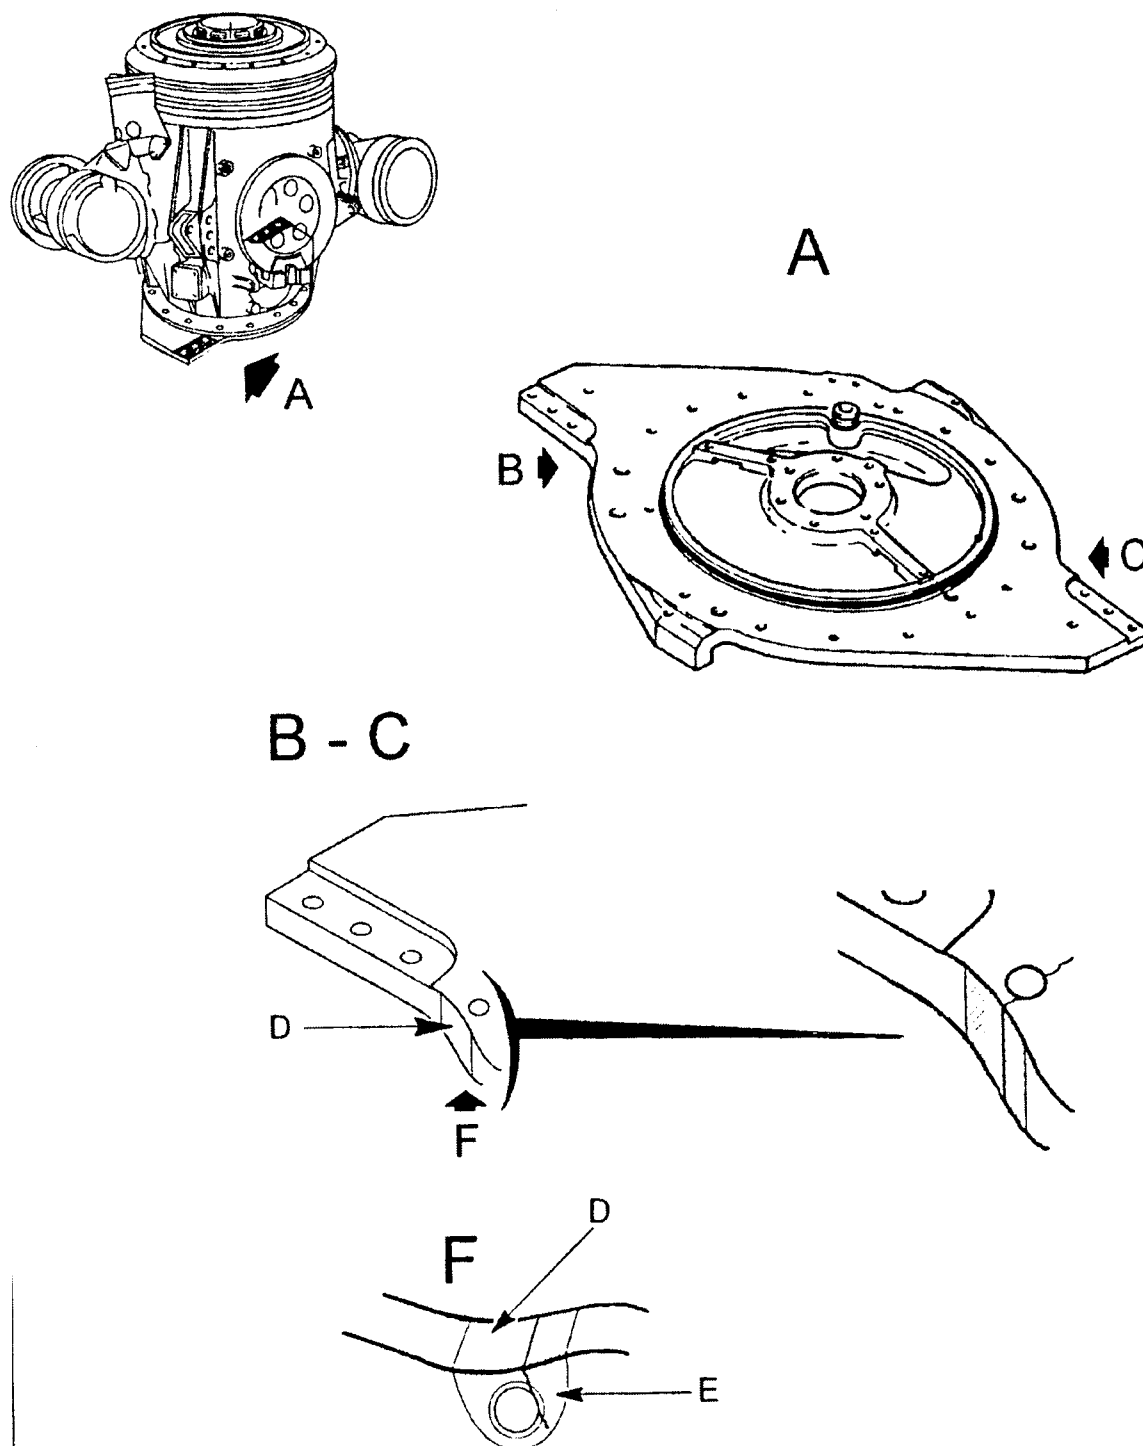
Figure 1

paint from area "D" on both sides ("B" and "C") of the MGB base plate as depicted in Figure 1.

(b) At the times indicated in the compliance table, inspect area "D" of the MGB base plate for a crack using a 10x or higher magnifying glass.

(c) If a crack is found in a MGB base plate, remove and replace the MGB with an airworthy MGB before further flight.
