Federal Register

[Docket No. 99-CE-85-AD]

#### Airworthiness Directives; EXTRA Flugzeugbau GmbH Models EA-300, EA-300L, and EA-300S Airplanes

**ACTION:** Notice of proposed rulemaking (NPRM).

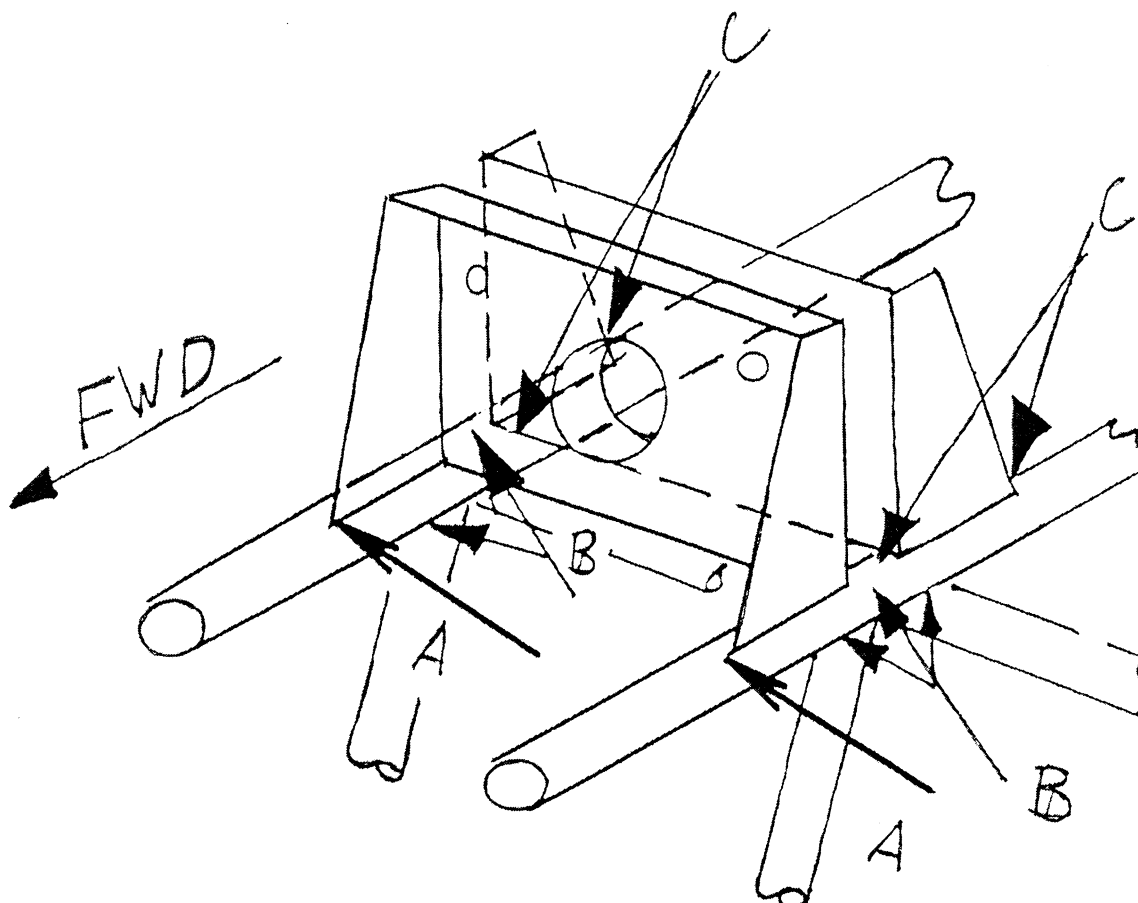
| Actions | Compliance | Procedures |
|---|---|---|
| (1) For all affected airplanes, inspect, using a fluorescent dye penetrant method, the upper longeron at the horizontal stabilizer attachment for cracks in the areas depicted in Figure 1 of this AD. | Upon accumulating 250 hours time-in-service (TIS) or within the next 50 hours TIS after the effective date of this AD, whichever occurs later. | In accordance with Part I of Extra Service Bulletin No. 300-2-95 (pages 2-6 at Issue: C, dated July 15, 1998; and pages 1 and 7 through 11 at Issue: D, dated January 30, 2001). No further action is required by this paragraph if the modification is already accomplished in accordance with Part II of Extra Service Bulletin No. 300-2-95 (all pages at Issue: C, dated July 15, 1998). |
| (3) For all affected airplanes, if any crack is found during the inspection required by this AD and the crack(s) is(are) in Area A or Area B as depicted in Figure 1 of this AD, accomplish the following:<br>(i) Repair and modify the upper longeron at the horizontal stabilizer attachment; and<br>(ii) Weld the cracks tight during repair. | Prior to further flight after the inspection where any crack is found in Area A or Area B as depicted in Figure 1 of this Ad. | In accordance with Part II of Extra Service Bulletin No. 300-2-95, Issue: D, dated January 30, 2001. No further action is required by this paragraph if already accomplished in accordance with Part II of Extra Service Bulletin No. 300-2-95 (all pages at Issue: C, dated July 15, 1998). |
| (4) For all affected airplanes, if any crack is found during the inspection and the crack(s) is(are) in Area C as depicted in Figure 1 of this AD, accomplish the following:<br>(i) Obtain a repair scheme from the manufacturer;<br>(ii) Incorporate this repair scheme; and<br>(iii) Accomplish any follow-up actions as directed by the FAA. | Prior to further flight after the inspection where any crack is found. | In accordance with a repair scheme obtained from EXTRA Flugzeugbau GmbH, Flugplatz Dinslaken, D-46569 Hünxe, Federal Republic of Germany; telephone: (0 28 58) 91 37-00; facsimile: (0 28 58) 91 37-30. Obtain this repair scheme through FAA at the address specified in paragraph (f) of this and AD. |

| Actions | Compliance | Procedures |
|---|---|---|
| (2) For all affected air planes, if no crack(s) is(are) found during the inspection required by this AD, modify the upper longeron at the horizontal stabilizer attachment. | Prior to further flight after the inspection required by paragraph (d)(1) of this AD. | In accordance with Part II of Extra Service Bulletin No. 300-2-95 (pages 2-6 at Issue: C, dated July 15, 1998; and pages 1 and 7 through 11 at Issue: D, dated January 30, 2001). No further action is required by this paragraph if already accomplished in accordance with Part II of Extra Service Bulletin No. 300-2-95 (all pages at Issue: C, dated July 15, 1998). |
