[Docket No. 98–NM–300–AD; Amendment 39–14355; AD 2005–22–11]

#### Airworthiness Directives; Mitsubishi Model YS–11 Airplanes, and Model YS–11A–200, YS–11A–300, YS–11A–500, and YS–11A–600 Series Airplanes

**2005-22-11 Mitsubishi Heavy Industries, LTD.:** Amendment 39-14355. Docket 98-NM-300-AD.

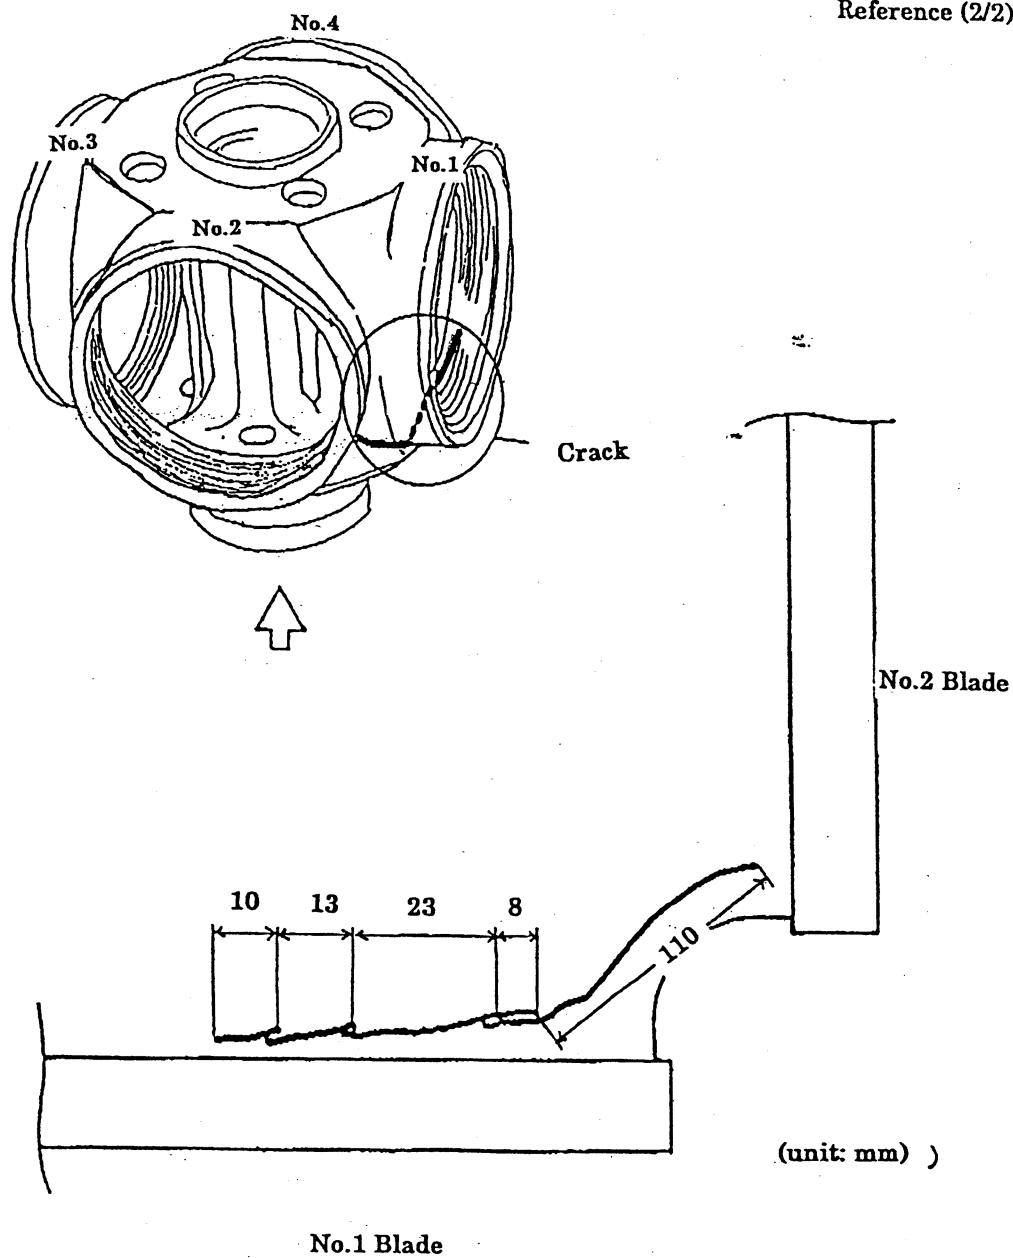
(a) Within 25 flight hours or 30 days after the effective date of this AD, whichever occurs first, remove the spinner and perform a detailed inspection for cracking of the propeller hub in the crack area shown in Figure 1 of this AD.

**HUB CRACK - VIEW FROM BOTTOM**

(2) If any crack is detected, prior to further flight, replace the hub with a new hub according to a method approved by either the Manager, Los Angeles Aircraft Certification Office (ACO), FAA; or the Japan Civil Aviation Bureau (JCAB) (or its delegated agent). Chapter 61 of the Nihon Aeroplane

Manufacturing Company YS-11 and YS-11A Aircraft Maintenance Manuals is one approved method. Repeat the actions required by paragraph (a) of this AD thereafter at intervals not to exceed 25 flight hours.
