#### Airworthiness Directives; Eurocopter France Model AS–365N2, AS 365 N3, EC 155B, EC155B1, SA–365N, N1, and SA–366G1 Helicopters

**ACTION:** Notice of proposed rulemaking (NPRM).

**SUMMARY:** This document proposes to revise an existing airworthiness directive (AD) for Eurocopter France (Eurocopter) Model AS–365N2, AS 365 N3, EC 155B, EC155B1, SA–365N, N1, and SA–366G1 helicopters. That AD currently requires inspecting the main gearbox (MGB) base plate for a crack and replacing the MGB if a crack is found. This action would increase the

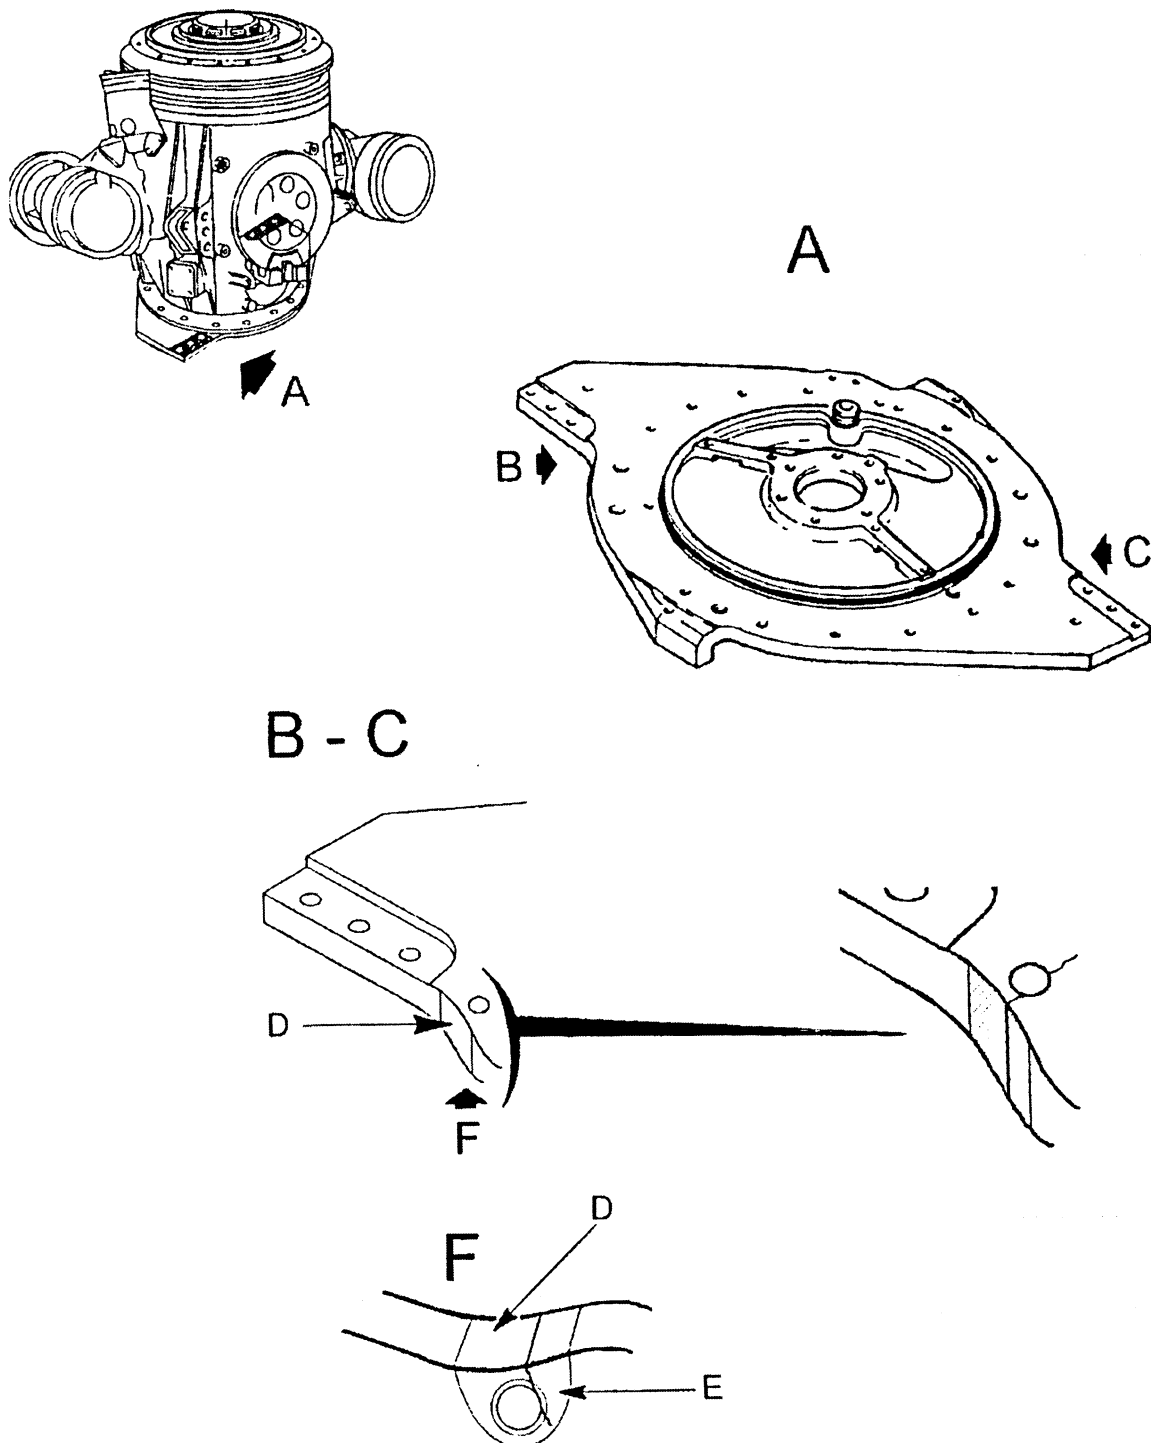
strip the paint from area "D" on both sides ("B" and "C") of the MGB base plate as depicted in Figure 1 of this AD.

(b) At the times indicated in the compliance table, inspect area "D" of the MGB base plate for a crack using a 10x or higher magnifying glass. Area "D" to be inspected is depicted in Figure 1 of this AD.

(c) If a crack is found in a MGB base plate, remove and replace the MGB with an airworthy MGB before further flight.
