[Docket No. FAA-2012-0060; Directorate Identifier 2012-NE-02-AD; Amendment 39-17123; AD 2012-14-09]

#### Airworthiness Directives; Pratt & Whitney (P&W) Division Turbofan Engines

**2012–14–09 Pratt & Whitney Division:**  
Amendment 39–17123; Docket No. FAA–2012–0060; Directorate Identifier 2012–NE–02–AD.

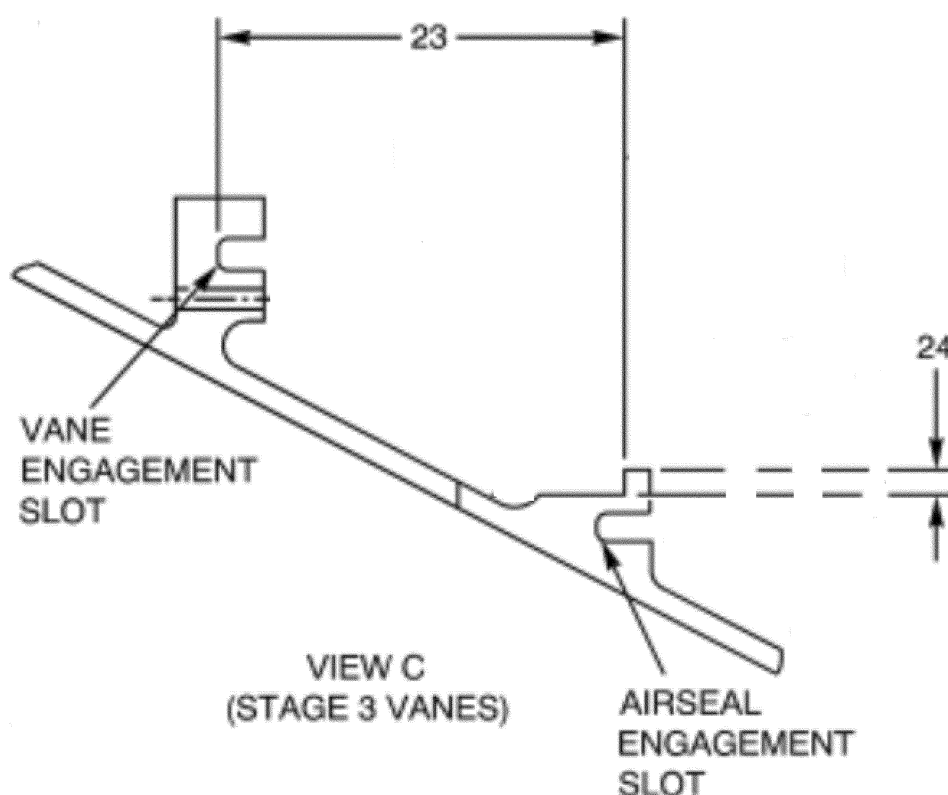
Figure 4 to Paragraph (e) - Determination of Case Eligibility

(iv) Dimensionally examine index 23 and index 24 of the vane engagement slots on the rear turbine case, where the 3rd stage vane is installed. Use Table 3 to paragraph (e) of this AD and Figure 4 to paragraph (e) of this AD to determine whether the case is eligible for installation.

| Inspect: | Eligible for installation limits: |
|---|---|
| 23 ..... | 1.875 inch (47.625 mm) minimum. |
