[Docket No. 2001-SW-50-AD]

**Airworthiness Directives; Eurocopter France Model EC120B, EC155B, SA330F, SA330G, SA330J, AS332C, AS332L, AS332L1, AS332L2, AS350B, AS350BA, AS350B1, AS350B2, AS350B3, AS350D, AS355E, AS355F, AS355F1, AS355F2, AS355N, AS365N2, AS365N3, SA-365N, and SA-365N1 Helicopters**

**ACTION:** Notice of proposed rulemaking (NPRM).

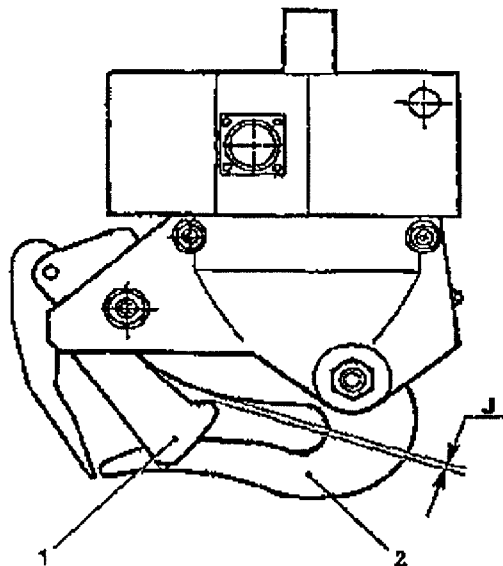
The Direction Generale De L'Aviation Civile (DGAC), the airworthiness authority for France, notified the FAA that an unsafe condition may exist on various ECF model helicopters. The DGAC advises of the discovery of an anomaly on the locking catch of certain cargo hooks that could jam the ring on the cargo hook and jeopardize the release of an underslung load.

Siren Load Release Unit  
P/N AS21-5-(1 through 7)

1. Locking Catch
2. Cargo Hook

Clearance "J" must be less than 14 mm (0.55 inches)

(a) With the cargo hook in the no-load position, measure the clearance "J" in accordance with Figure 1 of this AD. Remove any cargo hook if clearance "J" (see Figure 1) is equal to or greater than 14 millimeters (0.55 inches).
