**Figure 1 to Paragraph (g)(1)—TRB Tip Cap Check/Inspection**

**Airworthiness Directives; Deutsche Aircraft GmbH (Type Certificate Previously Held by 328 Support Services GmbH; AvCraft Aerospace GmbH; Fairchild Dornier GmbH; Dornier Luftfahrt GmbH) Airplanes**

**SUMMARY:** The FAA proposes to adopt a new airworthiness directive (AD) for all Deutsche Aircraft GmbH Model 328-100 and -300 airplanes. This proposed AD was prompted by operator reports of worn and ruptured bonding straps inside the feeder wing tanks and in both outer and inner wing tanks. This proposed AD would require a one-time detailed inspection of each affected part, and applicable corrective actions, as specified in a European Union Aviation Safety Agency (EASA) AD, which is proposed for incorporation by reference (IBR). The FAA is proposing this AD to address the unsafe condition on these products.

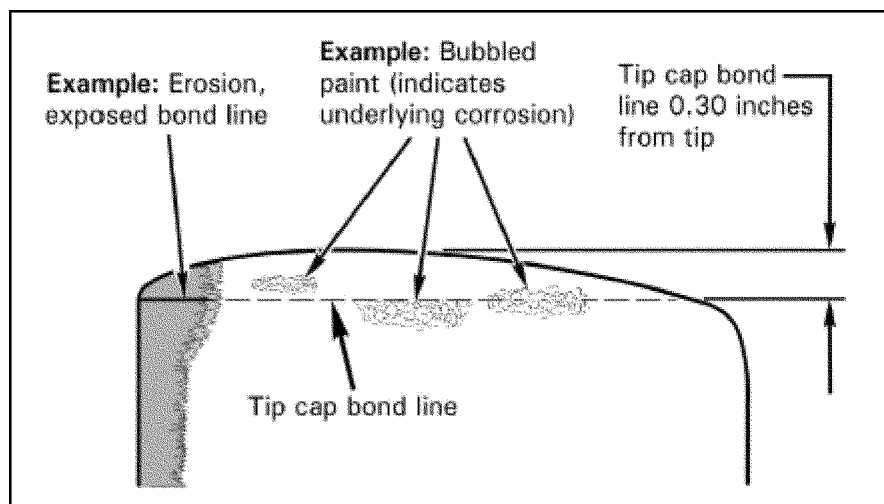
(2) Within 100 hours TIS or during the next 100 hour or annual inspection after the effective date of this AD, whichever occurs first, and thereafter at intervals not to exceed 100 hours TIS or during the next 100 hour or annual inspection, whichever occurs first, visually inspect each TRB tip cap area (at and adjacent to the tip cap bond line on each surface and edge of the TRB) for evidence of corrosion, which may be indicated by an exposed tip cap bond line or bubbled paint, as depicted in Figure 1 of paragraph (g)(1) of this AD.

(3) As a result of the actions required by either paragraph (g)(1) or (2) of this AD, if there is evidence of corrosion, an exposed tip cap bond line, or bubbled paint, before further flight, remove all of the corrosion.
