[Docket No. 2000-NM-136-AD; Amendment 39-11962; AD 2000-22-15]

#### **Airworthiness Directives; Boeing Model 747-100, -200B, -200C, -200F, and -300 Series Airplanes Delivered In or Modified Into the Stretched Upper Deck Configuration**

**2000-22-15 Boeing:** Amendment 39-11962. Docket 2000-NM-136-AD.

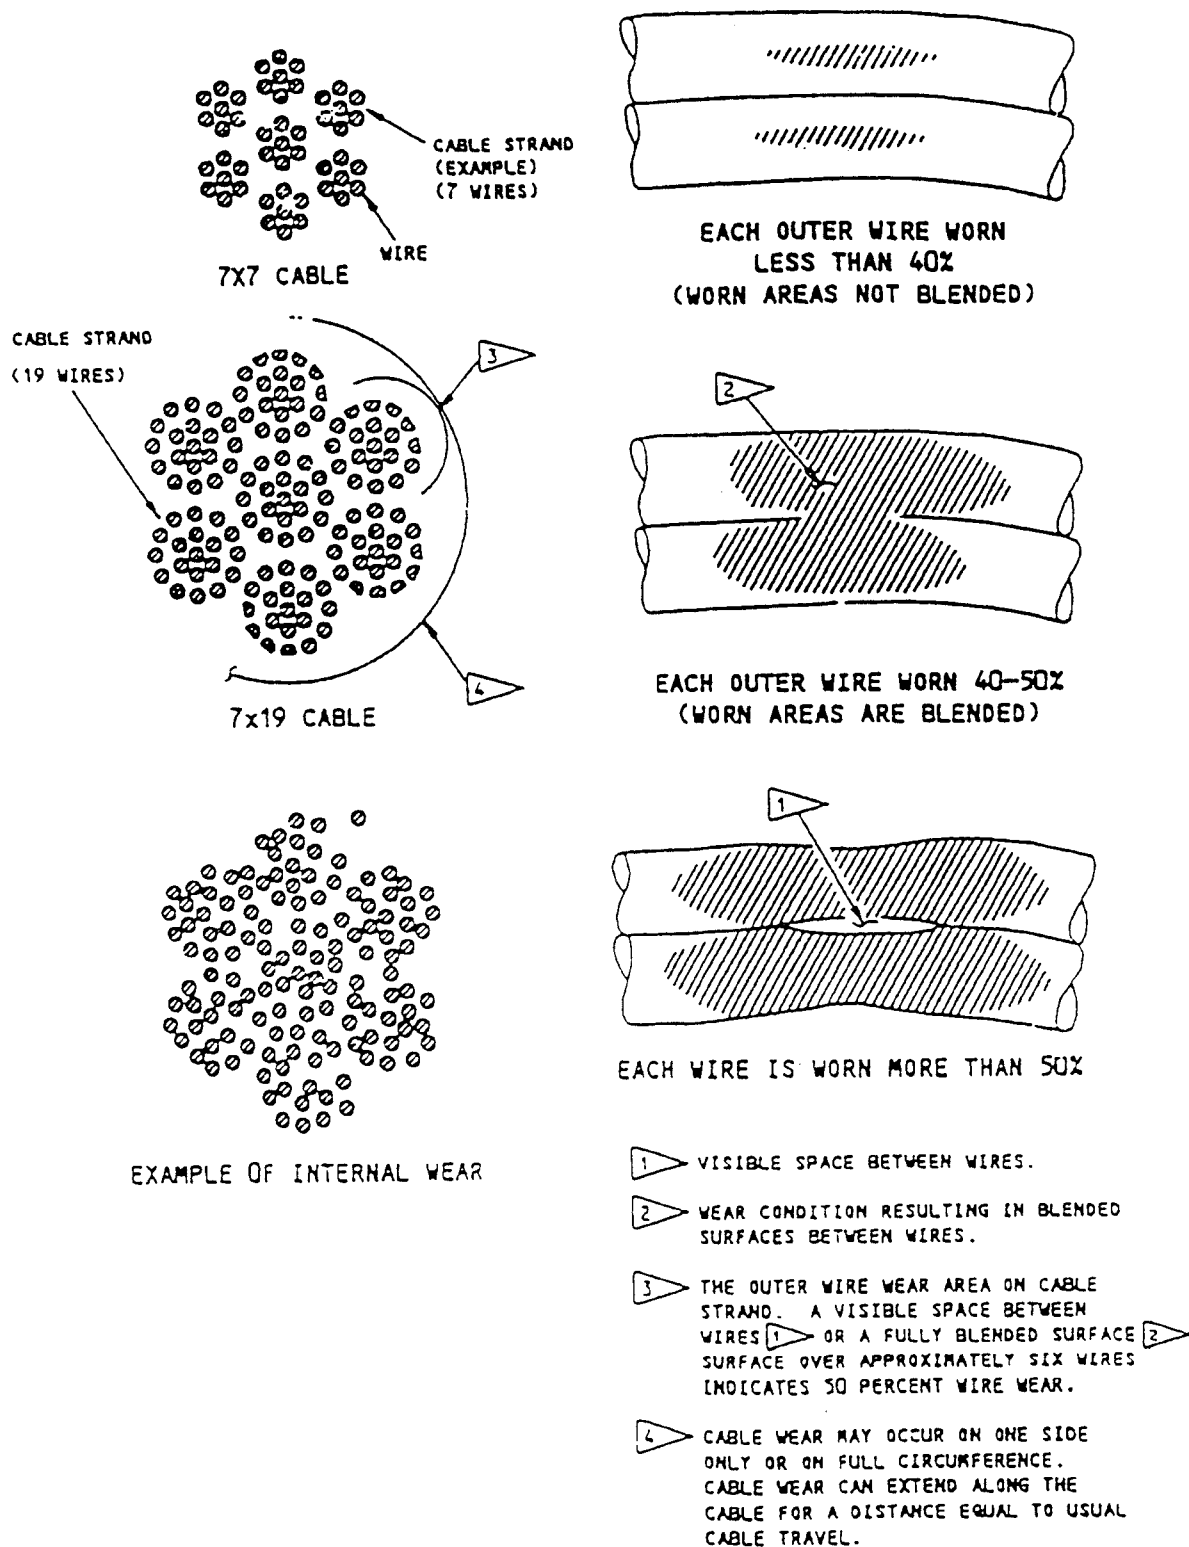
FIGURE 1

- (1) One cable strand had worn wires where one wire cross section is decreased by more than 40 percent (see Figure 1).
- (2) A kink is found.
- (3) Corrosion is found.

(2) Perform a detailed visual inspection of the engine thrust control cables in the area of the plate to detect wear and broken wires in accordance with Appendix 1 (including Figure 1) of this AD. If any wear is within the criteria contained in Appendix 1 (including Figure 1) of this AD, no further action is required by this paragraph. If any wear outside the criteria contained in Appendix 1 (including Figure 1) of this AD is found, prior to further flight, replace the cable with a new cable, in accordance with the procedures described in the Boeing 747 Maintenance Manual.

B. Replace the cable assembly if any of the following criteria are met:
