[Docket No. 2000-SW-38-AD]

### Airworthiness Directives; Marathon Power Technologies Company

**ACTION:** Notice of proposed rulemaking (NPRM).

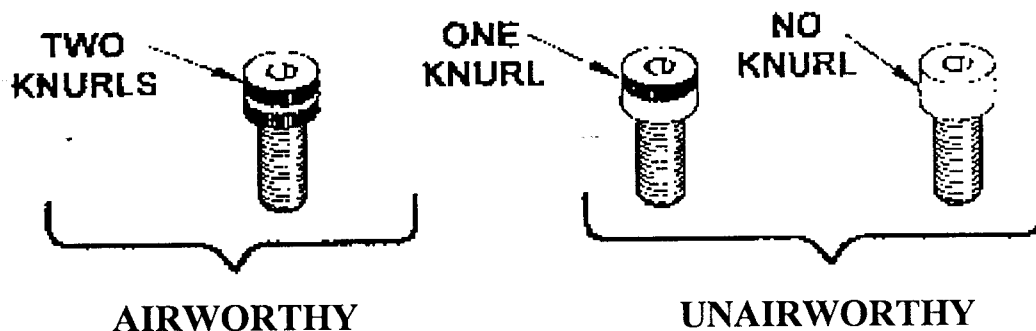
Figure 1

This document proposes adopting a new AD for certain nickel cadmium batteries produced by Marathon. The AD would require inspecting any affected battery to verify that each #10-32 socket head cap screw (screw) is part number (P/N) 10488-020 with two rows of straight knurls, which is the correct screw hardware. This AD also requires, before further flight, replacing any screw found with only one knurl or no knurl with a screw, P/N 10488-020, with two knurls. This proposal is

prompted by an explosion of a G.E./Saft battery during routine maintenance on a McDonnell Douglas DC-9 aircraft. Marathon battery, P/N 27183-001, is similar to the GE/Saft battery that exploded. A battery cell screw head broke off causing an electrical short circuit between the internal battery cell positive and negative posts. This resulted in a rapid discharge of energy, heat, and gases. Investigation revealed unapproved screws were installed, and maintenance procedures did not comply with the manufacturer's recommendations. Metallurgical tests cited chloride as a factor in causing the heads of the failed screws to shear and the eventual explosion of the battery. The actions specified by the proposed AD are intended to prevent an explosion of a battery, structural damage, and subsequent loss of power to the electrical systems.

(a) Visually inspect each #10-32 screw in the battery at the terminals to verify that each screw has two (2) rows of straight knurls (see Figure 1). If a screw is found with only one knurl or no knurl (see Figure 1), before further flight, fully discharge the battery, remove the unairworthy screw and replace it with an airworthy screw, P/N 10488-020.

replacing any unairworthy screw with an airworthy screw, P/N 10488-020.
