[Docket No. 2001-SW-58-AD; Amendment 39-12726; AD 2001-25-52]

#### Airworthiness Directives; Schweizer Aircraft Corporation Model 269A, 269A-1, 269B, 269C, and TH-55A Helicopters

##### **2001-25-52 Schweizer Aircraft**

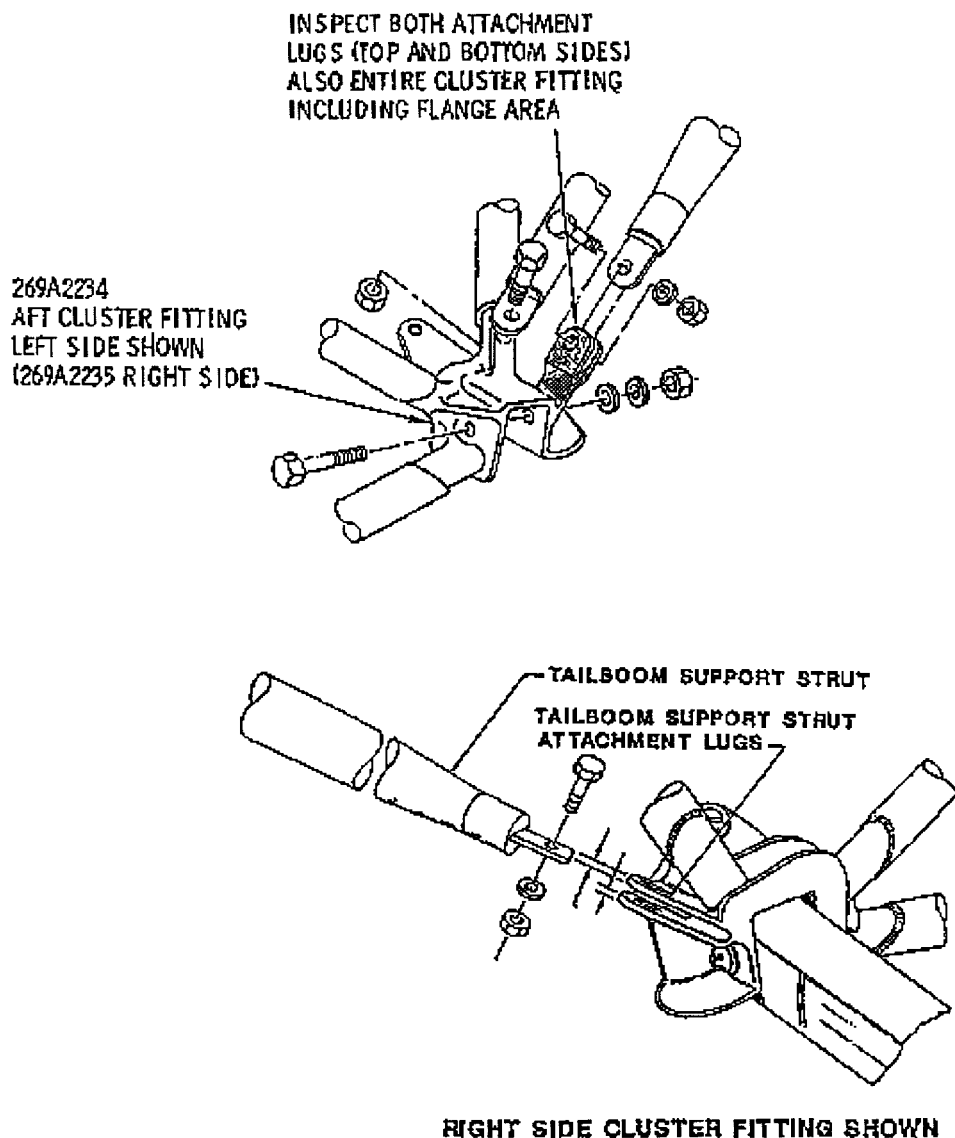
**Figure 1**

To prevent failure of a strut clevis lug (lug) on a center frame aft cluster fitting (cluster fitting), rotation of a tailboom into the main rotor blades, and subsequent loss of control of the helicopter, accomplish the following:

(2) Dye-penetrant inspect the lugs on each aft cluster fitting. See Figure 1.

(3) If a crack is found, before further flight, replace the cracked cluster fitting with an airworthy cluster fitting. Cluster fittings, P/N 269A2234 and 269A2235, are not eligible to replace a cracked cluster fitting.
