[Docket No. FAA–2010–1101; Directorate Identifier 2009–CE–013–AD; Amendment 39–16690; AD 2011–10–09]

**Airworthiness Directives; Cessna Aircraft Company Models 150, 152, 170, 172, 175, 177, 180, 182, 185, 188, 190, 195, 206, 207, 210, T303, 336, and 337 Airplanes**

**ACTION:** Final rule.

**SUMMARY:** We are superseding an existing airworthiness directive (AD) for Cessna Aircraft Company (Cessna) 150, 152, 170, 172, 175, 177, 180, 182, 185, 188, 190, 195, 206, 207, 210, T303, 336, and 337 series airplanes. That AD currently requires repetitive inspections and replacement of parts, if necessary,

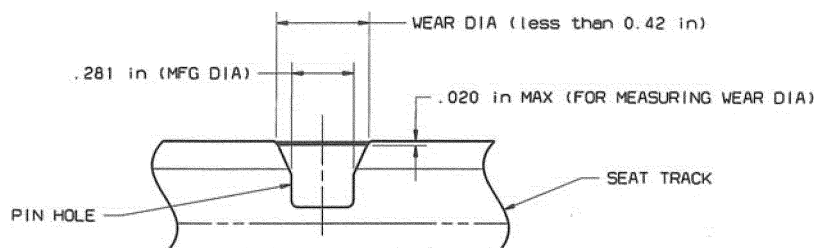
Figure 1. Diameter of seat pin locking engagement hole

Dave McFarlane requested we add a maximum allowable incremental 0.07-inch radius dimension to figure 1 at the outside diameter dimensions for clarification.

We disagree with this comment. The measurement dimensions in figure 1 adequately address the measurements necessary for this AD. Additional measurements will not provide any additional benefit.

(3) Inspect the diameter of each seat locking pin engagement hole in the pilot and copilot seat rails for excessive wear. Due to wear on the rail surface at the hole opening, we allow this measurement 0.020 of an inch below the surface of the rail. You must take this measurement somewhere between the surface of the rail or no more than 0.020 of an inch below the surface of the rail.

(i) If the diameter of any of the holes is 0.42 of an inch or more (see figure 1), before further flight, replace the rail.

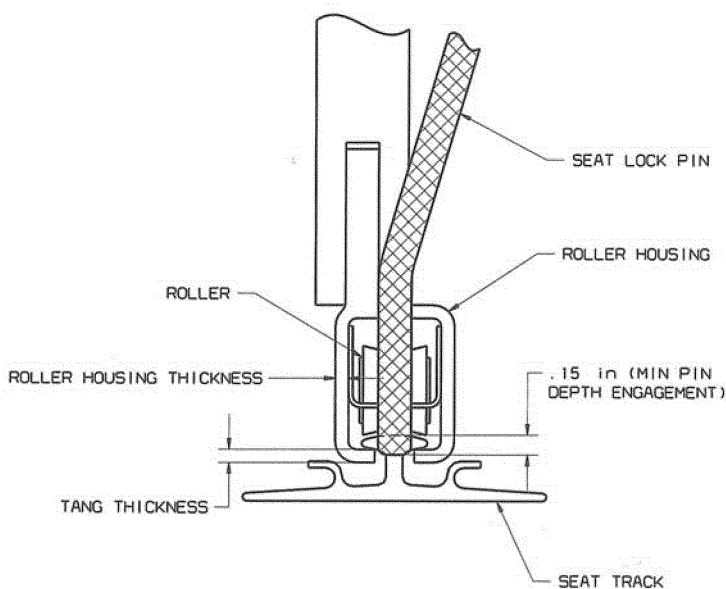
Figure 2. Seat locking pin depth engagement

(10) Lift up the forward edge of each seat to eliminate vertical play of the seat locking pin in the engagement hole, and from this position, inspect the depth of engagement of each seat locking pin (see figure 2). If the rail is worn, this depth is measured from the worn surface, not the manufactured surface.

(i) If engagement of any of the seat locking pins measures less than 0.15 of an inch, before further flight, replace or repair any seat components necessary to achieve a seat pin engagement of a minimum of 0.15 of an inch.

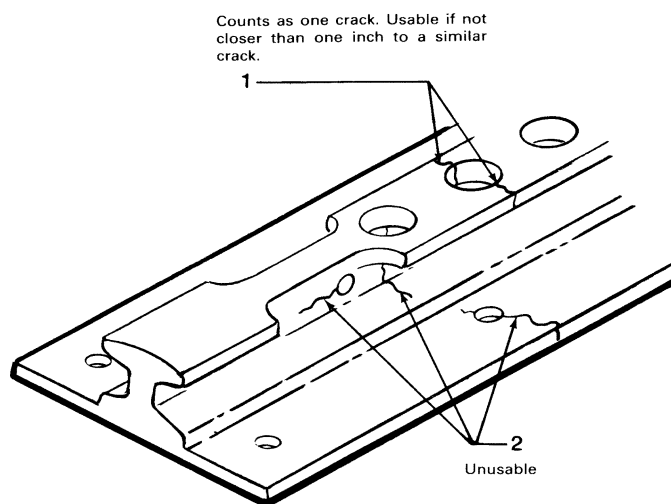
(8) Visually inspect the seat rails for cracks.

#### REPLACE SEAT RAIL WHEN:

- (1) Any portion of web or lower flange is cracked (index 2).
- (2) Any crack in crown of rail is in any direction other than right angle to length of rail.
- (3) Number of cracks on any one rail exceeds four, or any two cracks (index 1) are closer than one inch.

(i) If there are seat rail cracks that exceed the crack criteria in figure 5, before further flight, replace the seat rail.
