[Docket No. FAA-2007-0096; Directorate Identifier 2007-NE-39-AD; Amendment 39-16141; AD 2009-26-06]

Airworthiness Directives; Honeywell International Inc. ALF502 Series and LF507 Series Turbofan Engines

ACTION: Final rule.

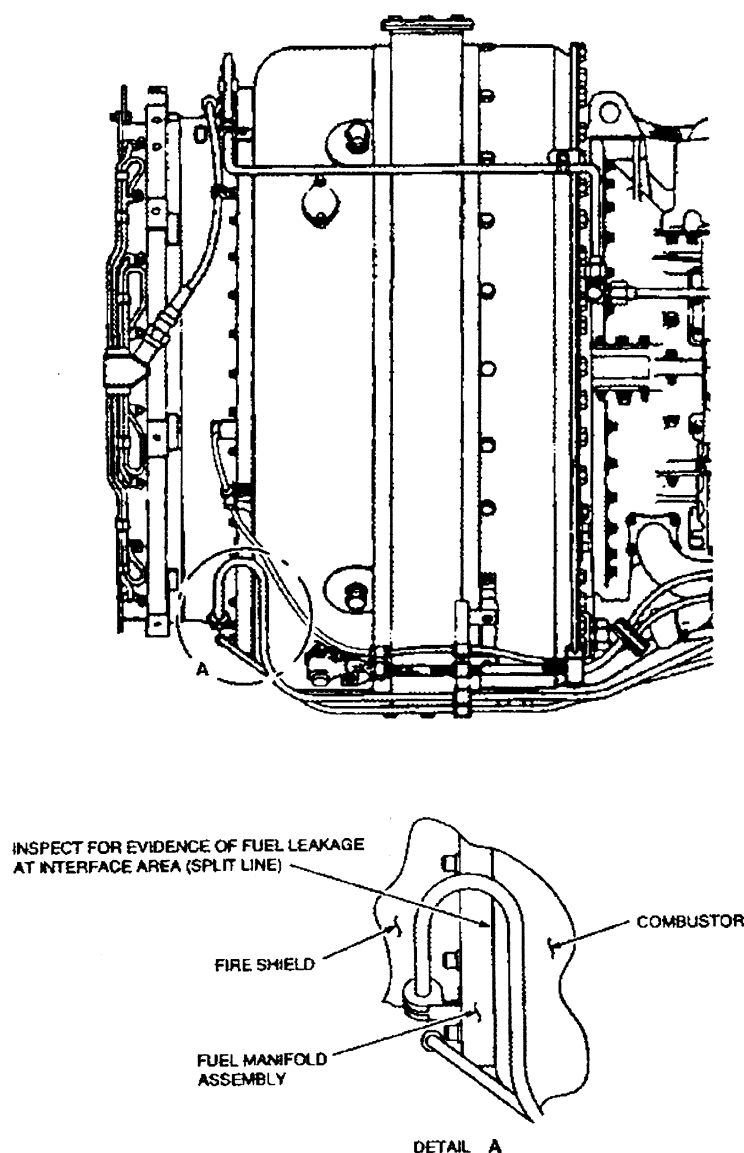
Figure 1 - Fuel Manifold Assembly-to-Fire Shield Interface Area

(d) This AD results from reports of fire in the engine nacelle. We are issuing this AD to detect cracks in certain fuel manifolds and fuel leaks from other fuel manifolds, which could result in a fire in the engine nacelle and a hazard to the aircraft.

(2) With the engine operating, look for fuel leaking from the fuel manifold assembly to the fire shield interface area (see Figure 1 of this AD). No leaks allowed.

(5) Look for fuel leaking from the fuel manifold assembly to the fire shield interface area (see Figure 1 of this AD). No leaks allowed.

(3) If you find any leaks, shutdown the engine and replace the fuel manifold assembly with an FAA-approved serviceable assembly.

(6) If you find any leaks, replace the fuel manifold assembly with an FAA-approved serviceable assembly.

(i) Replacing a fuel manifold assembly that has a P/N specified in paragraph (c) of this AD with a fuel manifold assembly, P/N 2-163-620-39, 2-163-620-40, 2-163-620-41, or 2-163-620-42, or an FAA-approved equivalent part, terminates the inspection requirement of this AD.
