## **DEPARTMENT OF TRANSPORTATION**

### **Federal Aviation Administration**

[Docket No. FAA-2010-1101; Directorate Identifier 2009-CE-013-AD]

**Airworthiness Directives; Cessna Aircraft Company Models 150, 152, 170, 172, 175, 177, 180, 182, 185, 188, 190, 195, 206, 207, 210, T303, 336, and 337 Airplanes**

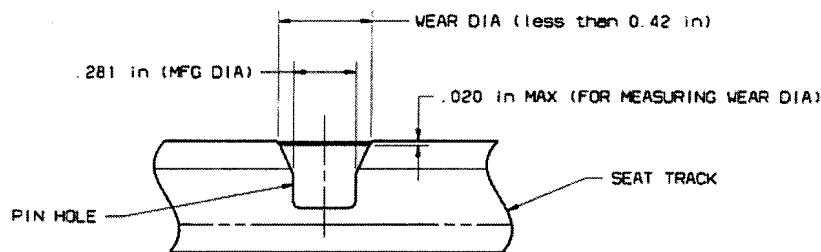
Figure 1. Diameter of seat pin locking engagement hole

(4) Inspect the diameter of each seat locking pin engagement hole in the pilot and copilot seat rails for excessive wear. Due to wear on the rail surface at the hole opening, we allow this measurement 0.020 of an inch

below the surface of the rail. You must take this measurement somewhere between the surface of the rail or no more than 0.020 of an inch below the surface of the rail.

(i) If the diameter of any of the holes is 0.42 of an inch or more (see figure 1), before further flight, replace the rail.

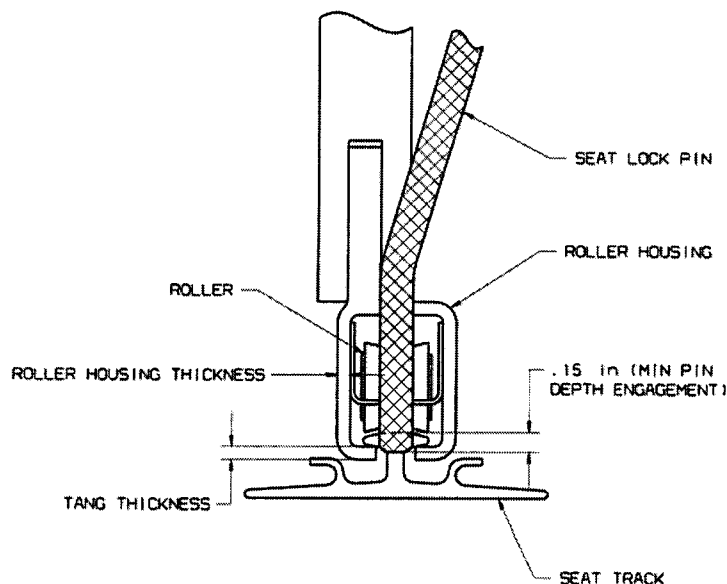
Figure 2. Seat locking pin depth engagement

(2) Lift up the forward edge of each seat to eliminate vertical play of the seat locking pin

in the engagement hole, and from this position, inspect the depth of engagement of each seat locking pin (see figure 2). If the rail is worn, this depth is measured from the worn surface, not the manufactured surface.

(i) If engagement of any of the seat locking pins measures less than 0.15 of an inch, before further flight, replace or repair any seat components necessary to achieve a seat pin engagement of a minimum of 0.15 of an inch.

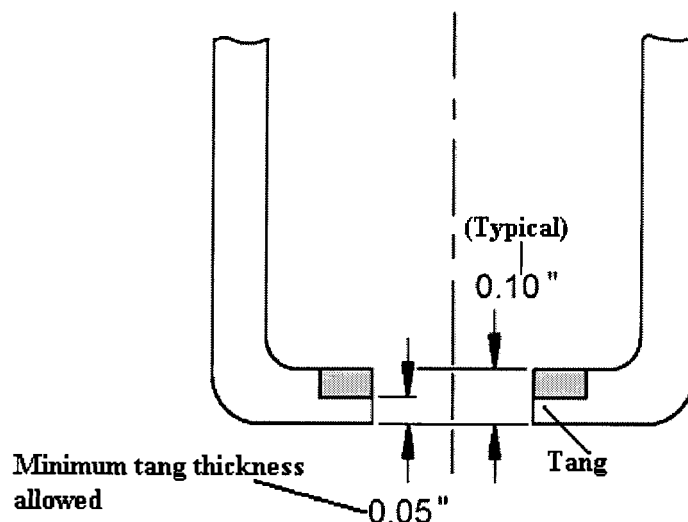
**Figure 3. Closeup of seat roller housing and tang thickness**

(6) Inspect the thickness of the tang (see figure 2 and figure 3). Due to wear of the tang chafing against the seat rail, measure the tang thickness where the tang inner edges contact the seat rail.

(i) If the tang thickness measures less than 0.05 of an inch, before further flight replace the roller housing.

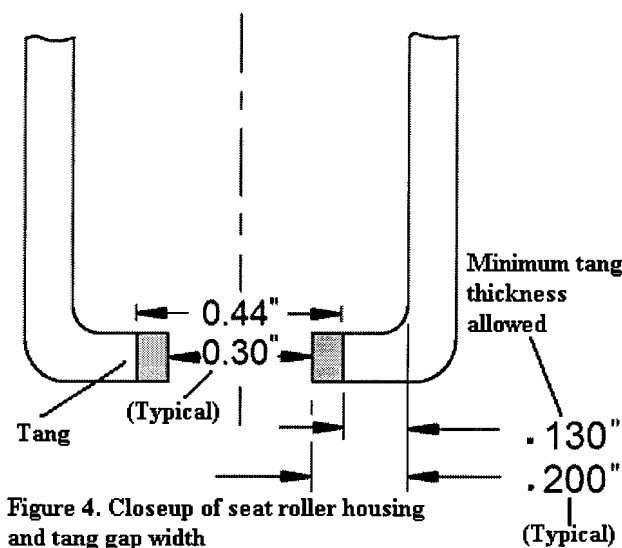
**Figure 4. Closeup of seat roller housing and tang gap width**

(7) Inspect the inner edges of the tangs. Due to wear or deformation of the tangs, measure the distance from one tang inner

edge to the other tang inner edge (see figure 4).

(i) The maximum distance allowed between tang edges is 0.44 inches. If the

distance between tang inner edges measures 0.44 of an inch or more, before further flight, replace the roller housing.

(ii) The minimum measurement allowed for the remaining tang is 0.130 inches remaining on either of the tangs, from the inner edge of the tang to the bend of the roller housing. If the measurement is less than 0.130 inches on either of the tangs, before further flight, replace the roller housing.

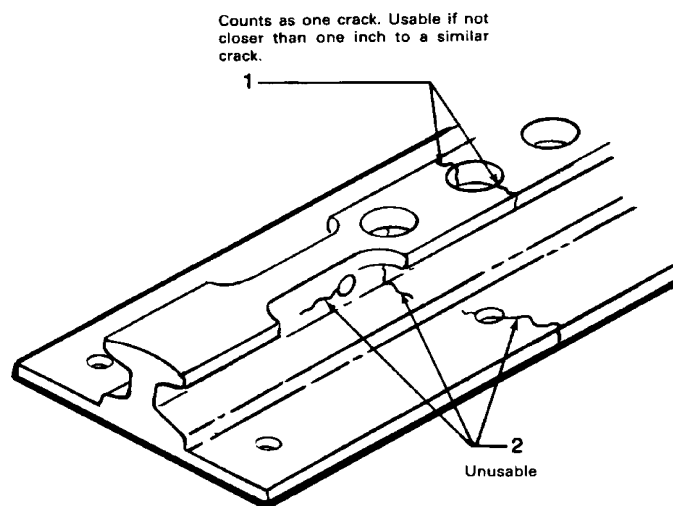
**Figure 5. Seat rail**

(9) Visually inspect the seat rails for cracks.

- (1) Any portion of web or lower flange is cracked (index 2).
- (2) Any crack in crown of rail is in any direction other than right angle to length of rail.
- (3) Number of cracks on any one rail exceeds four, or any two cracks (index 1) are closer than one inch.

(i) If there are seat rail cracks that exceed the crack criteria in figure 5, before further flight, replace the seat rail.
