[Docket No. 2002–NE–08–AD; Amendment 39–12865; AD 2002–16–26]

#### Airworthiness Directives; Bombardier-Rotax GmbH Type 912 F and 914 F Series Reciprocating Engines

**2002-16-26 Bombardier-Rotax GmbH:**  
Amendment 39-12865. Docket No. 2002-NE-08-AD.

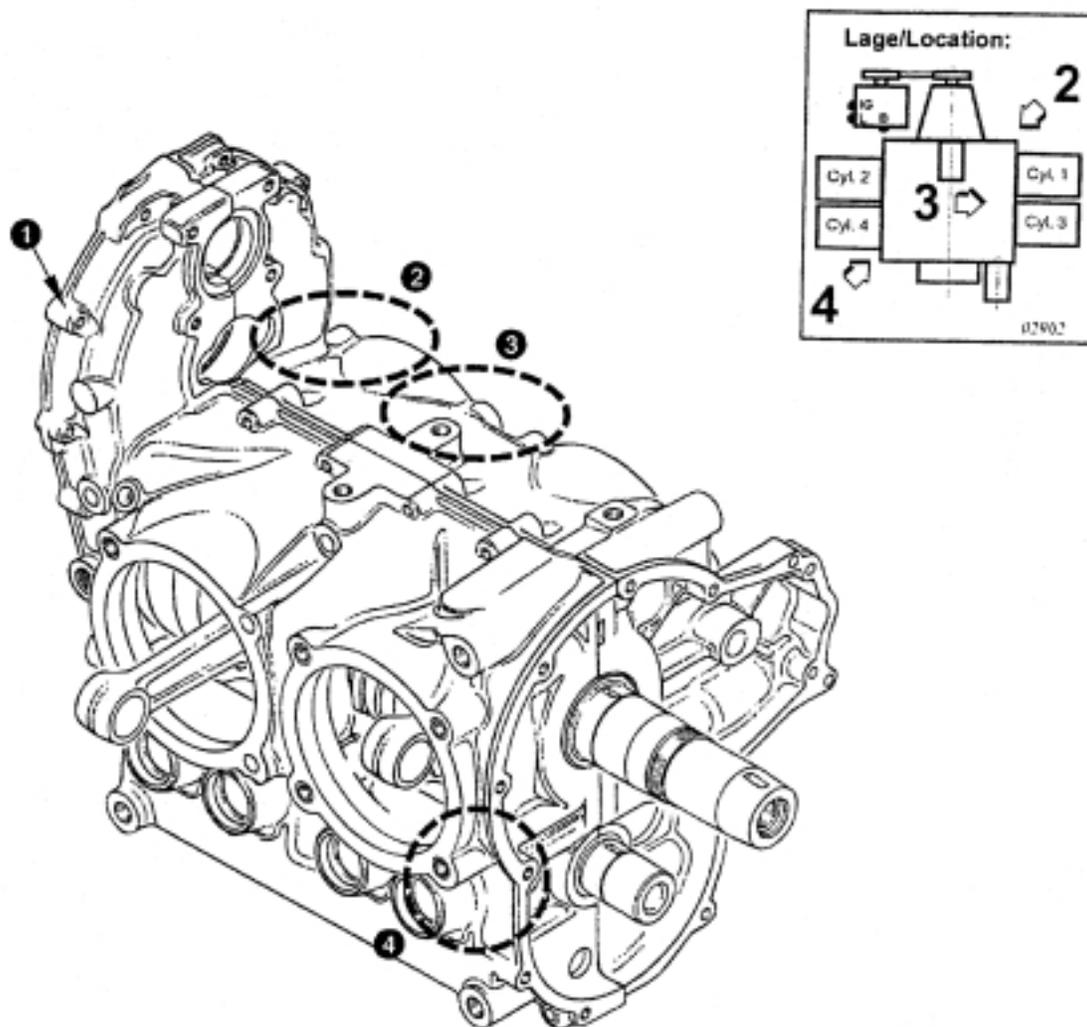
**Figure 1. Engine Crankcase Inspection Areas**

(1) Inspect the engine crankcase (item 1, Figure 1 of this AD) for cracks especially in the area of cylinder 1 upper side (item 2), between cylinder 1 and 3 upper side (item 3), and cylinder 4 lower side (item 4).

1. Engine Crankcase
2. Cylinder 1 Upper Side
3. Cylinder 3 Upper Side
4. Cylinder 4 Lower Side

(2) Cracks in crankcases of engines with a ROTAX cooling air baffle may not be easily visible, and oil leaks may be an indication of cracks. Visually inspect for oil leaks in areas of (item 2) and (item 3).

(3) If oil leaks are found, determine the source by either using a borescope or removing the object blocking the view such as the air baffle or accessory, and perform the inspection.

(4) If the engine crankcase is cracked, replace engine before further flight. Repair oil leaks from any other cause.

(b) Visually inspect the engine crankcase (item 1, Figure 1 of this AD) for cracks at each 100-hour, annual, or progressive inspection, or within 110 hours TIS since last inspection, whichever occurs first, in accordance with paragraph (a) of this AD.
