#### 2012-17-09 Eurocopter France:

Amendment 39-17172; Docket No. FAA-2012-0338; Directorate Identifier 2009-SW-51-AD.

[Docket No. FAA-2012-0008; Directorate Identifier 2011-NE-43-AD; Amendment 39-17115; AD 2012-14-01]

#### Airworthiness Directives; Rolls-Royce Deutschland Ltd & Co KG Turbofan Engines

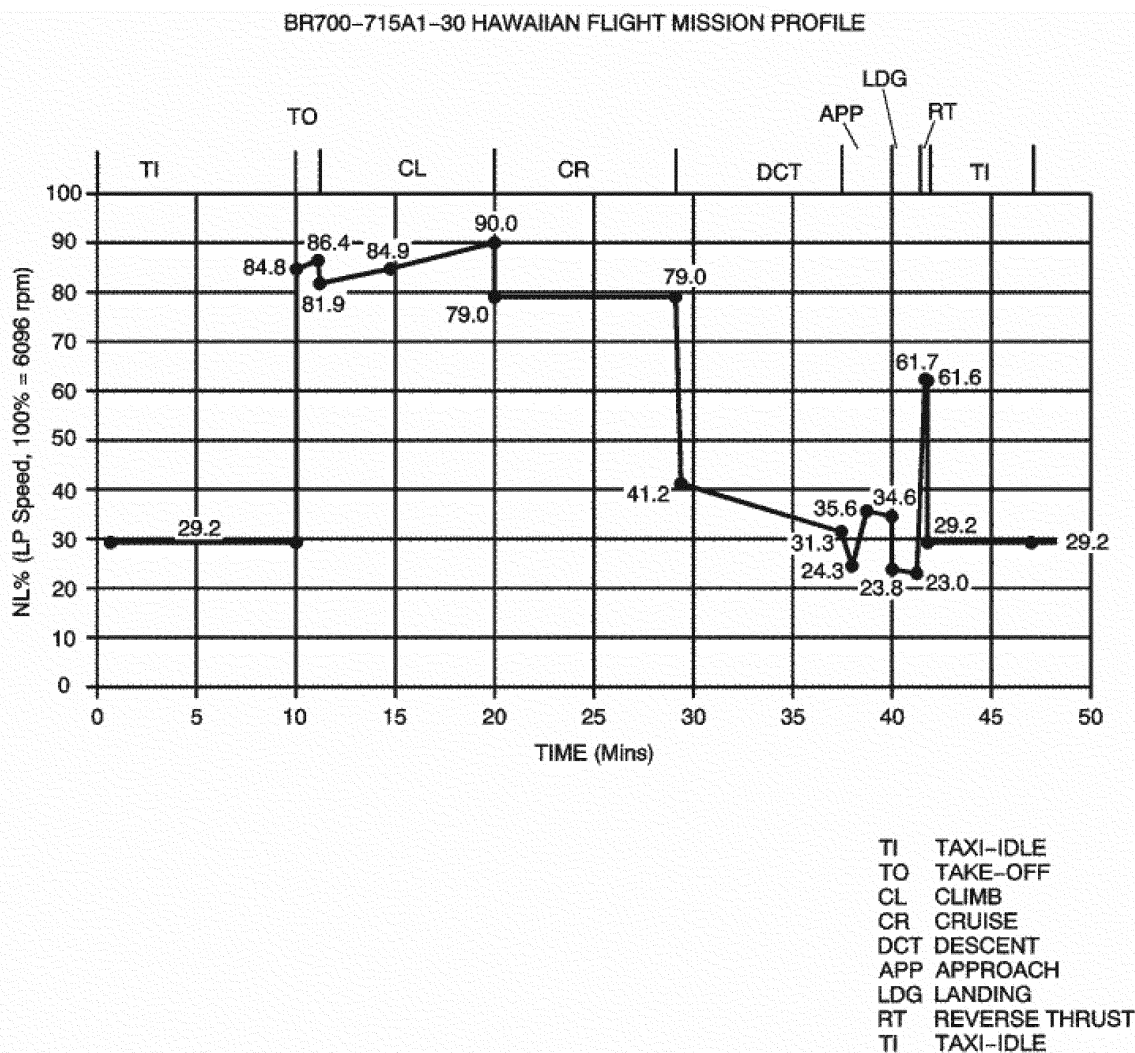
Figure 1 to paragraph (f)(2)

(2) The Hawaiian Flight Mission referenced in Table 1 to paragraph (e) is shown in Figure 1 to paragraph (f)(2):
