[Docket No. FAA-2011-0054; Directorate Identifier 2010-CE-070-AD; Amendment 39-16582; AD 2011-01-53]

Airworthiness Directives; PIAGGIO AERO INDUSTRIES S.p.A Model PIAGGIO P-180 Airplanes

2011-01-53 PIAGGIO AERO INDUSTRIES S.p.A: Amendment 39-16582; Docket No. FAA-2011-0054; Directorate Identifier 2010-CE-070-AD.

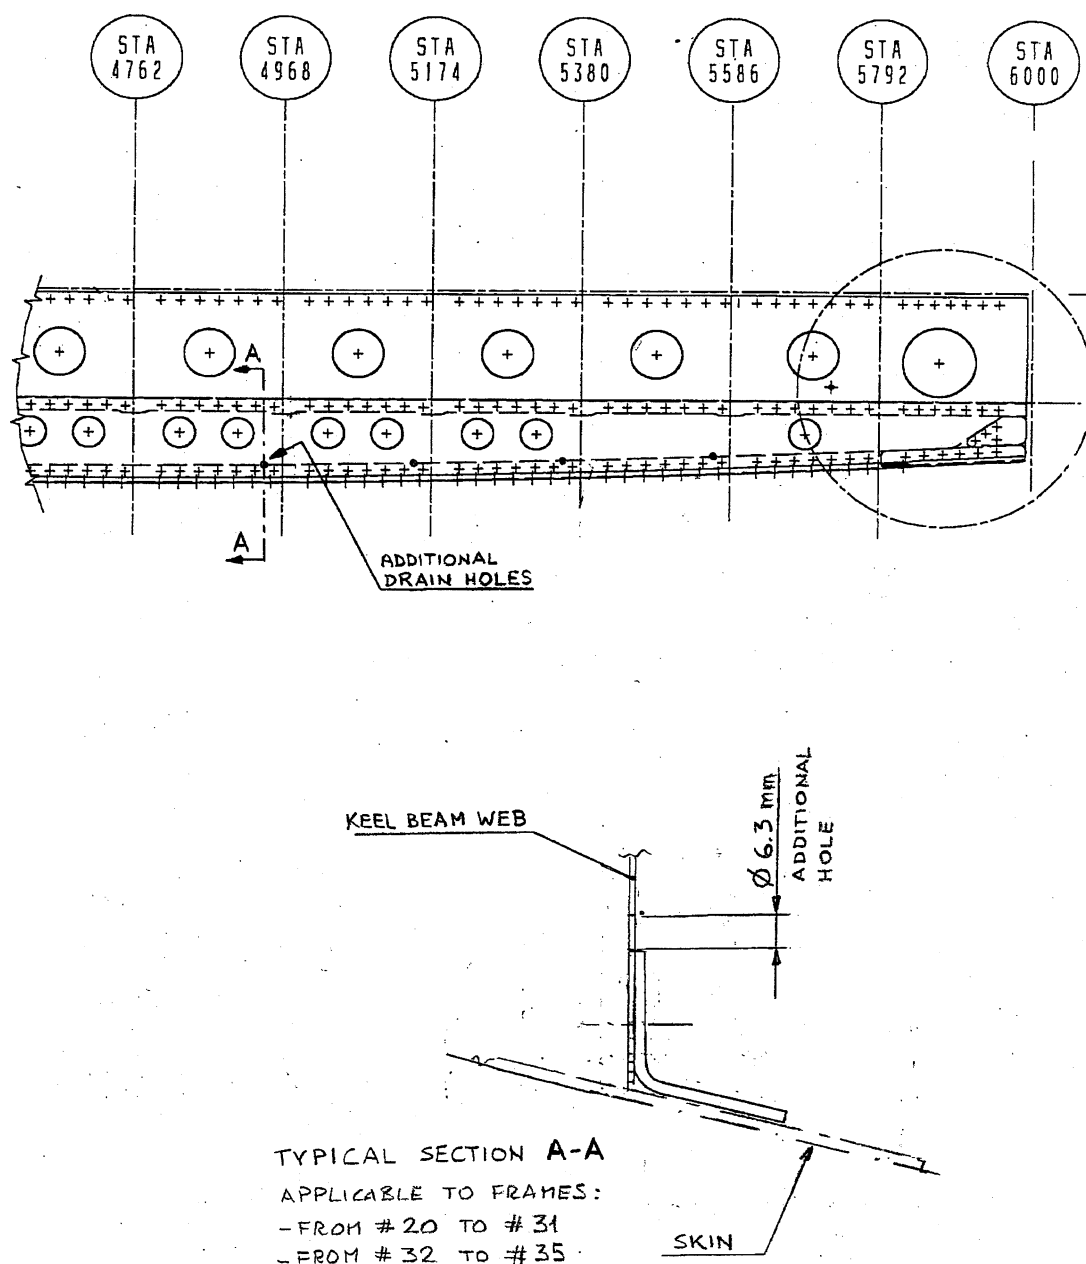
Figure 1. Additional drain holes on keel beam webs

i. If water is found only in the bottom of the belly (*i.e.*, undrainable within the keel

beams), go to step 6. Step 5 does not need to be accomplished at this time.

ii. If water is found in excess of item above (4-c-i), do step 5.

5. Add 6.3 mm draining holes as per attached figure 1 (additional drain holes on keel beam webs) connecting the lateral bays to the center ones or, as alternative, apply Piaggio Aero Industries Service Bulletin 80-0291. Then proceed with step 6.
