[Docket No. 99-SW-08-AD; Amendment 39-11657; AD 2000-07-03]

#### Airworthiness Directives; Robinson Helicopter Company Model R44 Helicopters

**AD 2000-07-03 Robinson Helicopter Company:** Amendment 39-11657. Docket No. 99-SW-08-AD.

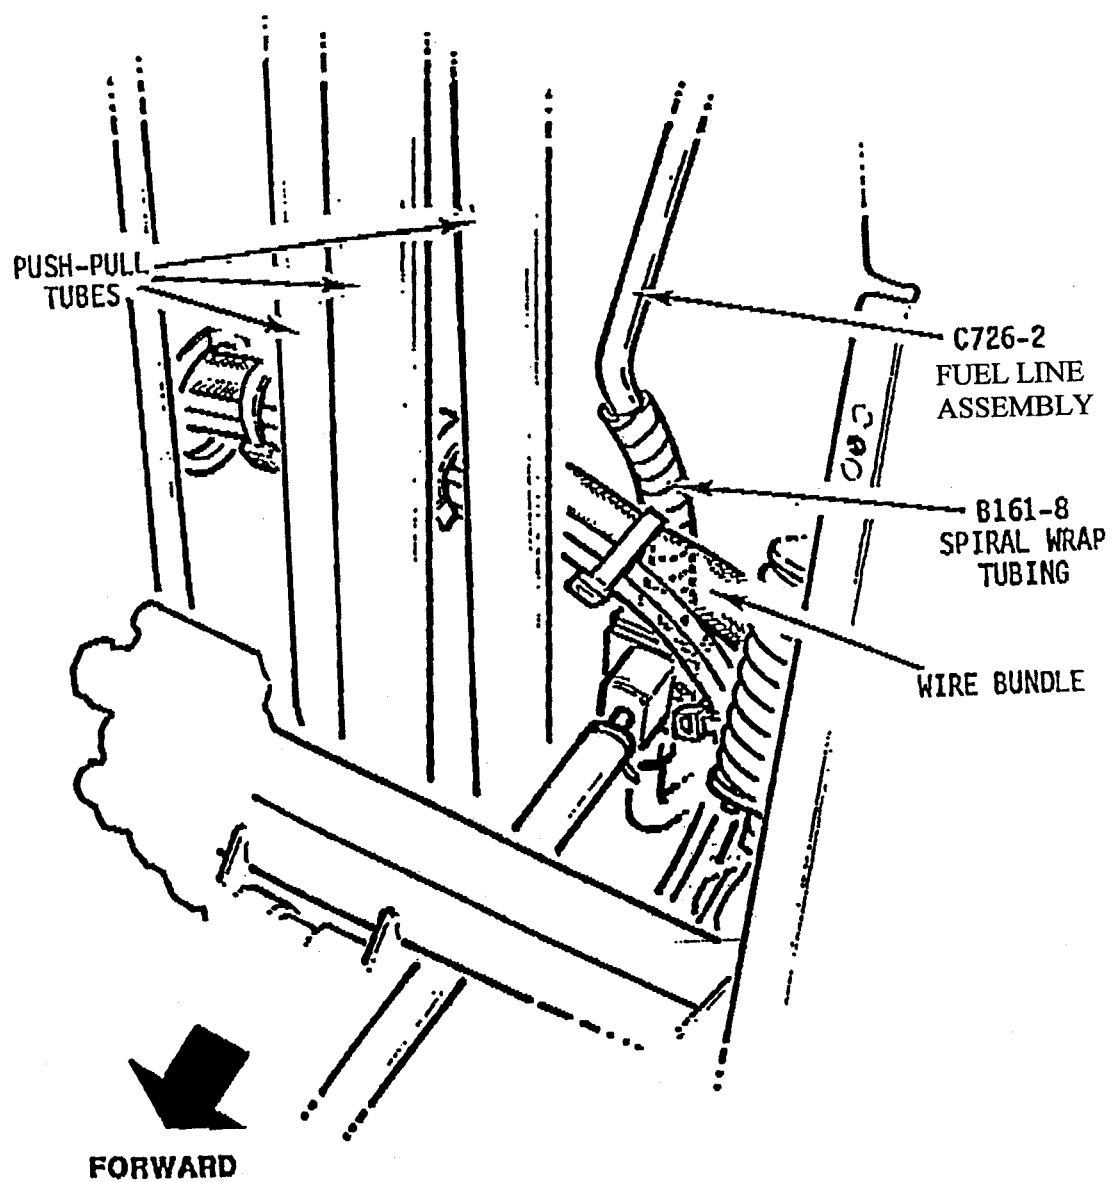
**FIGURE 1**

(b) Inspect the wire harness, P/N C059, and the fuel line assembly, P/N C726-2, above the fuel shutoff valve for contact. If the wire harness contacts the fuel line assembly, inspect for chafing.

(d) Install a 3-inch section of spiral wrap tubing, P/N B161-8, on the fuel line assembly as shown in Figure 1. Push the spiral wrap tubing down until it is against the fuel line fitting.
