[Docket No. 2003-SW-20-AD; Amendment 39-13181; AD 2003-08-53]

**Airworthiness Directives; Eurocopter France Model SA-365N1, AS365-N2, AS 365 N3, and SA-366G1 Helicopters**

##### 2003-08-53 Eurocopter France:

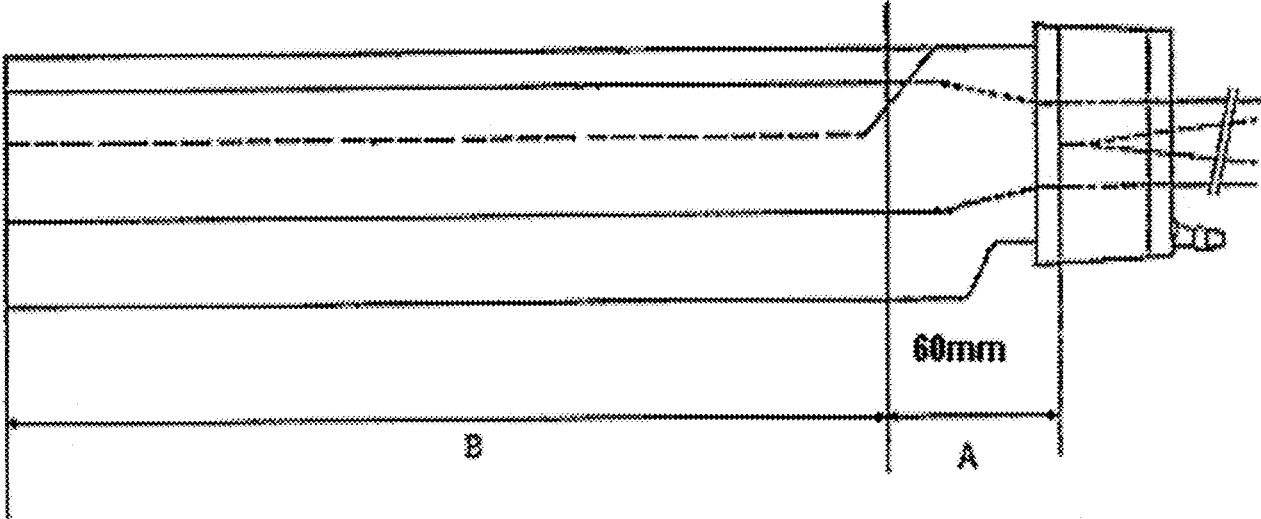
(b) If a crack, blister, or wrinkling is found as a result of the visual check, accomplish the following before further flight (see Figure 1 of this AD):

(1) Zone A: If a blister is detected on the blade suction face, conduct a tapping test inspection on the whole blade for bonding separation.

(ii) For blades, P/N 365A12-0020-02, and -03, if bonding separation exceeds 900 mm<sup>2</sup> in a 30 x 30 mm square or if there is a crack, replace the blade with an airworthy blade before further flight.

(2) Zone B: If a crack, wrinkling, or a blister is found, replace the blade with an airworthy blade before further flight.

(2) Thereafter, at intervals not to exceed 25 hours TIS, conduct a tapping test inspection for bonding separation on blades, P/N 365A12-0020-02 or 365A12-0020-03, in Zone A as depicted in Figure 1 of this AD.

(3) Thereafter, at intervals not to exceed 100 hours TIS or 200 cycles, whichever occurs first, conduct a tapping test inspection for bonding separation on blades, P/N 365A12-0020-02 or 365A12-0020-03, in Zone B as depicted in Figure 1 of this AD. If a crack, wrinkling, or a blister is found, replace the blade with an airworthy blade before further flight.

(i) For blades, P/N 365A33-2131-all dash numbers, 365A12-0010-all dash numbers, and 365A12-0020-00, and -01, if bonding separation or a crack is found, replace the blade with an airworthy blade before further flight.

(i) If bonding separation exceeds the criteria specified in paragraph (b)(1)(ii) of this AD or if a crack is found, replace the blade with an airworthy blade before further flight.

remove and replace the blade with an airworthy blade.
