Federal Register

[Docket No. 2002–NM–130–AD; Amendment 39–12840; AD 2002–16–01]

**Airworthiness Directives; McDonnell Douglas Model DC–8–21, –31, –32, –33, –41, –42, and –43 Airplanes; and Model DC–8–50, –60, and –70 Series Airplanes; Modified per Supplemental Type Certificates SA1063SO, SA1862SO, or SA1832SO**

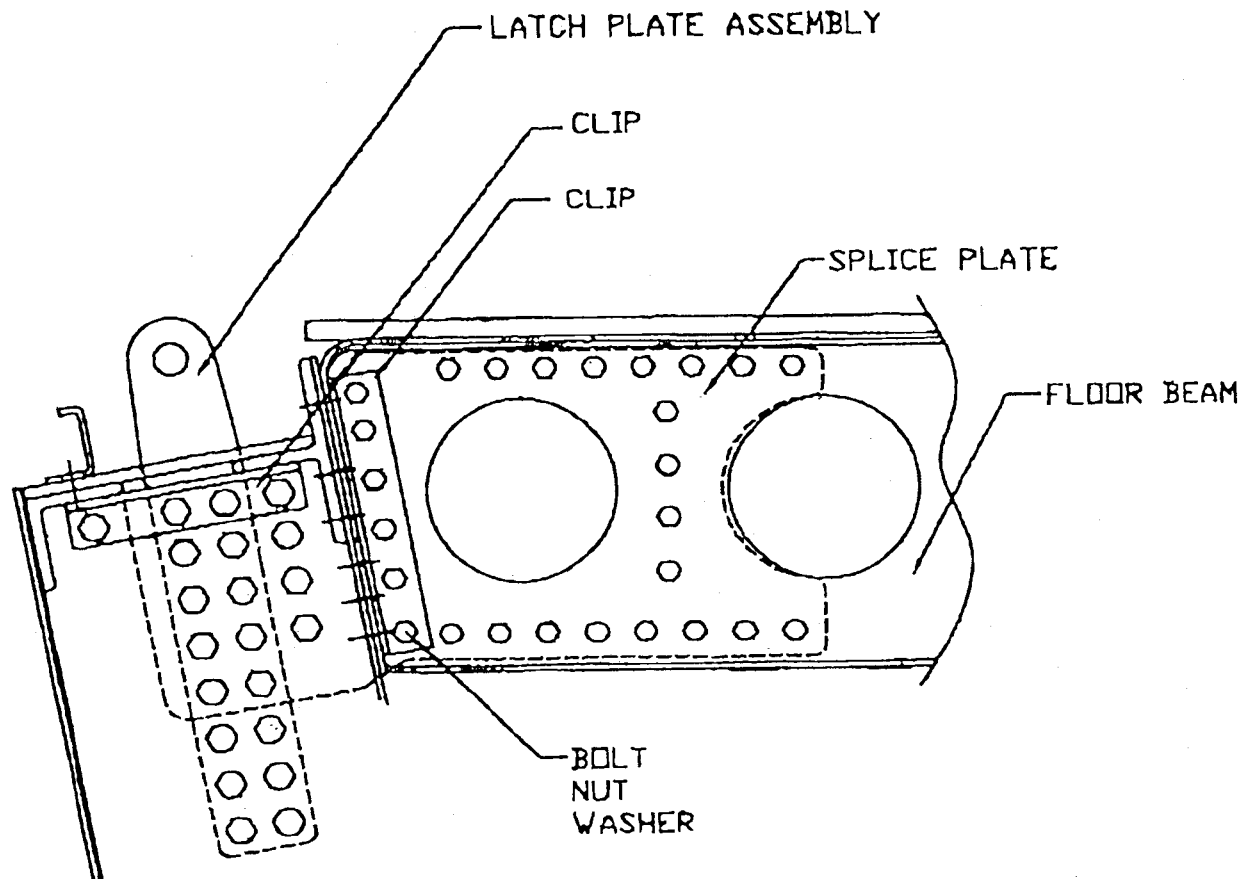
Figure 1.

**SUPPLEMENTARY INFORMATION:** The FAA has received several reports of findings of cracked or broken angles and splice plates on floor beam attachments to the lower door jamb of the main cargo door area on certain McDonnell Douglas Model DC–8–21, –31, –32, –33, –41, –42, and –43 airplanes; and Model DC–8–50, –60, and –70 series airplanes. One

report revealed that, during a routine C-check on a Model DC–8–62 airplane, fractures were found in 9 of 11 of the floor beam attachments to the lower door jamb. Findings indicate that such fractures could be due to factors associated with flight operations and/or loading operations on the ground. Such conditions, if not corrected, could cause failure of such floor beam attachments during ground or flight operations. This could cause damage to the floor structure and consequent jamming of the control cables, and result in loss of controllability of the airplane in flight.

Since an unsafe condition has been identified that is likely to exist or develop on other airplanes of the same type design, this AD is being issued to prevent failure of the floor beam attachments to the lower door jamb. Such failure could cause damage to the floor structure and consequent jamming of the flight control cables, and result in loss of controllability of the airplane in flight. This AD requires gaining access to the floor beam attachments to the lower door jamb within the main cargo door area; and performing repetitive inspections to detect cracking or damage of such attachments, including splice plates, angles, and clips. If any cracking or damage is found, this AD also requires extending the area of inspection 60 inches forward and aft of the main cargo door area, and replacing any cracked or damaged part with a new part. Figure 1 of Appendix 1 of this AD identifies the inspection area and parts to be inspected.

(2) Perform a detailed inspection of the main cargo door area to detect any cracking or damage of the floor beam attachments to the lower door jamb, including the splice plates, angles, and clips identified in Figure 1 of Appendix 1 of this AD. Thereafter, repeat the inspection at intervals not to exceed 2,500 flight cycles or 18 months, whichever occurs earlier.

(b) If any cracking or damage is found during any inspection required by paragraph (a)(2) of this AD, before further flight, extend the area of inspection 60 inches forward and aft of the main cargo door area, and replace any cracked or damaged part with a new part identified in Figure 1 of Appendix 1 of this AD.
