**[Docket No. FAA-2012-0739; Directorate Identifier 2012-SW-044-AD; Amendment 39-17125; AD 2012-14-11]**

#### **Airworthiness Directives; Various Restricted Category Helicopters**

**2012–14–11 Various Restricted Category Helicopters:** Amendment 39–17125; Docket No. FAA–2012–0739; Directorate Identifier 2012–SW–044–AD.

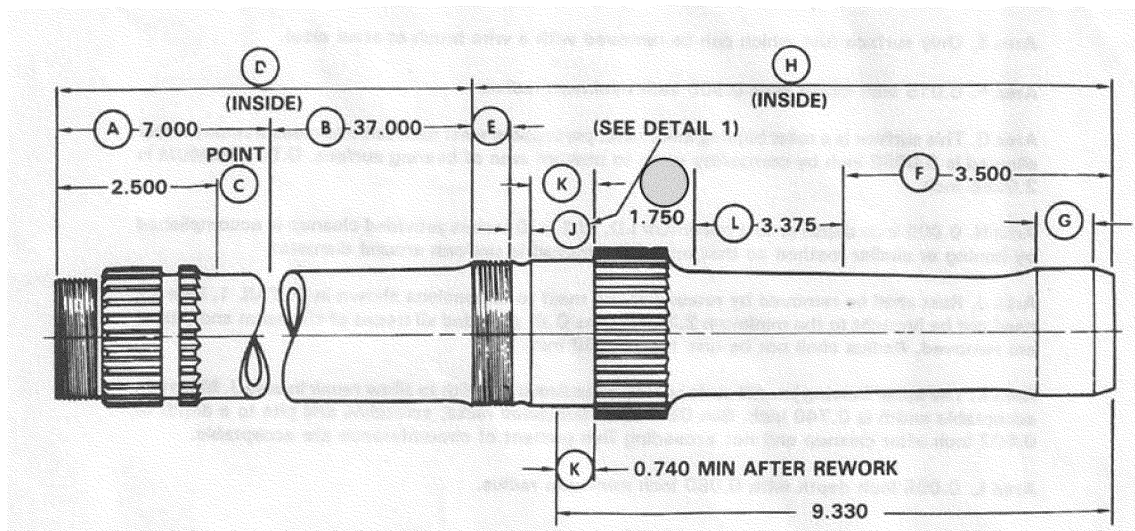
**Figure 1 to Paragraph (e)**

AFE reported two failures of a mast on an OH-58A+ and an OH-58C helicopter used in agricultural spraying operations. Investigation revealed that the mast failures were caused by fatigue cracking, which initiated from corrosion pitting found in the threaded section of the mast approximately 45 inches from

- (i) Overhaul the main rotor mast assembly and magnetic particle inspect the mast; mast bearing nut; plate, mast and seal; and bearing liner for a crack.
- (ii) Fluorescent penetrant inspect the locking plate for a crack.
- (iii) Using a 10X or higher magnifying glass, inspect the threaded area of the mast

as shown in area E of figure 1 to paragraph (e) of this AD for pitting, corrosion, or a

crack. Remove any surface rust with a wire brush or steel wool.

(2) If there is a crack, pitting, or corrosion, before further flight, replace the mast with an airworthy mast.
