Federal Register

[Docket No. FAA-2013-0023; Directorate Identifier 96-CE-072-AD]

#### Airworthiness Directives; Various Aircraft Equipped With Wing Lift Struts

**ACTION:** Notice of proposed rulemaking (NPRM).

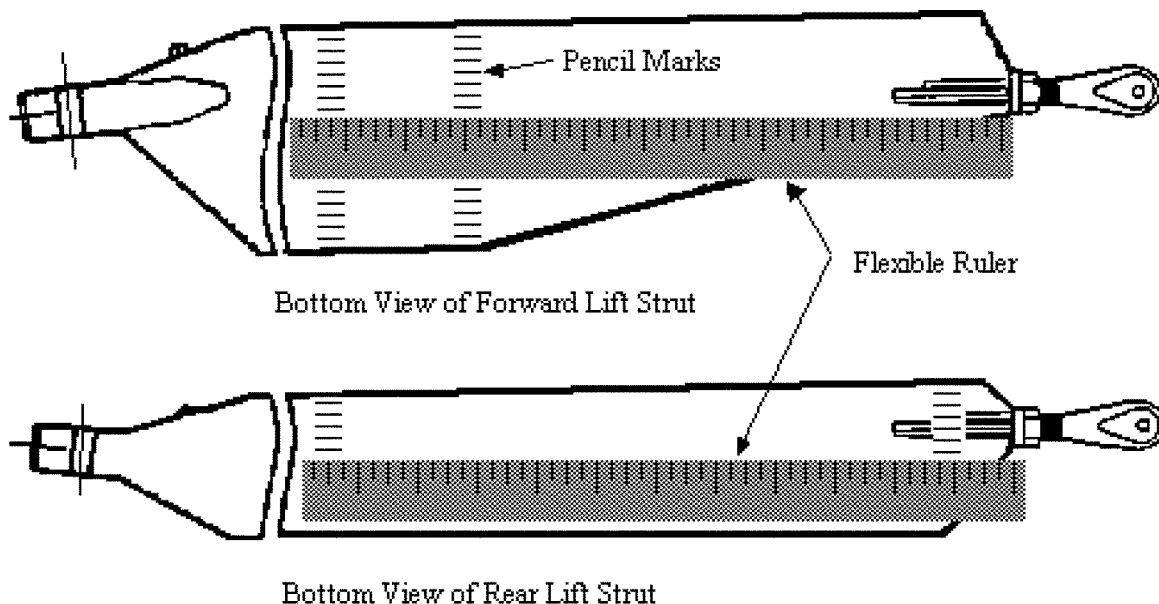
Figure 1

8. A measurement of 0.024-inch or less shall require replacement of the strut prior to further flight.
