## DEPARTMENT OF TRANSPORTATION

### Federal Railroad Administration

#### Notice of Safety Advisory 2006-02

**SUMMARY:** This safety advisory provides recommended practices for the testing, classification, and reuse of second-hand rail.<sup>1</sup> The purpose of this safety advisory is to reduce the number of rail defects that occur when second-hand rail is used.

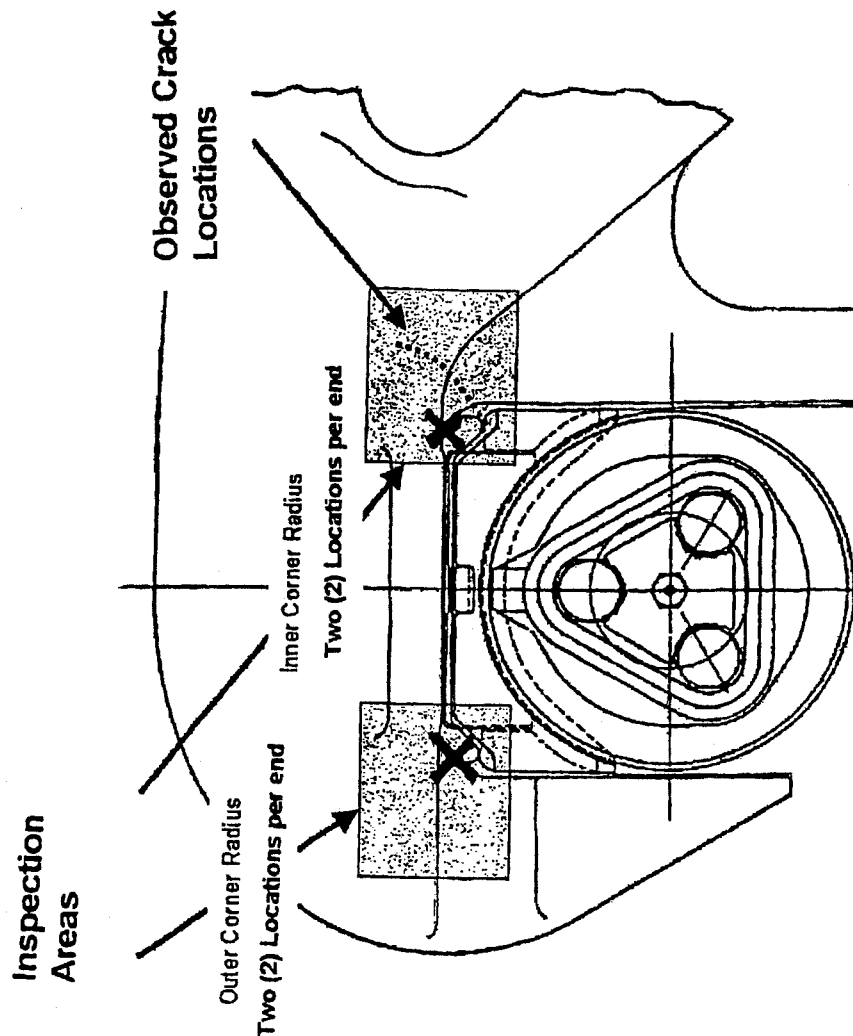
**Fig. 1 Showing Eight Inspection Locations Per Side Frame**
