[Docket No. FAA-2013-0486; Directorate Identifier 2010-SW-031-AD]

#### Airworthiness Directives; MD Helicopters, Inc. (MDHI), Helicopters

**ACTION:** Notice of proposed rulemaking (NPRM).

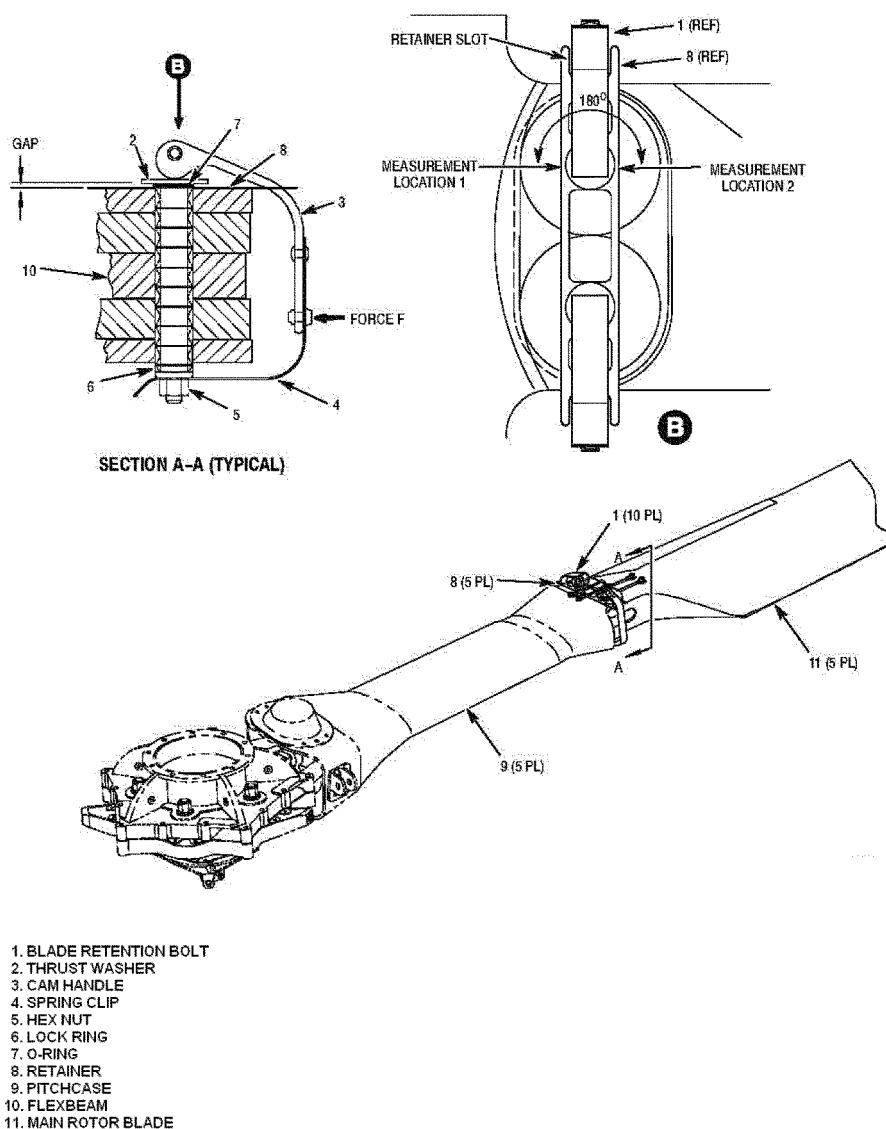
Figure 1 to paragraph (e) of this AD

This AD defines the unsafe condition as bolt failure. This condition could result in loss of main rotor blade structural integrity and subsequent loss of control of the helicopter.

- (1) Before the first flight of each day:
  - (i) Visually check each bolt for failure. Failure of a bolt may be indicated by movement of the bolt out of the bolt hole or by inconsistent extension of the bolt above or below the other bolts being inspected (a failed bolt migrates out of the bolt hole).
  - (ii) Visually check for a gap between the thrust washer and the retainer, P/N 900R2100009–101 or –103. The thrust washer is depicted as item 2 and the retainer is depicted as item 8 in Figure 1 to paragraph (e) of this AD.

(iv) If there is any indication of bolt failure or if there is no gap between the thrust washer and retainer, before further flight, remove and inspect the bolt for a crack.

Replace any cracked bolt with an airworthy bolt.

(iii) If there is a gap between the thrust washer and retainer, measure the gap in two locations, 180 degrees apart, with a feeler gage. If the gap is more than 0.100 inch (2.54 mm) at either location, before further flight, remove and inspect the bolt for a crack. Replace any cracked bolt with an airworthy bolt.
