## DEPARTMENT OF TRANSPORTATION

[Docket No. FAA-2013-0340; Directorate Identifier 2010-SW-081-AD]

#### Airworthiness Directives; Eurocopter Deutschland GmbH Helicopters

**ACTION:** Notice of proposed rulemaking (NPRM).

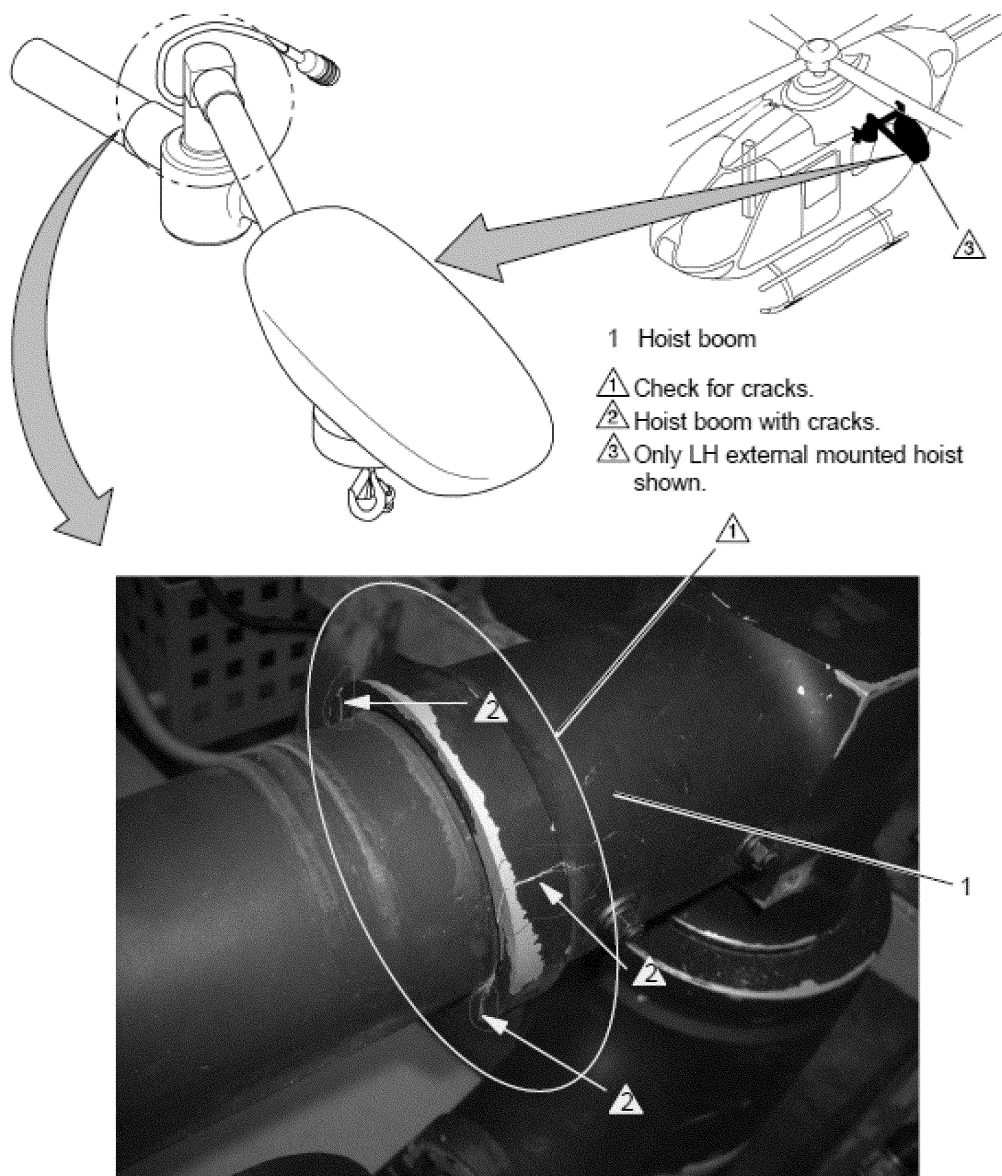
This AD defines the unsafe condition as a crack in the boom. This condition could result in loss of the boom and attached loads, and subsequent loss of helicopter control.

(1) Before further flight, and thereafter before the first flight of each day until you have performed the inspection required by paragraph (e)(2) of this AD, clean the hoist and visually check for a crack, paying particular attention to the areas that are circled as depicted in Figure 1 to paragraph (e) of this AD. The actions required by this paragraph may be performed by the owner/operator (pilot) holding at least a private pilot certificate, and must be entered into the aircraft records showing compliance with this AD in accordance with 14 CFR 43.9 (a)(1)–(4) and 14 CFR 91.417 (a)(2)(v). The record must be maintained as required by 14 CFR 91.417, 121.380, or 135.439.

(2) Within 30 days, perform a dye penetrant inspection of the boom in accordance with the Accomplishment Instructions, Section 2.D, of the Goodrich Service Bulletin 44307-500-03, Revision 2, dated April 30, 2010 (SB).

(3) If a crack exists in the boom, replace the cracked boom with an airworthy boom before further flight.
