[Docket No. 2002–NE–07–AD; Amendment 39–12760; AD 2002–10–14]

Airworthiness Directives; Bombardier-Rotax GmbH 914 F Series Reciprocating Engines

2002-10-14 Bombardier-Rotax GmbH:
Amendment 39-12760. Docket No. 2002-NE-07-AD.

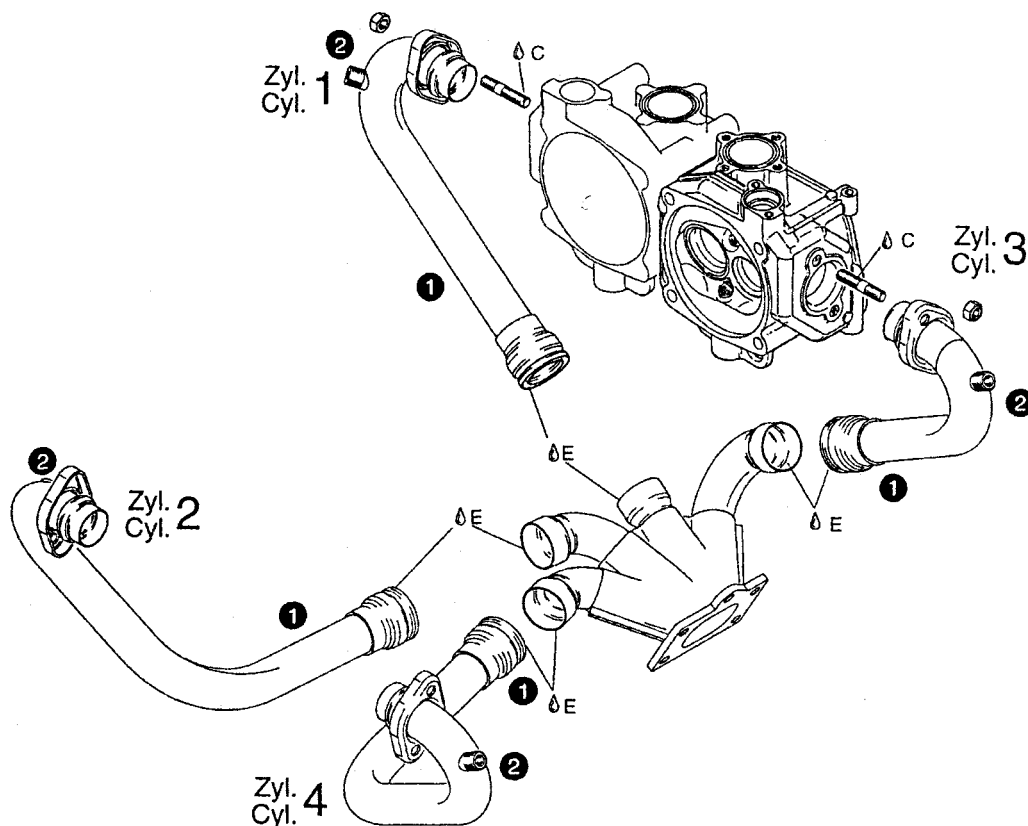
(a) Within 50 hours time-in-service (TIS) after the effective date of this AD, visually inspect the exhaust bend assemblies (item 1, Figure 1, of this AD), located between the cylinder heads and exhaust manifold assembly, for exterior traces of smoke, cracks, and damage, especially around the exhaust gas temperature (EGT) bosses (item 2). Replace any exhaust bend assembly found cracked. Figure 1 follows:

1) Exhaust Bend Assembly

2) EGT Boss

(b) Thereafter, inspect the exhaust bend assemblies every additional 50 hours TIS. Replace any exhaust manifold assembly found cracked.

(c) If any exhaust bend assembly is replaced, perform a ground test run and exhaust leakage test.
