[Docket No. 99-SW-34-AD]

Airworthiness Directives; Eurocopter France Model SA-365N1, AS-365N2, and SA-366G1 Helicopters

ACTION: Notice of proposed rulemaking (NPRM).

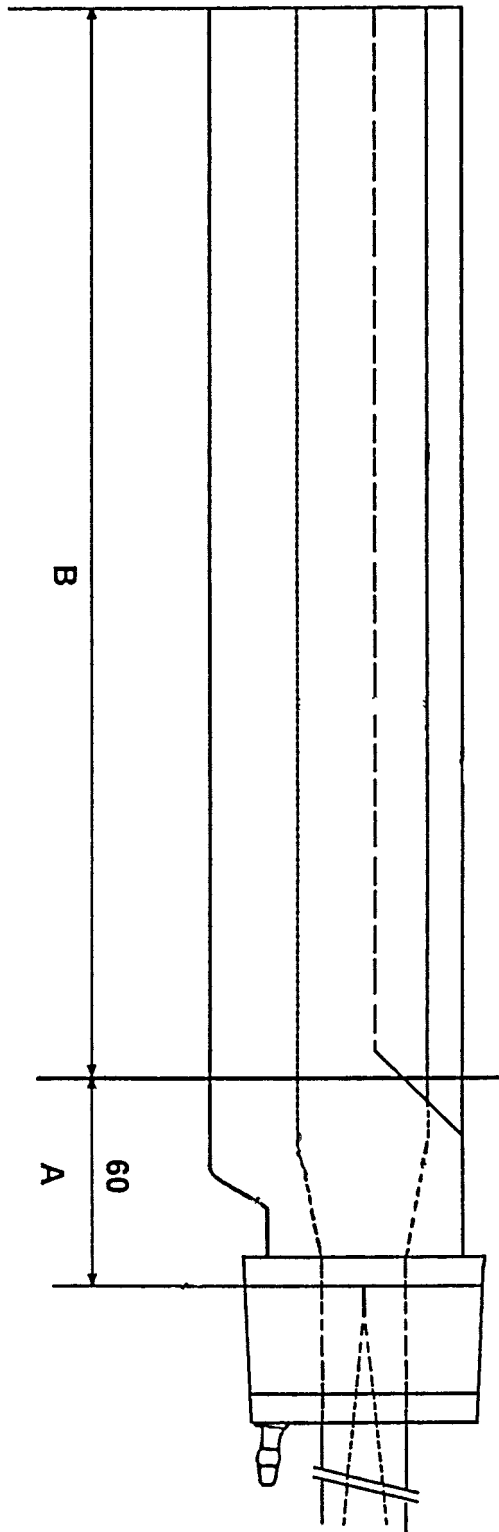
FIGURE 1

day, conduct the following visual inspection of each blade (see Figure 1):

(1) Zone A: If a blister is detected on the blade suction face, conduct a tapping test inspection on the whole blade for bonding separation. If bonding separation or a crack is found, replace the blade with an airworthy blade before further flight.

(2) Zone B: If a crack, wrinkling, or a blister is found, replace the blade with an airworthy blade before further flight.
