[Docket No. FAA-2010-1303; Directorate Identifier 2010-SW-049-AD]

#### Airworthiness Directives; Eurocopter France (Eurocopter) Model SA-365N, SA-365N1, AS-365N2, AS 365 N3, and SA-366G1 Helicopters

**ACTION:** Notice of proposed rulemaking (NPRM).

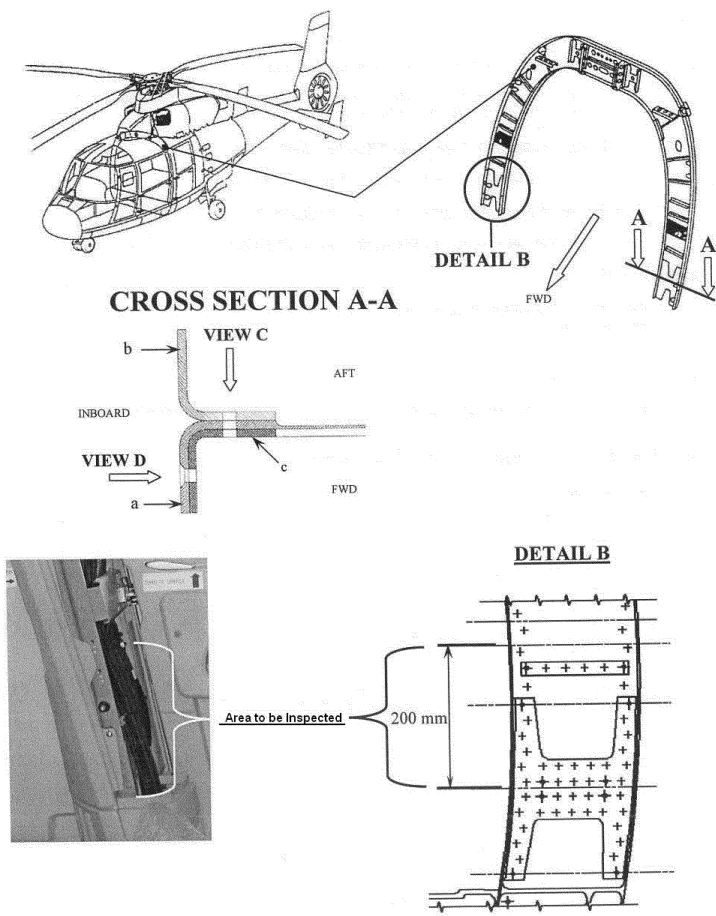
- (a) On or before the affected model helicopters reach the hours time-in-service (TIS) listed in Table 1 of this AD or within 10 hours TIS, whichever occurs later, unless accomplished previously, and thereafter at intervals not to exceed 110 hours TIS, using a 10X or higher magnifying glass, inspect the inner angles and flanges of the 9-degree fuselage frame on the right hand and left hand sides for a crack in the area depicted in Figure 1 and as shown in Figure 2 of this AD.

(b) If you find a crack, before further flight, repair the frame. Repairing a frame does not constitute terminating action for the
