[Docket No. FAA-2007-27229; Directorate Identifier 2007-NE-03-AD; Amendment 39-15359; AD 2008-03-09]

Airworthiness Directives; CFM International, S.A. CFM56-7B Series Turbofan Engines

ACTION: Final rule.

2008–03–09 CFM International, S.A.:
Amendment 39–15359, Docket No. FAA–2007–27229; Directorate Identifier 2007–NE–03–AD.

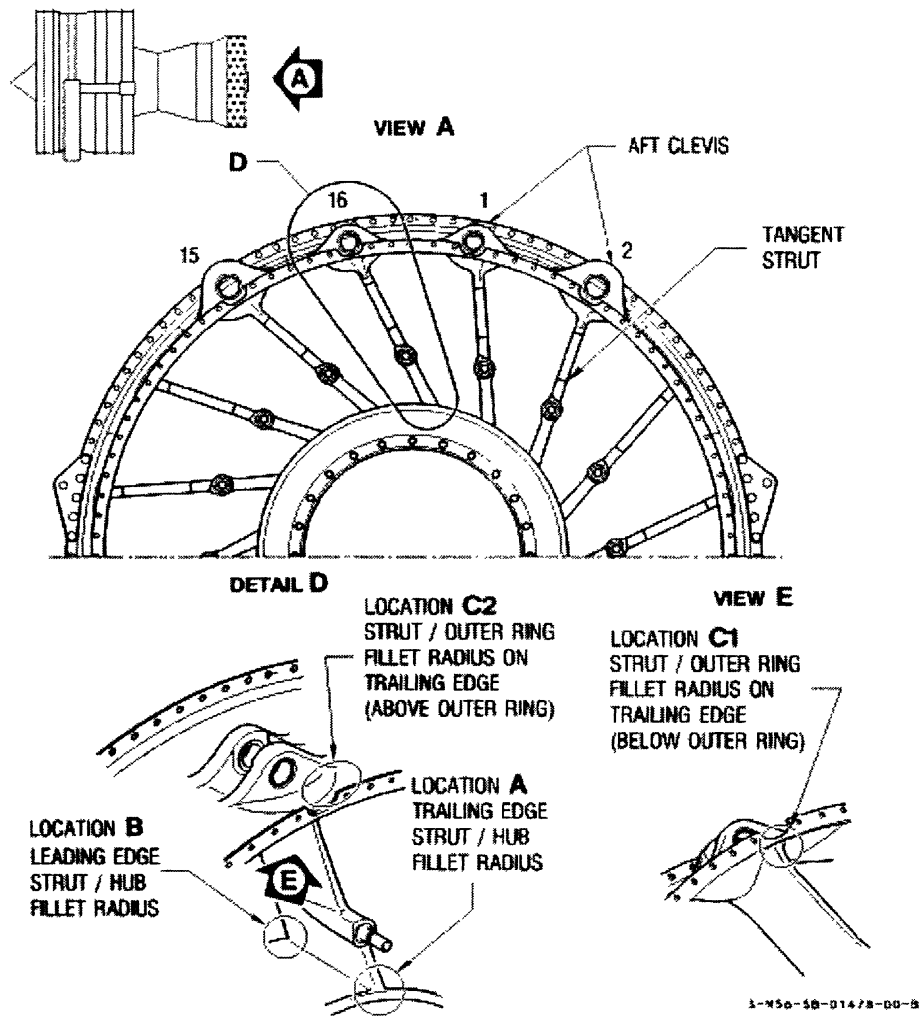
Figure 805

threshold for inspecting certain TRFs. We are issuing this AD to prevent failure of the TRF from low-cycle fatigue cracks. Failure of the TRF could result in engine separation from the airplane, which could lead to loss of control of the airplane.

Figure index No.	Inspection location	Inspection threshold (cycles since new)	Inspection intervals (cycles)	Inspection reference
805	Strut/outer ring fillet radius on trailing edge (A). Strut/hub fillet radius on leading edge (B). Strut/outer ring fillet radius on trailing edge (C1 below outer ring). Strut/outer ring fillet radius on trailing edge (C2 above outer ring).	25,000* for –7B SAC (except business jet) engine models. 19,000* for –7B SAC business jet engine models.	Refer to Figure 806* for –7B SAC (except business jet) engine models. Refer to Figure 807* for –7B SAC business jet engine models.	Refer to SB 72–0579.*

Turbine Rear Frame with Tangential Struts P/N 340-166-205-0,
 340-166-206-0, 340-166-207-0, 340-166-208-0, 340-166-209-0, 340-166-210-0 –
 Areas to Be Inspected

If no crack is found on any of the four mount struts, the turbine rear frame is serviceable and must be re-inspected at 4,700 cycle repetitive intervals. If cracks are found on the mount struts, the TRF must be re-inspected according to the following repetitive intervals:

TOTAL CUMULATED CRACK LENGTH AT EACH LOCATION	RE-INSPECT WITHIN
$L < 0.20$ (5)	4,700
$0.20 (5) \leq L < 0.28$ (7)	3,300
$0.28 (7) \leq L < 0.39$ (10)	1,300
$0.39 (10) \leq L < 0.59$ (15)	700
$0.59 (15) \leq L < 0.79$ (20)	120
$L \geq 0.79$ (20)	IMMEDIATELY REMOVE THE TURBINE FRAME

During each inspection, all the locations must be inspected. If cracks are found at different locations, the repetitive inspection interval is the minimum interval corresponding to the max. cumulated crack lengths.
