[Docket No. FAA-2022-0891; Project Identifier AD-2022-00585-A,E,R]

Airworthiness Directives; Various Airplanes, Helicopters, and Engines

ACTION: Notice of proposed rulemaking (NPRM).

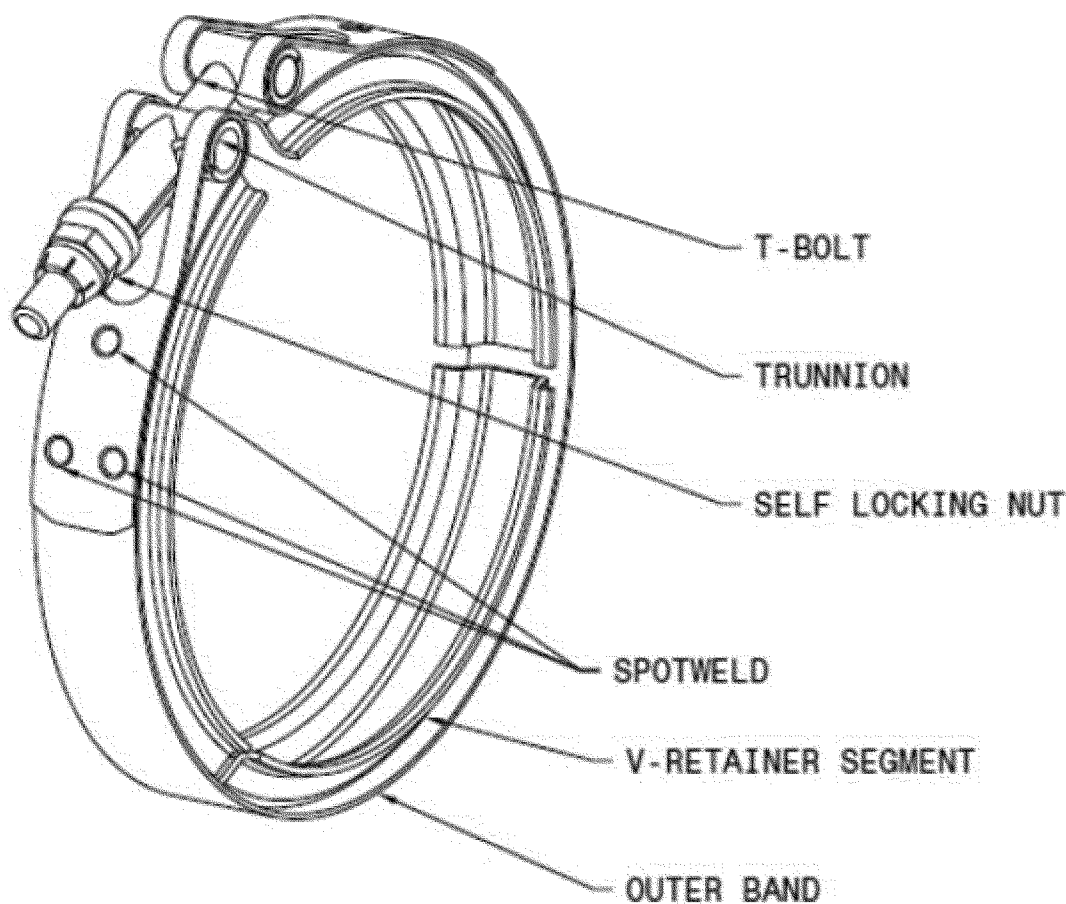
Figure A

The final report concluded that the common denominator in the incidents and accidents reviewed is the spot-welded, multi-segment exhaust tailpipe v-band coupling (see Figure A). These couplings come in either two or three segment varieties. The segments are the number of v-retainer segments, which are attached to the outer band via spot welds. Although multi-segment exhaust tailpipe couplings can also be riveted, the riveted couplings do not create an unsafe condition.

Spot-welded, multi-segment exhaust tailpipe v-band coupling

The majority of the events studied by the working group indicated fatigue failure of spot-welded, multi-segment exhaust tailpipe v-band couplings as a result of stress corrosion cracking that originated at or near a spot weld. This is the same unsafe condition identified in the other v-band coupling AD actions previously referenced. The data studied by the working group contained evidence of pre-existing cracking of the couplings, known embrittlement at the spot weld locations simply due to that manufacturing method, and outer band cupping on the multi-segment couplings (which is the result of age, over-use, and potential over-torqueing). The working group also found that many of the couplings had safety wire across the bolt end. The safety wire could be helpful if there was a bolt or nut failure (extremely rare events) or the nut was missing. However, the safety wire was of no value when the failure was transverse band cracking and total

This condition, if not addressed, could lead to failure of the spot-welded, multi-segment exhaust tailpipe v-band coupling, leading to detachment of the exhaust tailpipe from the turbocharger and allowing high-temperature exhaust gases to enter the engine compartment. This could result in smoke in the cockpit, in-flight fire, and loss of control of the aircraft.

- Repetitively inspecting the spot-welded, multi-segment exhaust tailpipe

- Establishing a life limit for the spot-welded, multi-segment exhaust tailpipe v-band couplings by removing them from service every 500 hours TIS.

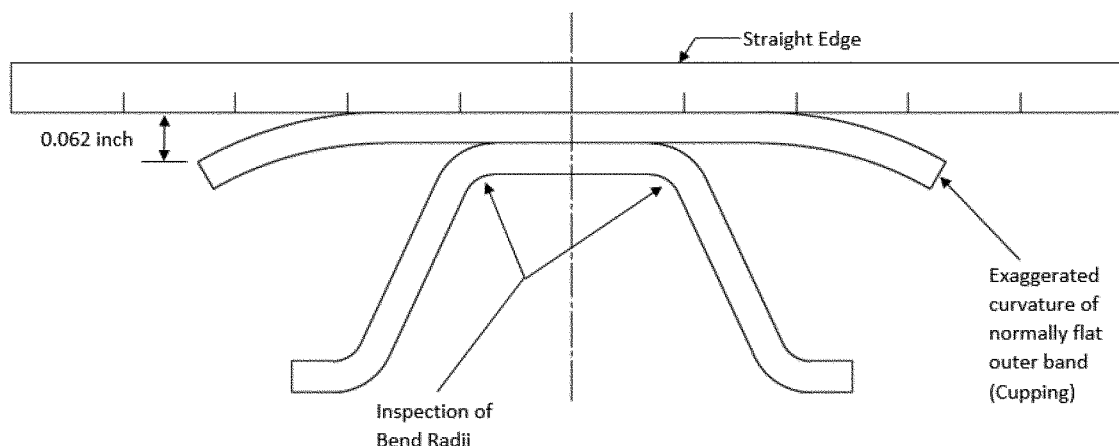
Figure 1 to paragraph (k)(1)(iii) – Inspection Depiction

(iii) Visually inspect the flatness of the outer band using a straight edge. Lay the straight edge across the width of the outer band as depicted in figure 1 to paragraph (k)(1)(iii) of this AD. If the gap between the outer band and the straight edge exceeds 0.062 inch, before further flight, remove the v-band coupling from service and install a new v-band coupling.

(v) Visually inspect the bend radii of the v-retainer coupling segments, throughout the length of the segment, as depicted in figure 1 to paragraph (k)(1)(iii) of this AD, for cracks. If there are any cracks, before further flight, remove the v-band coupling from service and install a new v-band coupling.
