[Docket No. 2002-SW-31-AD]

Airworthiness Directives; Model HH-1K, TH-1F, TH-1L, UH-1A, UH-1B, UH-1E, UH-1F, UH-1H, UH-1L, and UH-1P; and Southwest Florida Aviation Model SW204, SW204HP, SW205, and SW205A-1 Helicopters, Manufactured by Bell Helicopter Textron, Inc. (BHTI) for the Armed Forces of the United States

ACTION: Notice of proposed rulemaking (NPRM).

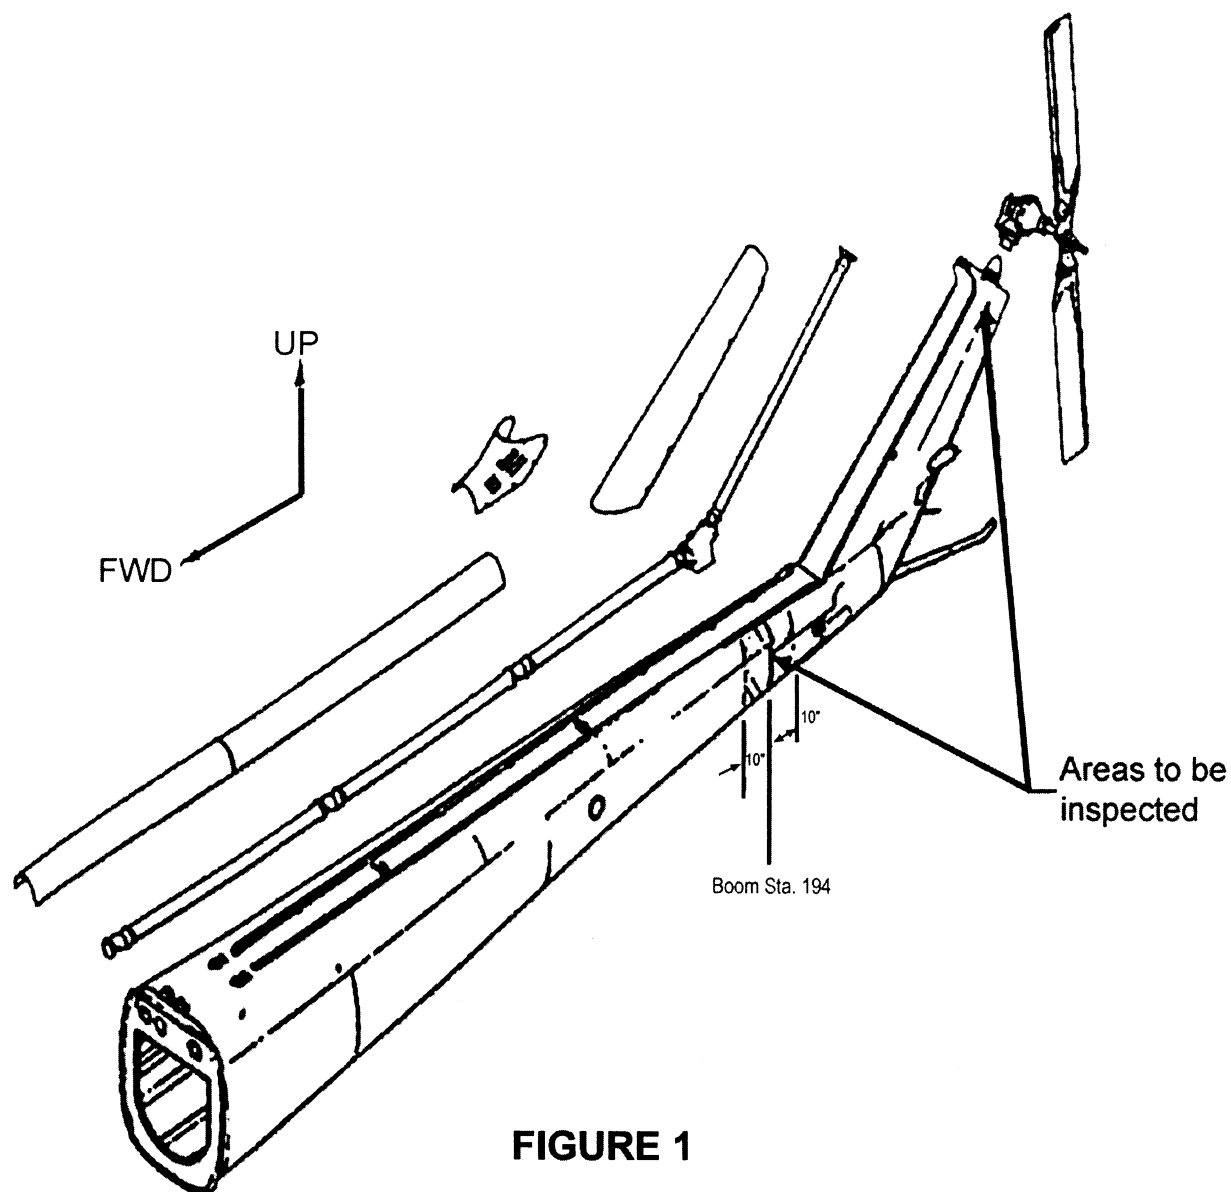
FIGURE 1

To detect a crack in the skin of a tailboom assembly, tail rotor gearbox support fitting, or vertical fin spar, which could cause failure of the tailboom and loss of control of the helicopter, accomplish the following:

(1) Visually inspect the tailboom assembly skin joint at Boom Station (BS) 194 for fretting, corrosion, loose or working rivets, or a crack. Inspect 10 inches forward and 10 inches aft of BS 194 (BS 194 skin joint area) as shown in the following Figure 1:

Note 2: The tailboom skin joint at BS 194 is located at the bulkhead just forward of the attachment area for the 42-degree tail rotor gearbox assembly (42-degree gearbox) and the intersection between the vertical fin forward canted bulkhead and the lower tailboom skin.

(2) Visually inspect the vertical fin forward spar caps (2) for a crack at the intersection with the tail rotor gearbox support fitting. Refer to Figure 1 of this AD.

(b) Before further flight, and thereafter at intervals not to exceed 500 hours TIS, radiographically inspect the BS 194 skin joint area in accordance with the requirements of ASTM E 1742-00, MIL-STD-453C, or another FAA-accepted equivalent, for any tailboom assembly with:

(c) If a crack is found in any part, replace it with an airworthy part before further flight. Repair any corrosion or other damage that exceeds the limitations in the maintenance or overhaul manuals before further flight.
