[Docket No. FAA–2008–1207; Directorate Identifier 2007–NE–47–AD; Amendment 39–15880; AD 2009–08–07]

Airworthiness Directives; Honeywell International Inc. ALF502L–2 and ALF502L–2C Turbofan Engines

2009-08-07 Honeywell International Inc. (Formerly AlliedSignal and Lycoming): Amendment 39-15880. Docket No. FAA-2008-1207; Directorate Identifier 2007-NE-47-AD.

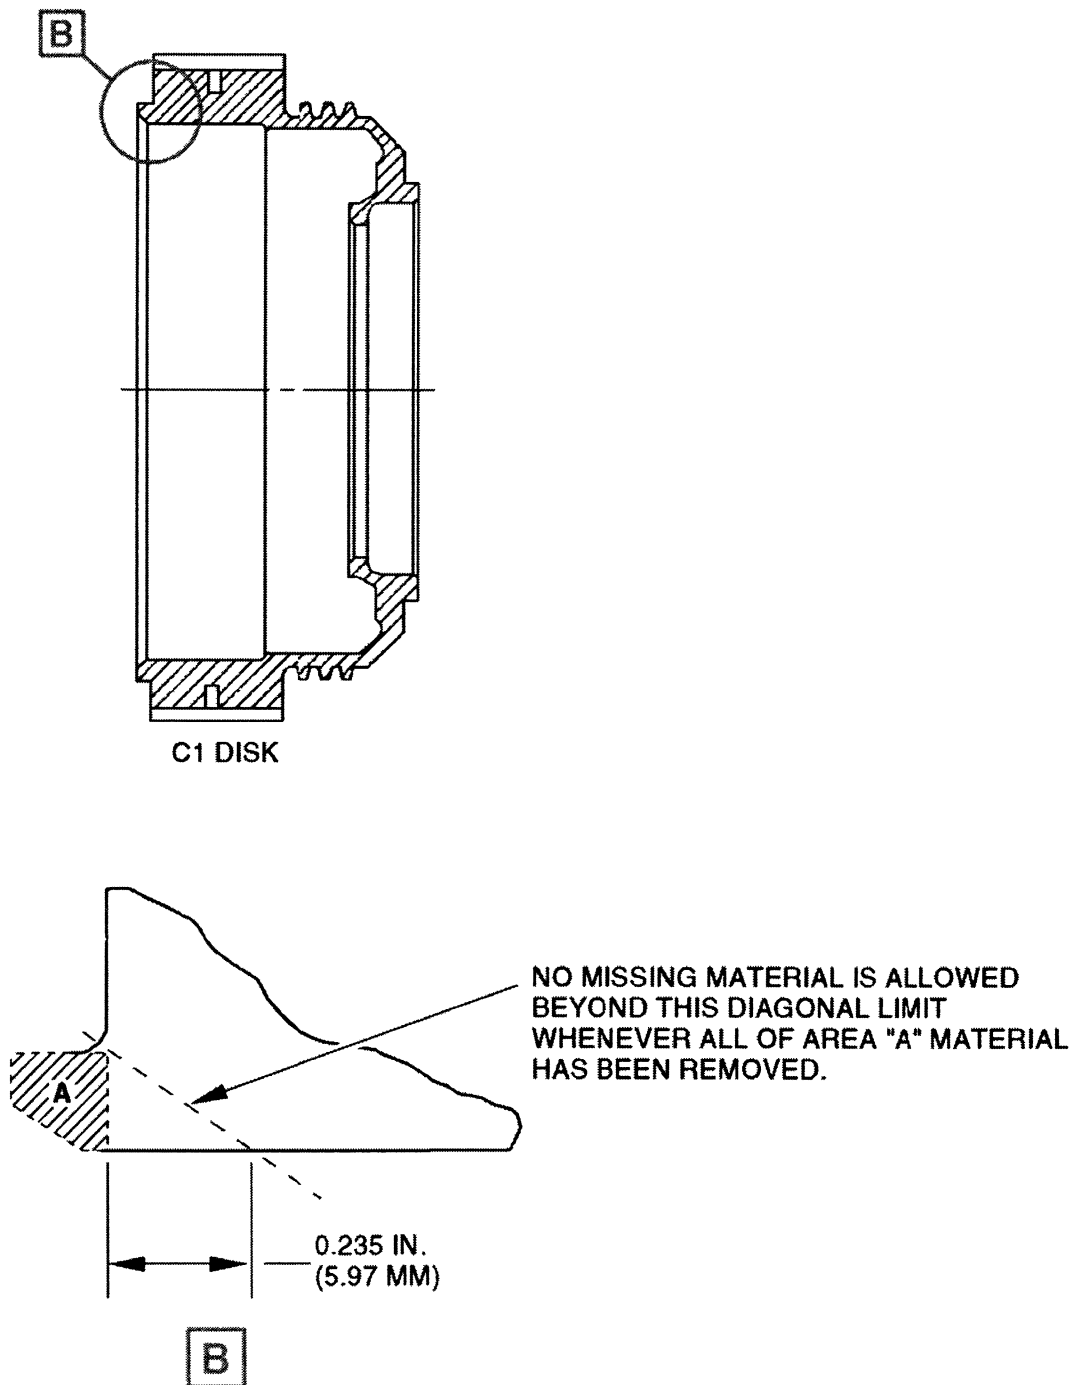
Limits for Removed Balance Material, Disc Forward Flange
Figure 1 (Sheet 1 of 2)

- (f) For discs with 5,000 or more cycles-since-new on the effective date of this AD, perform a dimensional inspection of the HPC first stage disc to determine if excessive disc

balance material was removed. See the following Figure 1 for limits.

(g) Replace the disc if excessive disc balance material was removed. See limits in Figure 1 of this AD.

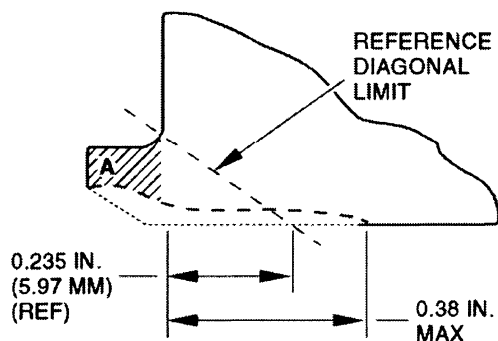
Any remaining Area 'A' lip material is sufficient to permit axial material removal up to 0.38 inch (9.7 mm) limit. Surface shall have a smooth contour and 0.020 inch (0.51 mm) minimum blend radius.

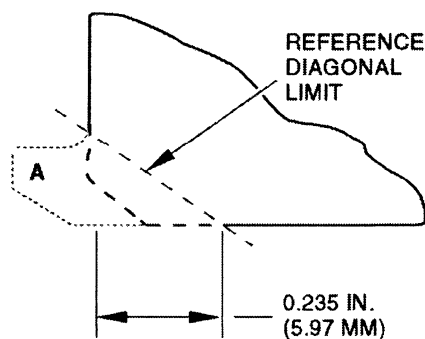
Removal of all Area 'A' material is permitted when axial material removal is less than 0.235 inch (5.97 mm) diagonal limit. Surface shall have a smooth contour and 0.020 inch (0.51 mm) minimum blend radius.

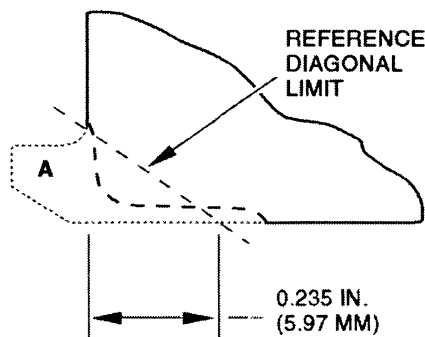
No Area 'A' material remaining and 0.235 inch (5.97 mm) diagonal limit is exceeded.
