## DEPARTMENT OF TRANSPORTATION

[Docket No. FAA-2013-0695; Directorate  
Identifier 2011-NM-264-AD]

#### Airworthiness Directives; Saab AB, Saab Aerosystems Airplanes

**ACTION:** Notice of proposed rulemaking  
(NPRM).

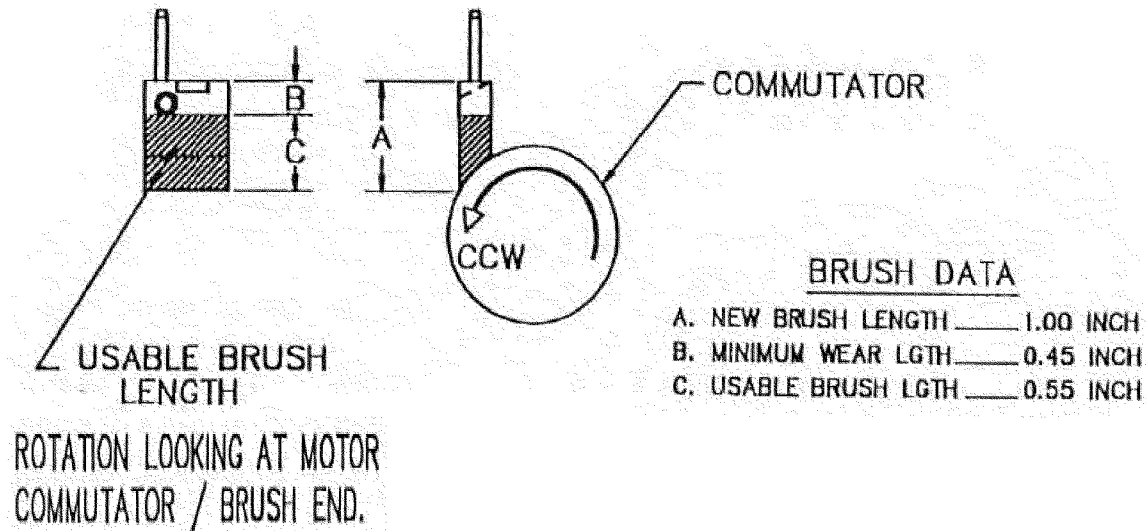
Figure 1 to paragraph (m)(2)(vii) of this AD – Measuring the Brush

(vii) Measure each brush as shown in figure below and record values.

(viii) Using the brush with the shortest measured length calculate the wear by subtracting the measured value from 1.000 inch.

(11) Install each new brush set by lifting brush springs, sliding brush into holder (with brush leading edge in direction of motor rotation) and lightly releasing the brush spring on the brush. (See Figure 1 to paragraph (m)(2)(vii) of this AD). CAUTION: Do not allow brush spring to strike hard into place or damage to brush may result.
