**[Docket No. 99-CE-85-AD; Amendment 39-12917; AD 2002-21-11]**

#### **Airworthiness Directives; EXTRA Flugzeugbau GmbH Model EA-300S Airplanes**

**2002-21-11 Extra Flugzeugbau GmbH:**  
Amendment 39-12917; Docket No. 99-CE-85-AD.

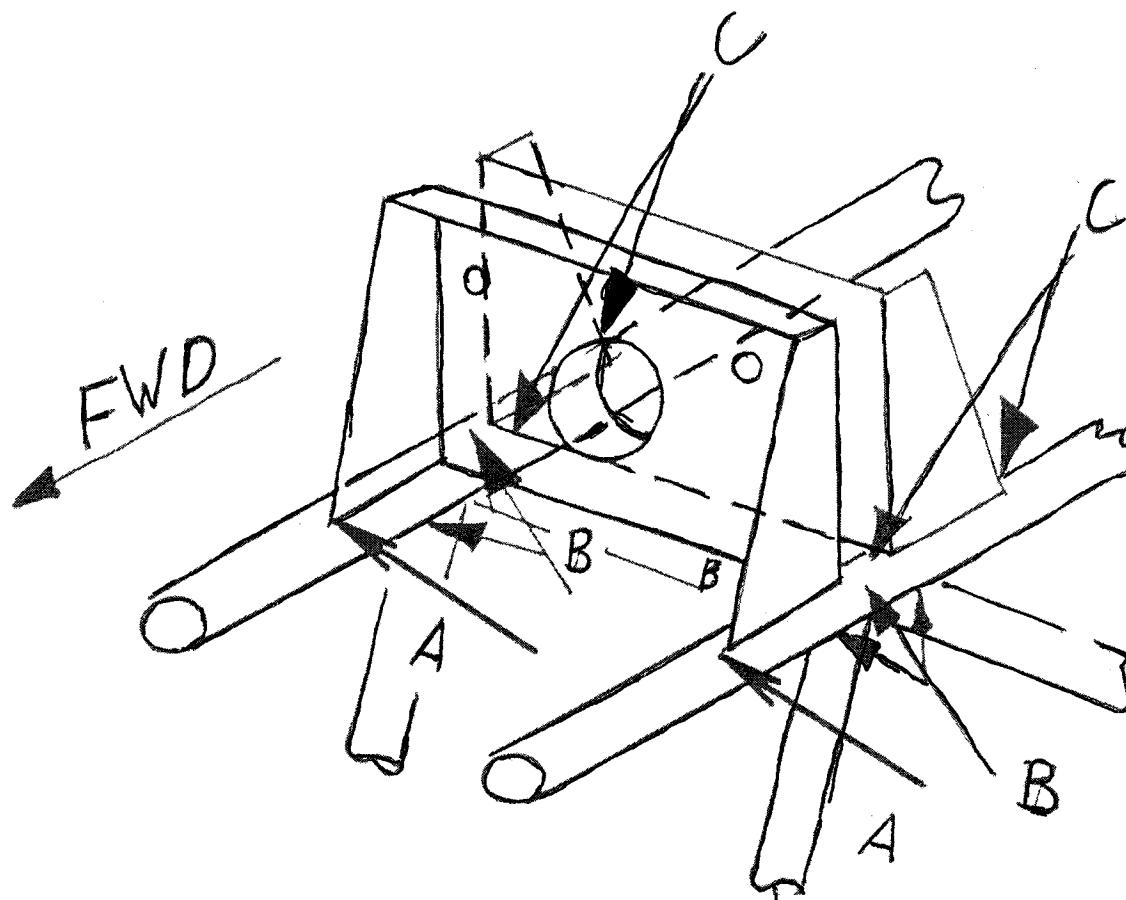
| Actions | Compliance | Procedures |
|---|---|---|
| (1) For all affected airplanes, inspect, using a fluorescent dye penetrant method, the upper longeron at the horizontal stabilizer attachment for cracks in the areas depicted in Figure 1 of this AD. | Upon accumulating 250 hours time-in-service (TIS) or within the next 50 hours TIS after December 17, 2002 (the effective date of this AD), whichever occurs later. | In accordance with Part I of Extra Service Bulletin No. 300-2-95 (pages 2-6 at Issue: C, dated July 15, 1998; and pages 1 and 7 through 11 at Issue: D, dated January 30, 2001). No further action is required by this paragraph if the modification is already accomplished in accordance with Part II of Extra Service Bulletin No. 300-2-95 (all pages at Issue: C, dated July 15, stabilizer 1998). |
| (3) For all affected airplanes, if any crack is found during the inspection required by this AD and the crack(s) is (are) in Area A or Area B as depicted in Figure 1 of this AD, accomplish the following:<br>(i) Repair and modify the upper longeron at the horizontal stabilizer attachment; and<br>(ii) Weld the cracks tight during repair. | Prior to further flight after the inspection where any crack is found in Area A or Area B as depicted in Figure 1 of this AD. | In accordance with Part II of Extra Service Bulletin No. 300-2-95, Issue: D, dated January 30, 2001. No further action is required by this paragraph if already accomplished in accordance with Part II of Extra Service Bulletin No. 300-2-95 (all pages at Issue: C, dated July 15, 1998). |
| (4) For all affected airplanes, if any crack is found during the inspection and the crack(s) is (are) in Area C as depicted in Figure 1 of this AD, accomplish the following:<br>(i) Obtain a repair scheme from the manufacturer;<br>(ii) Incorporate this repair scheme; and<br>(iii) Accomplish any follow-up actions as directed by the FAA. | Prior to further flight after the inspection where any crack is found. | In accordance with a repair scheme obtained from EXTRA Flugzeugbau GmbH, Flugplatz Dinslaken, D-46569 Hünxe, Federal Republic of Germany; telephone: (0 28 58) 91 37-00; facsimile: (0 28 58) 91 37-30. Obtain this repair scheme through the FAA at the address specified in paragraph (g) of this AD. |

| Actions | Compliance | Procedures |
|---|---|---|
| (2) For all affected airplanes, if no crack(s) is (are) found during the inspection required by this AD, modify the upper longeron at the horizontal stabilizer attachment. | Prior to further flight after the inspection required by paragraph (d)(1) of this AD. | In accordance with Part II of Extra Service Bulletin No. 300-2-95 (pages 2-6 at Issue: C, dated July 15, 1998; and pages 1 and 7 through 11 at Issue: D, dated January 30, 2001). No further action is required by this paragraph if already accomplished in accordance with Part II of Extra Service Bulletin No. 300-2-95 (all pages at Issue: C, dated July 15, 1998). |
