[Docket No. FAA-2004-18850; Directorate Identifier 2004-SW-19-AD; Amendment 39-14694; AD 2004-16-15 R1]

**Airworthiness Directives; Eurocopter France Model AS-365N2, AS 365 N3, EC 155B, EC155B1, SA-365N, N1, and SA-366G1 Helicopters**

#### 2004–16–15 R1 Eurocopter France:

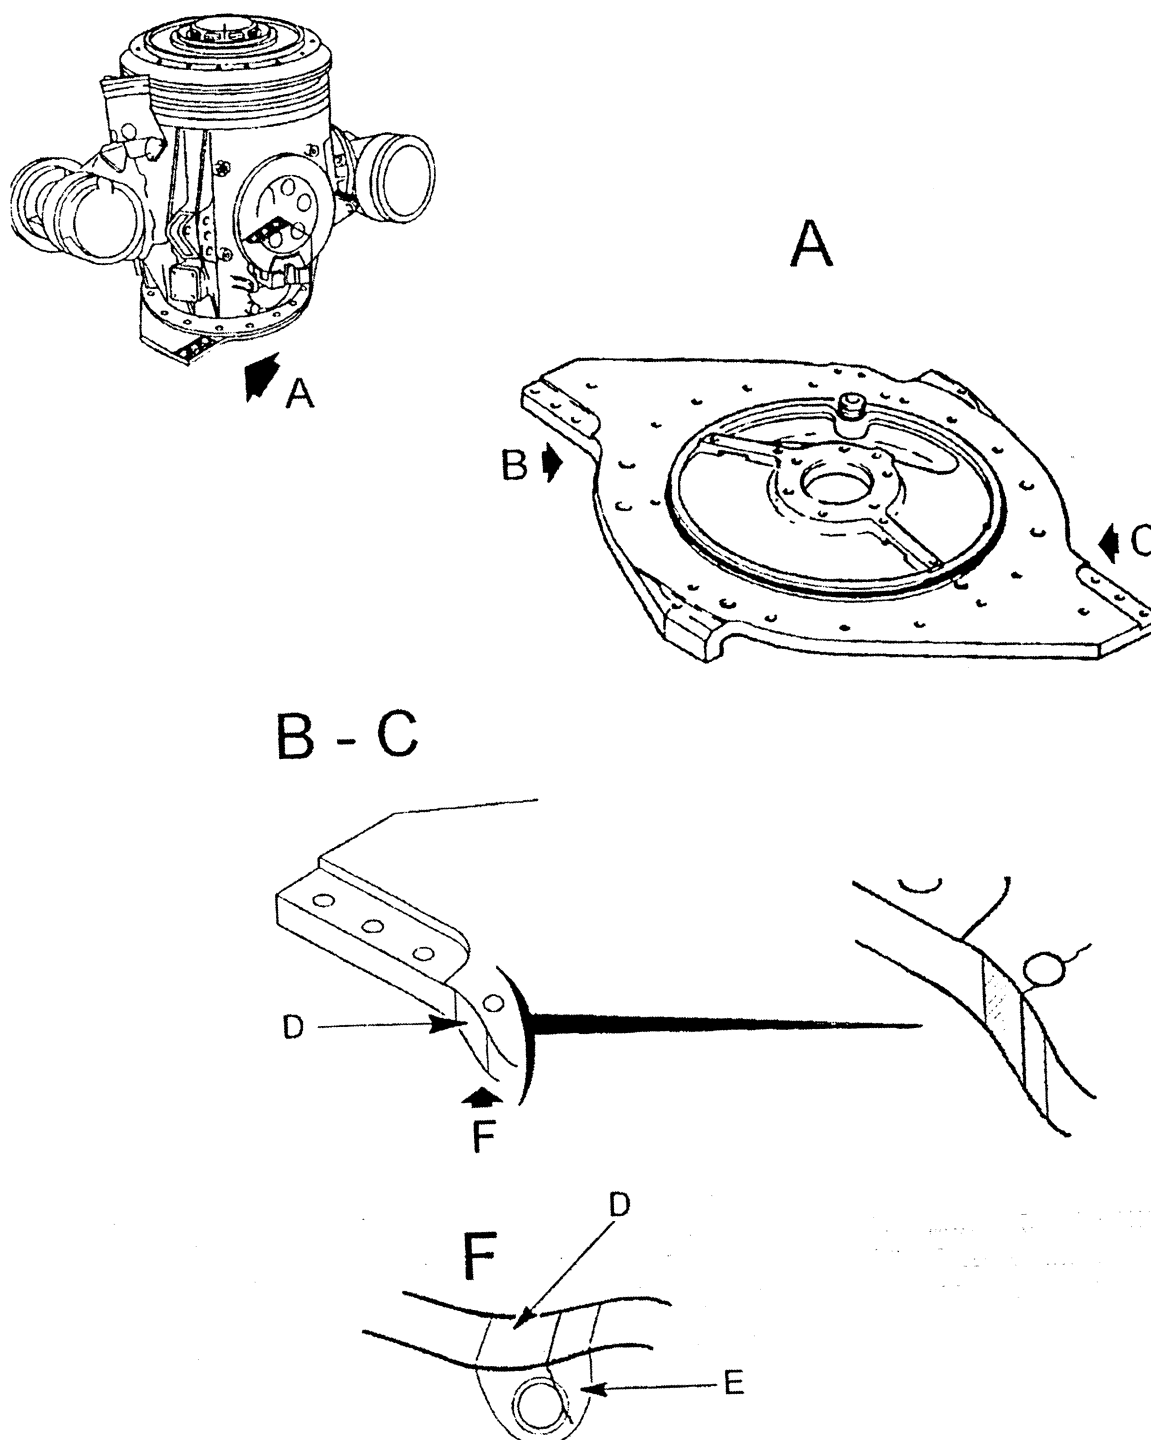
strip the paint from area "D" on both sides ("B" and "C") of the MGB base plate as depicted in Figure 1 of this AD.

(b) At the times indicated in the compliance table, inspect area "D" of the MGB base plate for a crack using a 10x or higher magnifying glass. Area "D" to be inspected is depicted in Figure 1 of this AD.

(c) If a crack is found in a MGB base plate, remove and replace the MGB with an airworthy MGB before further flight.
