[Docket No. 99-SW-34-AD]

#### **Airworthiness Directives; Eurocopter France Model SA-365N1, AS-365N2, and SA-366G1 Helicopters**

**ACTION:** Notice of proposed rulemaking.

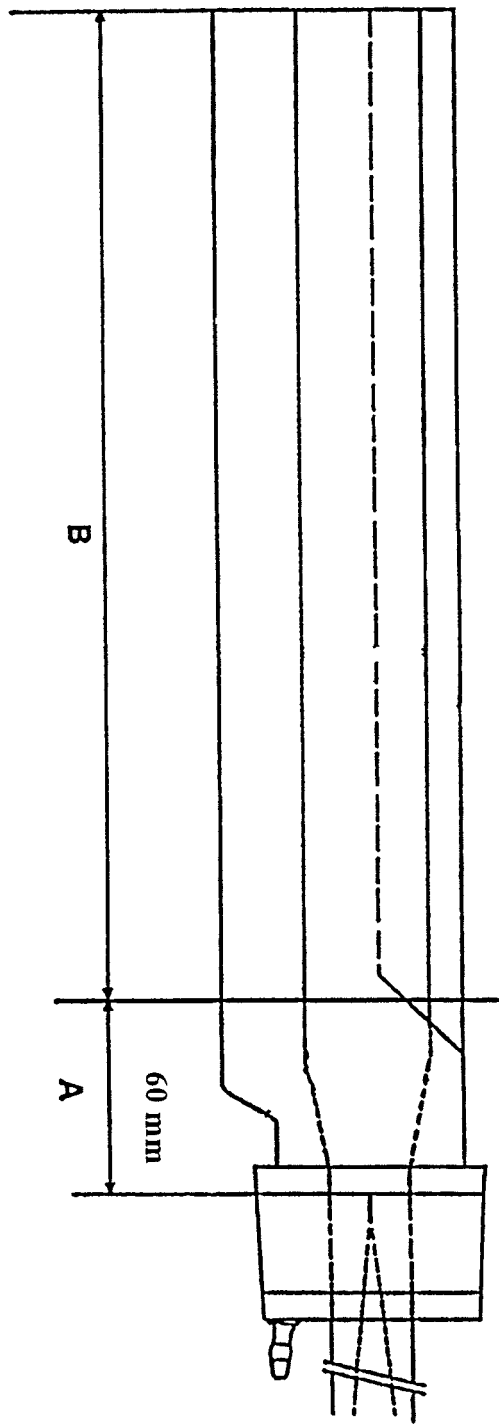
FIGURE 1

(a) Within 10 hours time-in-service (TIS) and thereafter before the first flight of each day, visually check each blade (see Figure 1) for a crack, blister, or wrinkling. An owner/operator (pilot), holding at least a private pilot certificate, may perform the visual check and must enter compliance into the aircraft maintenance records in accordance with 14 CFR sections 43.11 and 91.417(a)(2)(v).

(b) If a crack, blister, or wrinkling is found as a result of the visual check, accomplish the following before further flight (see Figure 1):

(1) Zone A: If a blister is detected on the blade suction face, conduct a tapping test inspection on the whole blade for bonding separation.

(ii) For blades, P/N 365A12-0020-02, and -03, if bonding separation exceeds 900 mm<sup>2</sup> in a 30 x 30 mm square or if there is a crack, replace the blade with an airworthy blade before further flight.

(2) Zone B: If a crack, wrinkling, or a blister is found, replace the blade with an airworthy blade before further flight.

(i) For blades, P/N 365A33-2131-all dash numbers, 365A12-0010-all dash numbers, and 365A12-0020-00, and -01, if bonding separation or a crack is found, replace the blade with an airworthy blade before further flight.

(c) Within 10 hours TIS, conduct a tapping test inspection on each blade. If there is bonding separation that exceeds the criteria in paragraph b(1) of this AD, replace the blade with an airworthy blade before further flight.
