[Docket No. 2003–SW–23–AD]

#### **Airworthiness Directives; Bell Helicopter Textron, a Division of Textron Canada Model 222, 222B, 222U and 230 Helicopters**

**ACTION:** Notice of proposed rulemaking (NPRM).

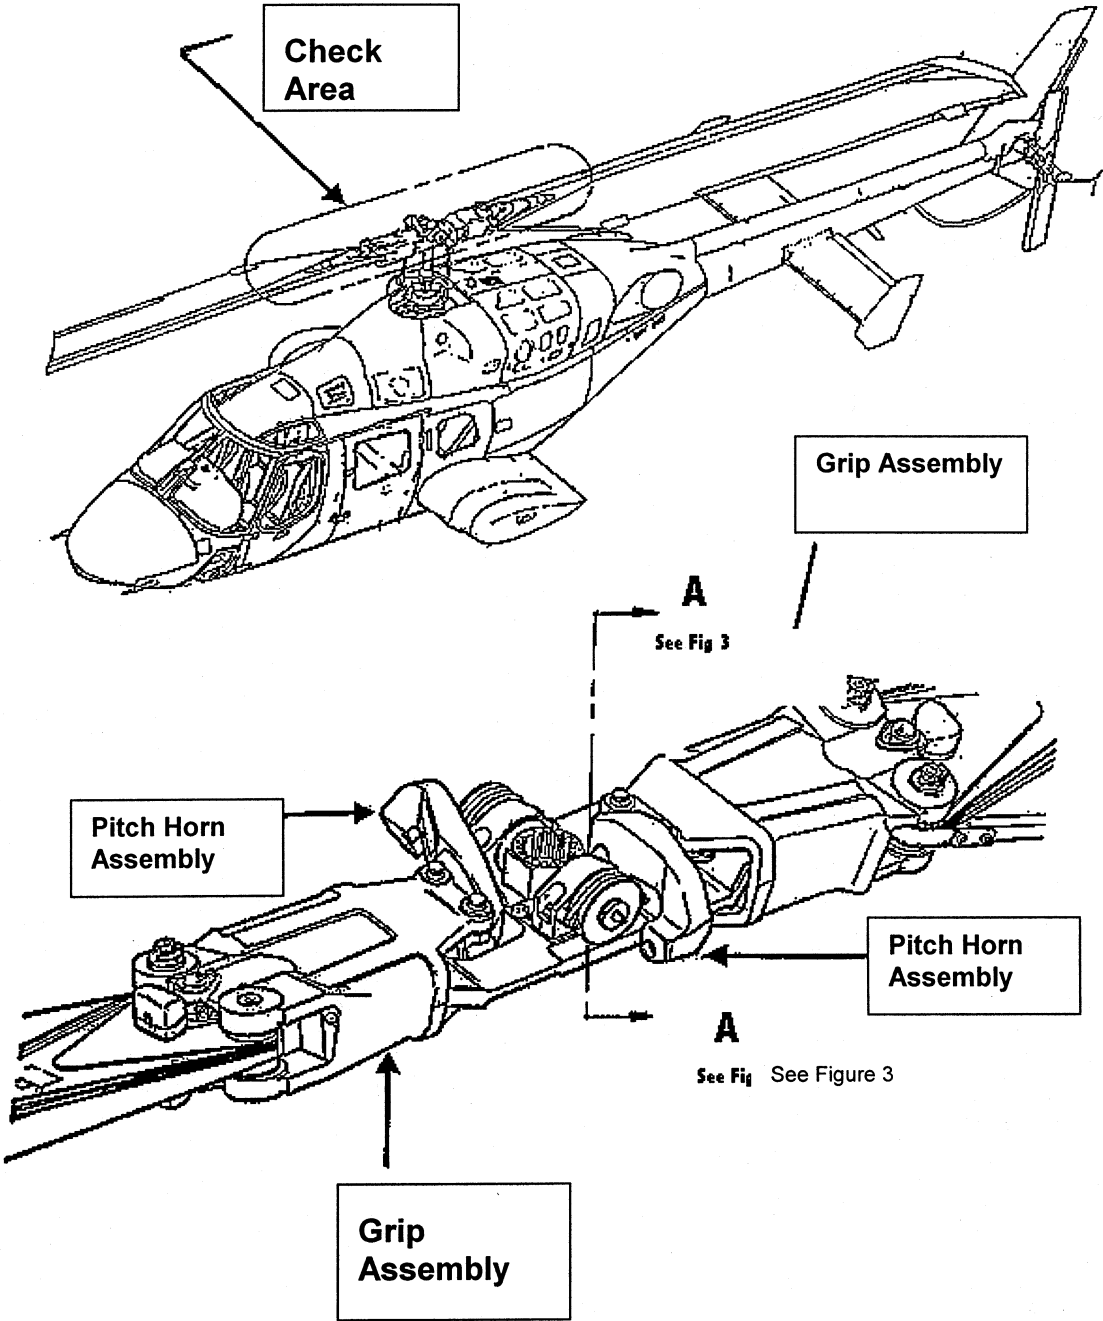
(1) Wipe clean the main rotor grip and pitch horn surfaces to remove grease and dirt

in the check area as shown in Figure 1 of this AD:

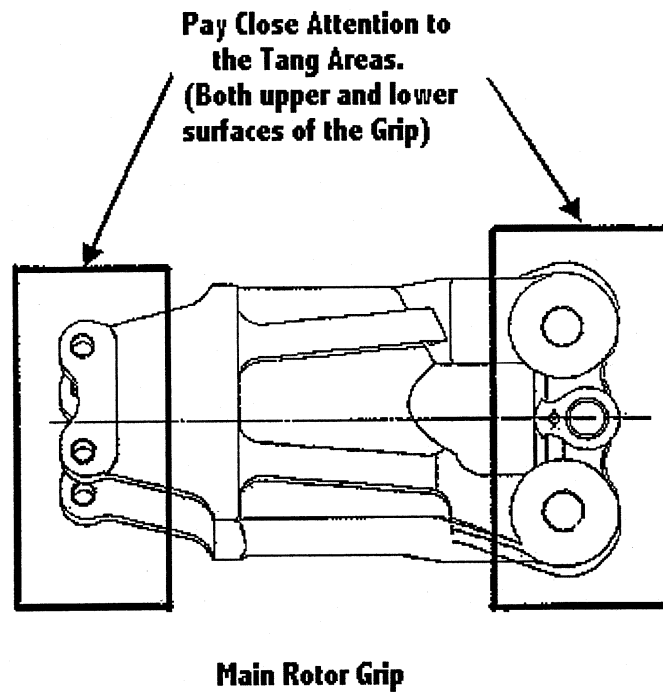
**Figure 2**

(2) Visually check both main rotor grips for a crack. Pay particular attention to the inboard and outboard tangs portions of the

grip, which are in direct contact with the pitch horns and the main rotor blades and check the area to at least 3 inches beyond the

grip to pitch and grip to blade contact areas as shown in Figure 2 of this AD:

**Entire surface of the grip must be checked**

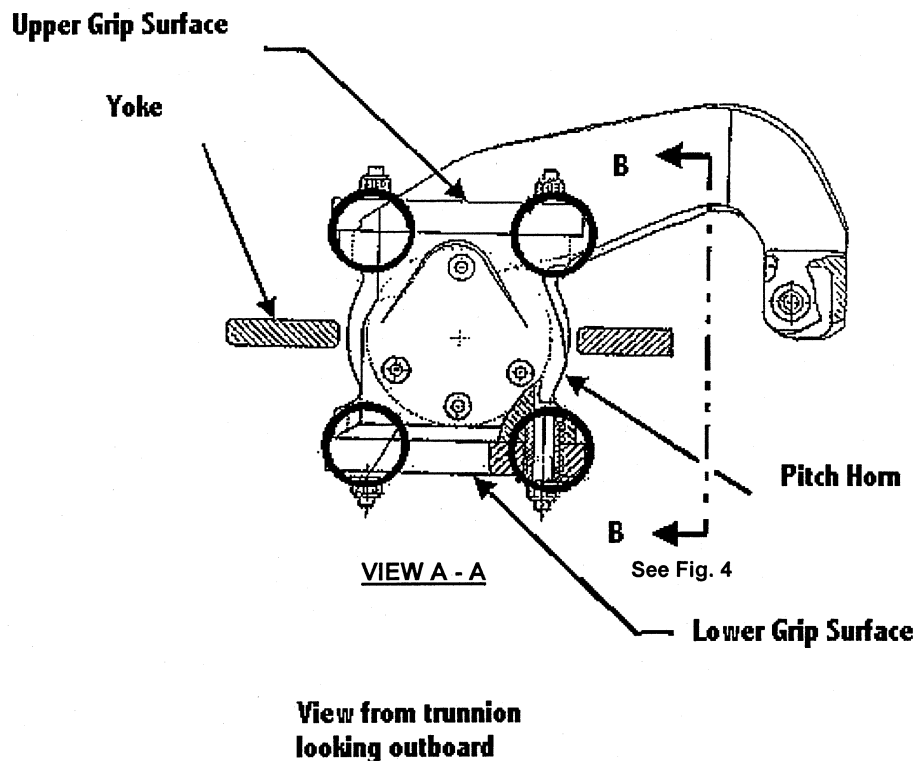
**Figure 3**

(3) Visually check all visible portions of each pitch horn for a crack. Pay particular attention to the attachment lugs of the pitch

horns, which are in direct contact with the inboard tangs of the main rotor grips, as shown in Figure 3 of this AD, and the four

**All visible portions of the pitch horn must be checked.  
Pay particular attention to the circled areas shown above and View B-B, Fig. 4.**

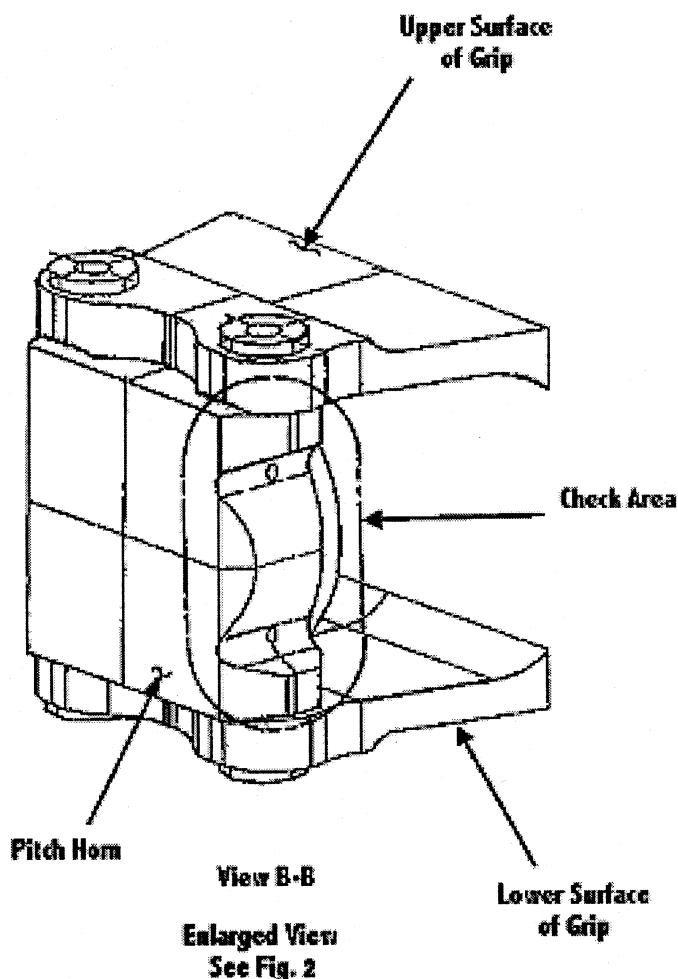
large bolt cutouts, as shown in Figure 4 of this AD:
