[Docket No. 2000–SW–51–AD; Amendment 39–11960; AD 2000–20–51]

**Airworthiness Directives; Robinson Helicopter Company Model R22 Helicopters**

**2000-20-51 Robinson Helicopter Company:**  
Amendment 39-11960. Docket No. 2000-SW-51-AD.

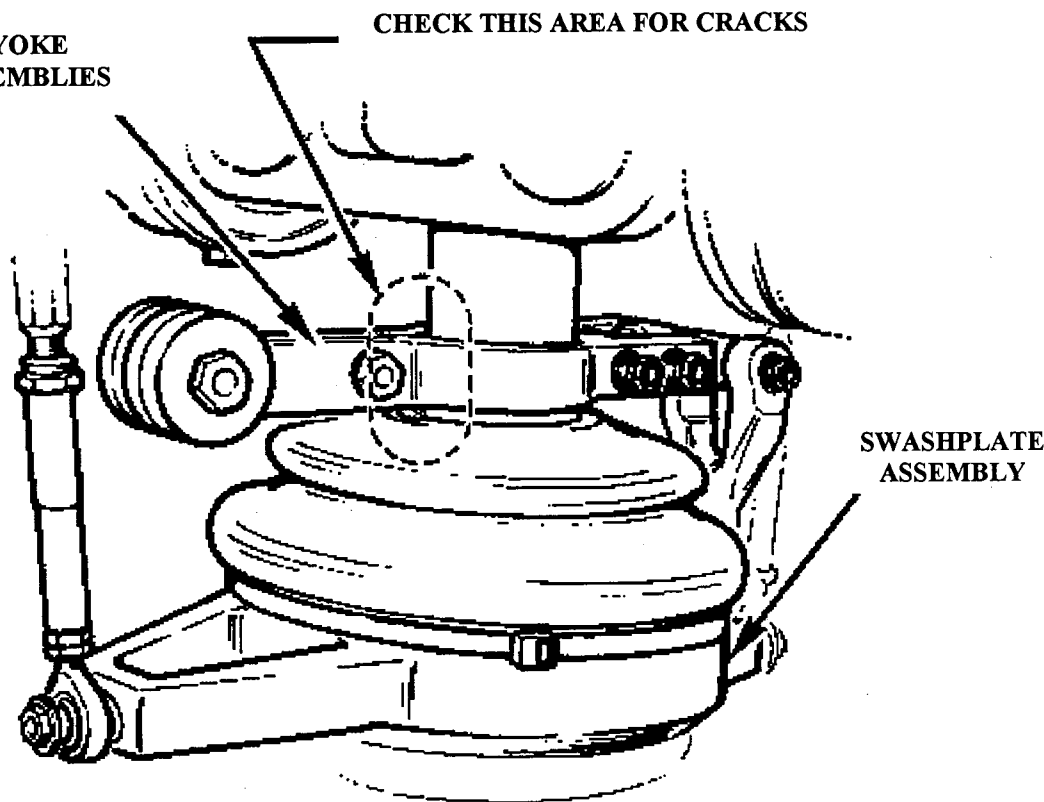
**Figure A**

**SUPPLEMENTARY INFORMATION:** On October 4, 2000, the FAA issued Emergency AD 2000–20–51, for RHC Model R22 helicopters, which requires checking the yoke for any crack and replacing a cracked yoke assembly before further flight. The Emergency AD also requires replacing certain yokes with airworthy yokes before further flight after January 1, 2001. That action was prompted by the discovery of cracks in the yokes. The cracked yokes were still in service and functioned for an unknown duration. Several lots of the yokes were machined from 2024-T3 aluminum billet, which has poor stress corrosion properties in the transverse grain directions. Clamping the yokes in place causes a preload tension in areas that have exposed transverse grain. When these areas are exposed to a corrosive environment, such as salty air, stress corrosion causes crack formation and growth. This condition, if not

(a) Before further flight and thereafter before the first flight of each day, check each yoke for a crack. See Figure A.

(b) If a yoke is cracked, before further flight, replace the yokes with airworthy yokes, P/N A203-7. Both yokes must be replaced with yokes, P/N A203-7.

(2) If the Lot identifier is from 24 through 43, if it is a letter code, or if it is illegible, replace yokes, P/N A203-5, with airworthy yokes, P/N A203-7. Yoke, P/N A203-7, cannot be installed with yoke, P/N A203-5.
